# **Detailed Study of the 8 and 14 September 2023 Landslides on Slope No. 11SE-D/F47 at Shek O Road, Shek O**

**GEO Report No. 376**

**Fugro (Hong Kong) Limited**

**Geotechnical Engineering Office  
Civil Engineering and Development Department  
The Government of the Hong Kong  
Special Administrative Region**

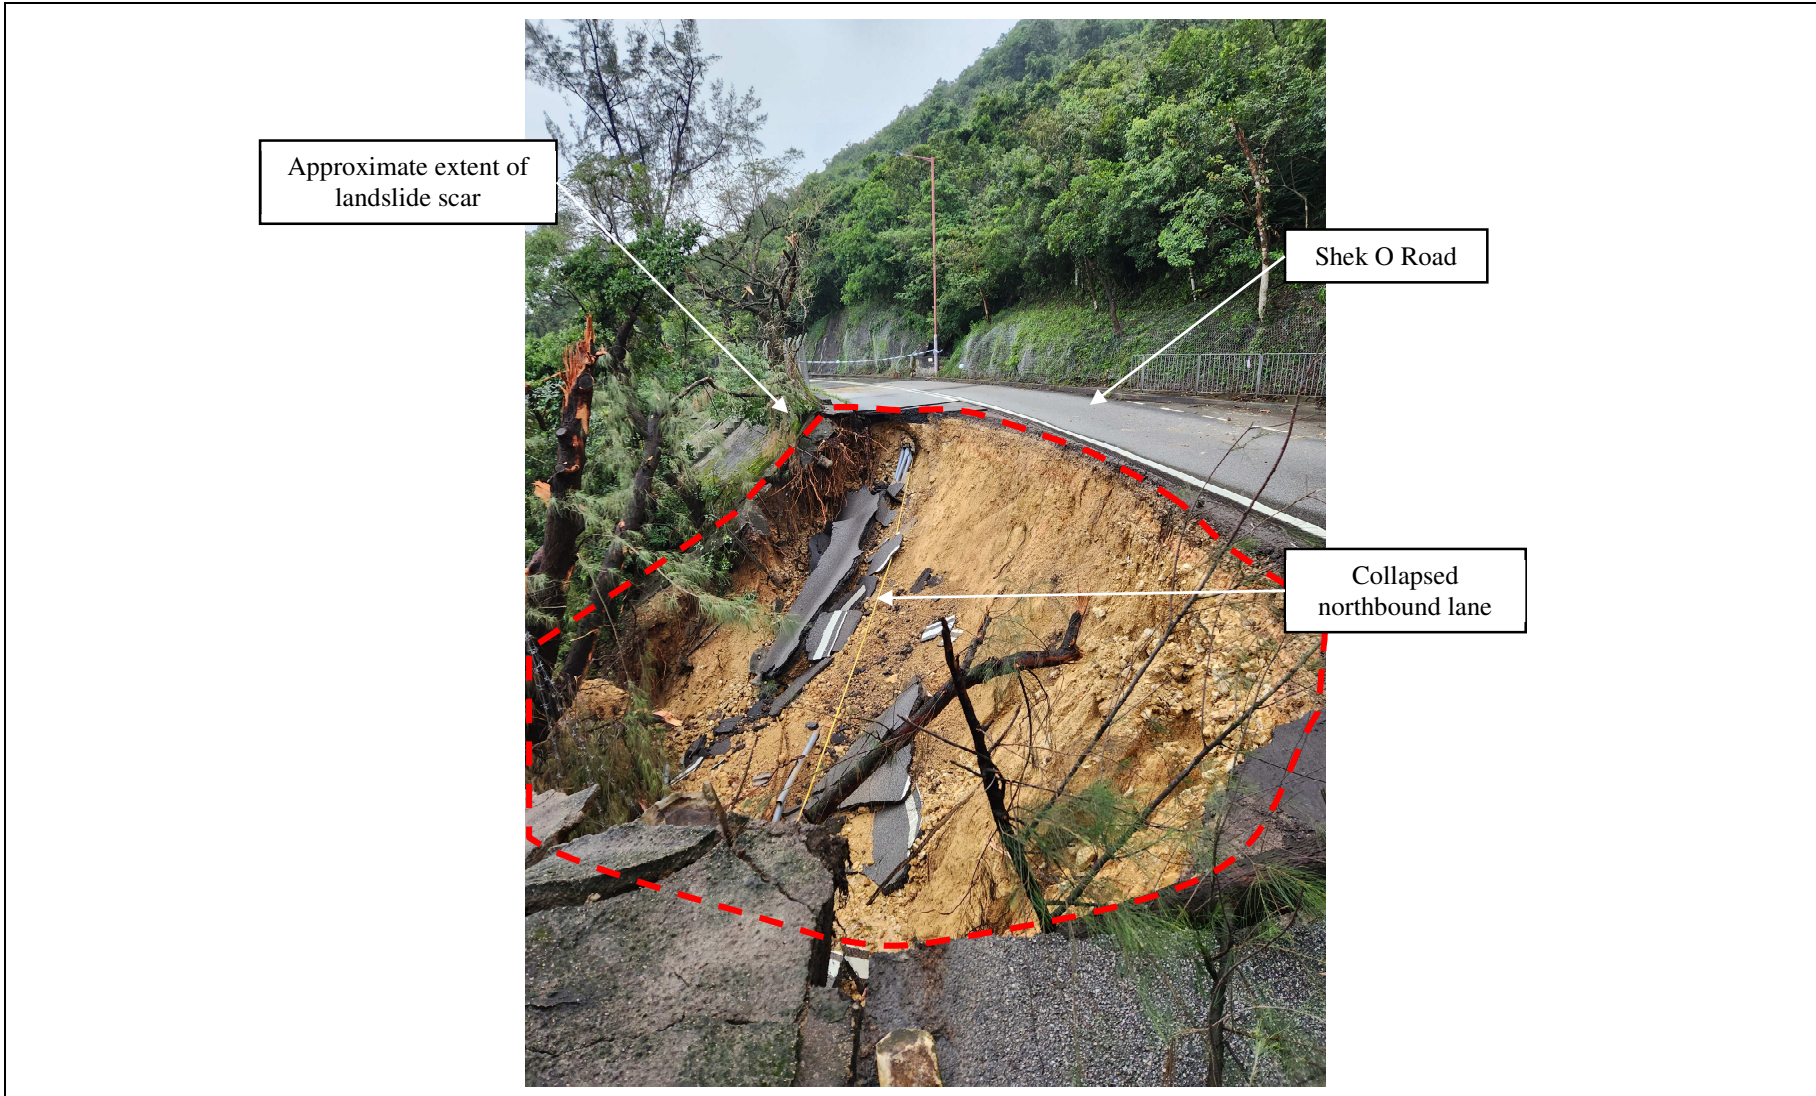
At 9:34 a.m. on 8 September 2023, a major landslide (Incident No. 2023/09/3265) was reported to have occurred at a roadside registered fill slope (slope No. 11SE-D/F47) (referred to as “the fill slope” unless otherwise specified) located underneath Shek O Road, Shek O, when Black Rainstorm Warning and Landslip Warning were in effect. However, the exact time of failure is unknown. The landslide involved a sliding failure with an estimated volume of about 650 m<sup>3</sup>. As a result, a section of the northbound lane of Shek O Road collapsed. Landslide debris was deposited below the failure scar, and some of the debris was directed away by surface water on a rocky natural stream course downhill (Figures 1.1 and 1.2).

**Figure 1.2 General View of the Landslide on 8 September 2023 (Photograph Taken on 8 September 2023)**

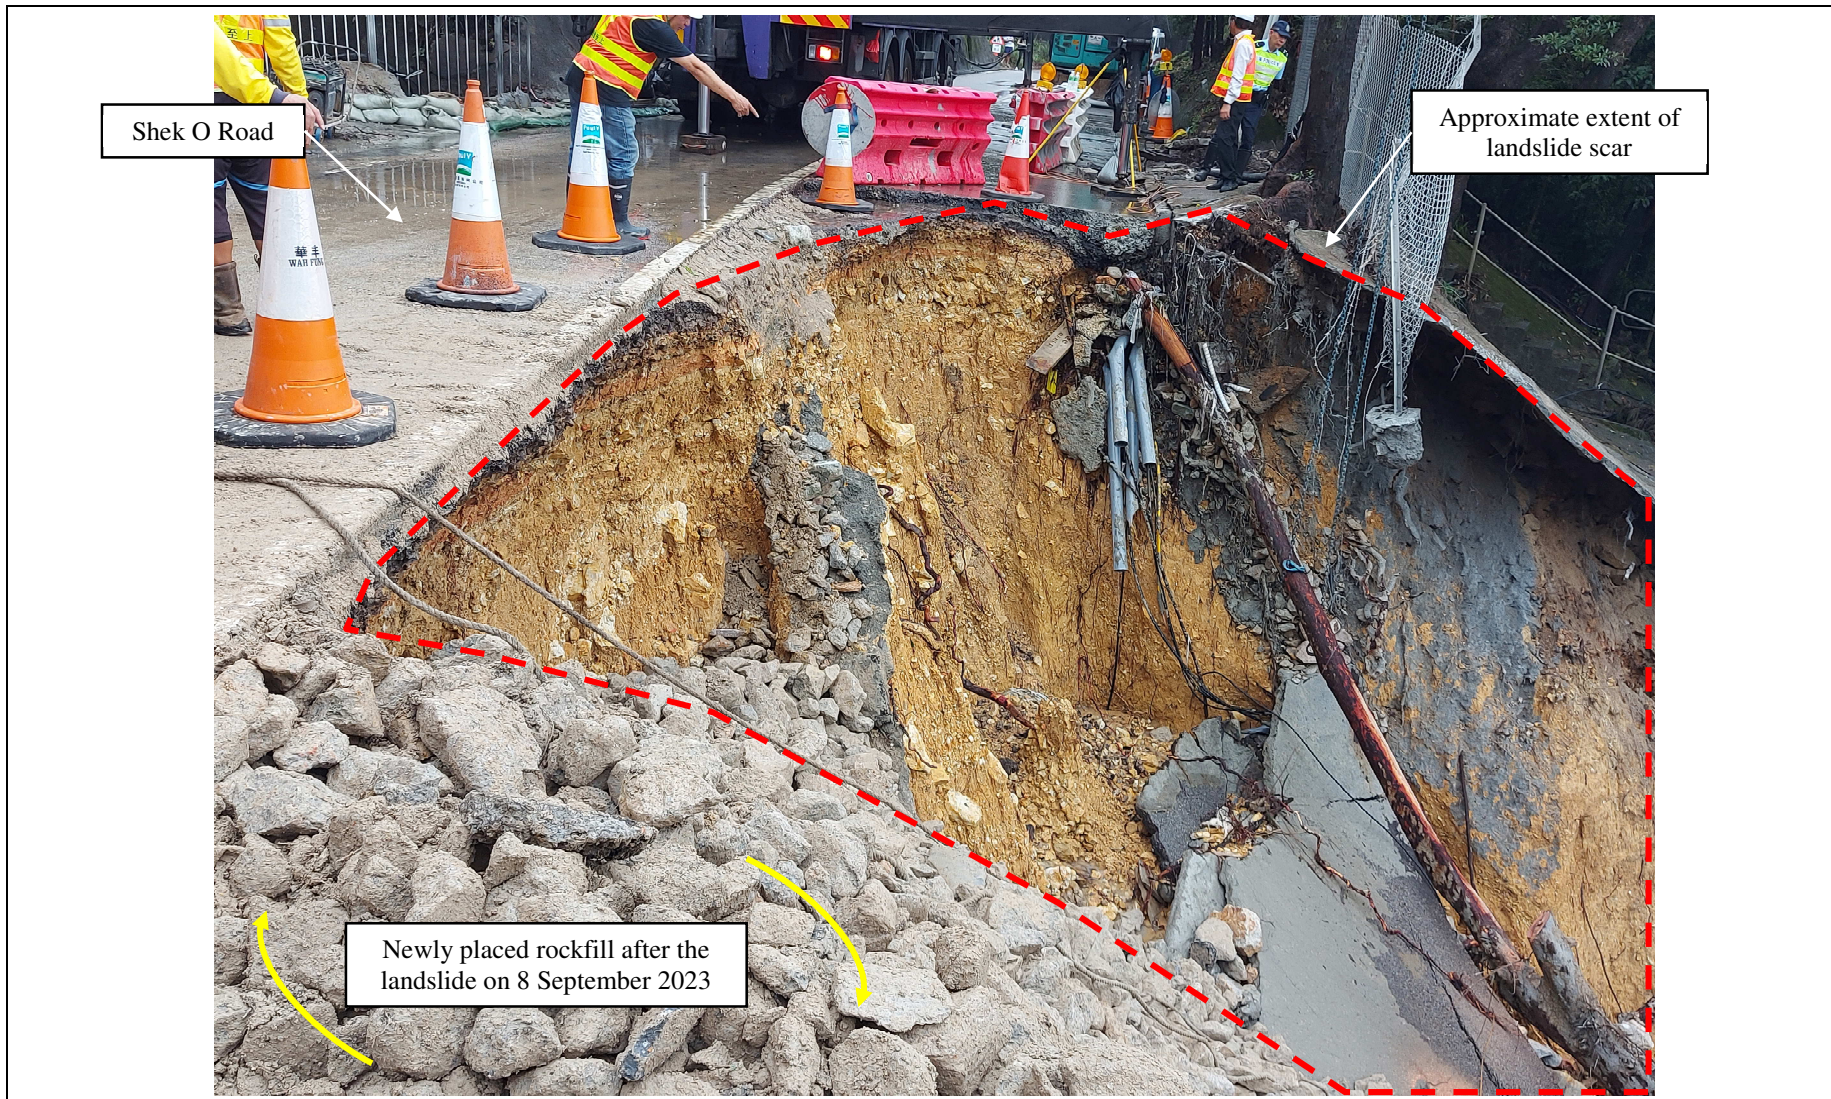
Another major landslide was reported to have occurred at 8:00 a.m. on 14 September 2023 during a Red Rainstorm Warning. It involved a washout failure with an estimated volume of about 126 m<sup>3</sup>. Landslide debris was deposited at the slope toe, and some travelled further downhill along the rocky natural stream course. The previously closed northbound lane collapsed again, including the newly placed rockfill of post-landslide emergency repair works for the landslide on 8 September 2023 (Figures 1.1 and 1.3). No casualties were reported, but the blockage of Shek O Road isolated hundreds of residents from Shek O. The media widely reported these incidents.

**Figure 1.3 General View of the Landslide on 14 September 2023 (Photograph Taken on 14 September 2023)**

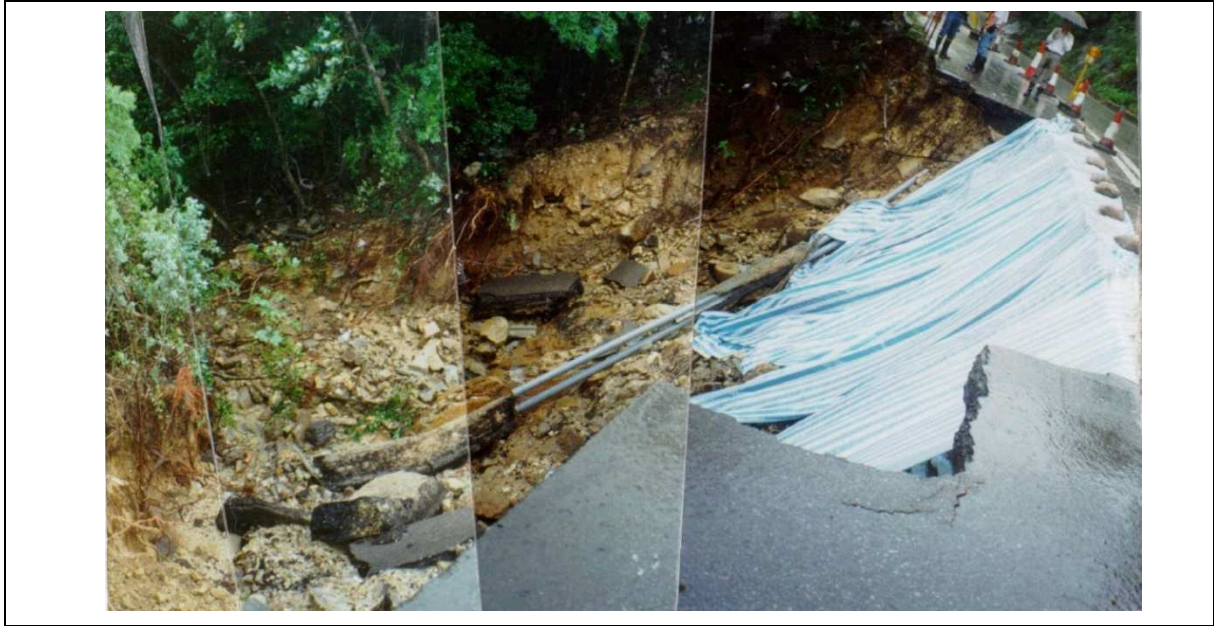
On 13 August 1995, Incident No. HK95/8/31 occurred at the present-day registered fill slope No. 11SE-D/F174, which was part of the fill slope when the failure occurred (Figure 3.3). The slip initiated from the fill slope below Shek O Road and took down a section of the northbound lane with an estimated failure volume of about 120 m<sup>3</sup>. The incident report suggested that direct infiltration could be a possible cause of the landslide. The failed slope portion was later backfilled with rockfill and registered as slope No. 11SE-D/F174.

**Figure 3.3 The 1995 Landslide (Photograph Taken on 13 August 1995)**

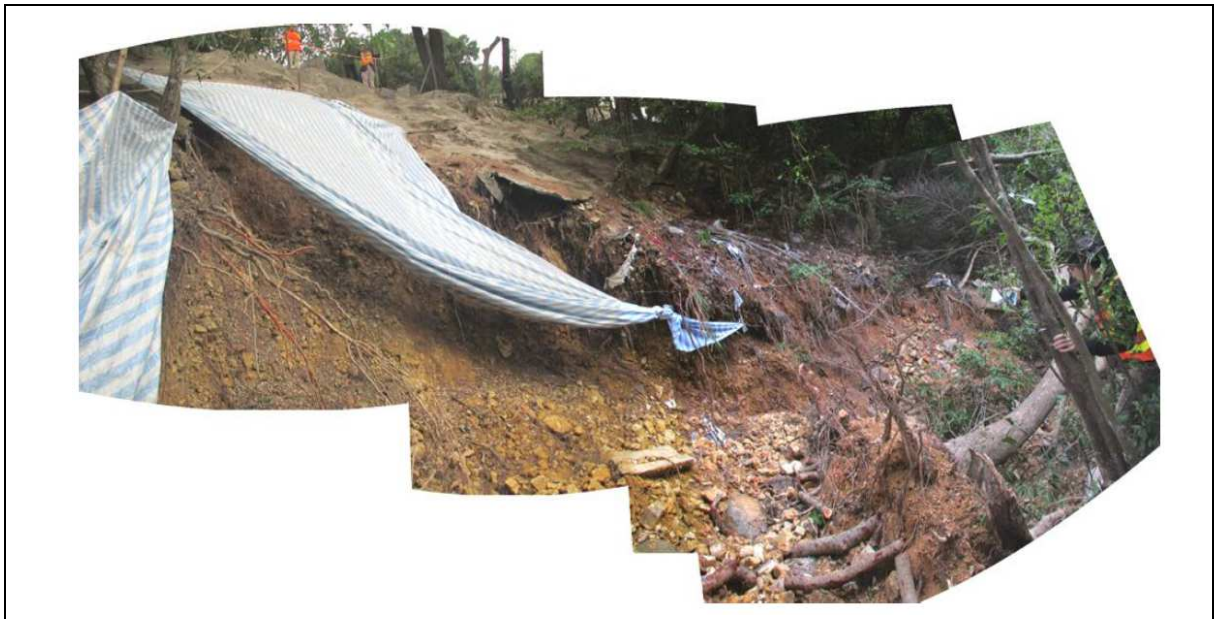
On 19 October 2016, Incident No. 2016/11/1997 occurred at the fill slope, with an estimated failure volume of about 60 m<sup>3</sup> (Figure 3.4). The incident report revealed that a large amount of surface runoff might have accumulated on Shek O Road due to the partial blockage of a culvert upslope and the complete blockage of gullies east of the 2016 incident location. The absence of a concrete upstand on the road led to overspilling of concentrated surface water onto the fill slope through the cracked shotcrete cover, resulted in the failure. Subsequently, the failed slope portion was repaired by backfilling no-fines concrete.

**Figure 3.4 The 2016 Landslide (Photograph Taken on 29 November 2016)**

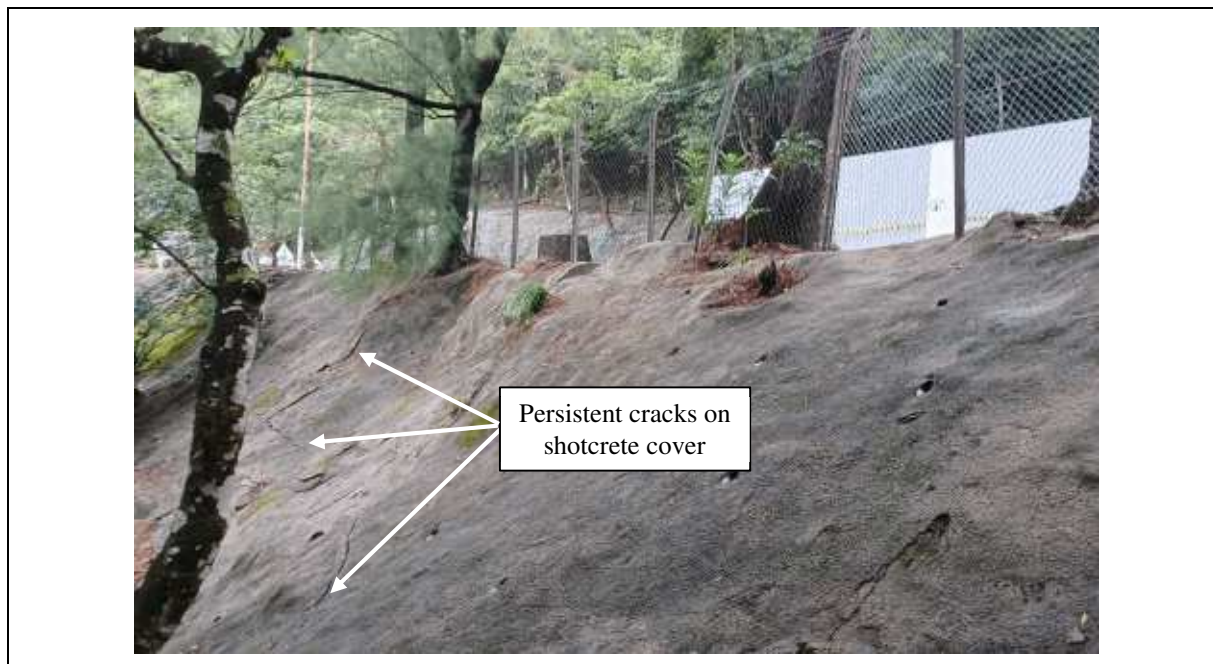
The last Engineer Inspection (EI) was carried out by the HyD in February 2020. According to the EI records, the shotcrete cover was in fair condition, with clear weepholes and drainage channels. No signs of distress or seepage were noted during the inspection. The Routine Maintenance Inspection was conducted on the fill slope in November 2022 with maintenance works recommended, including clearing drainage channels and removing surface debris and vegetation. However, after the maintenance works were completed, several persistent cracks were observed on the shotcrete cover in November 2022 (Figure 3.5).

**Figure 3.5 Surface Condition of Slope No. 11SE-D/F47 after Maintenance Works (Photograph Taken on 4 November 2022)**

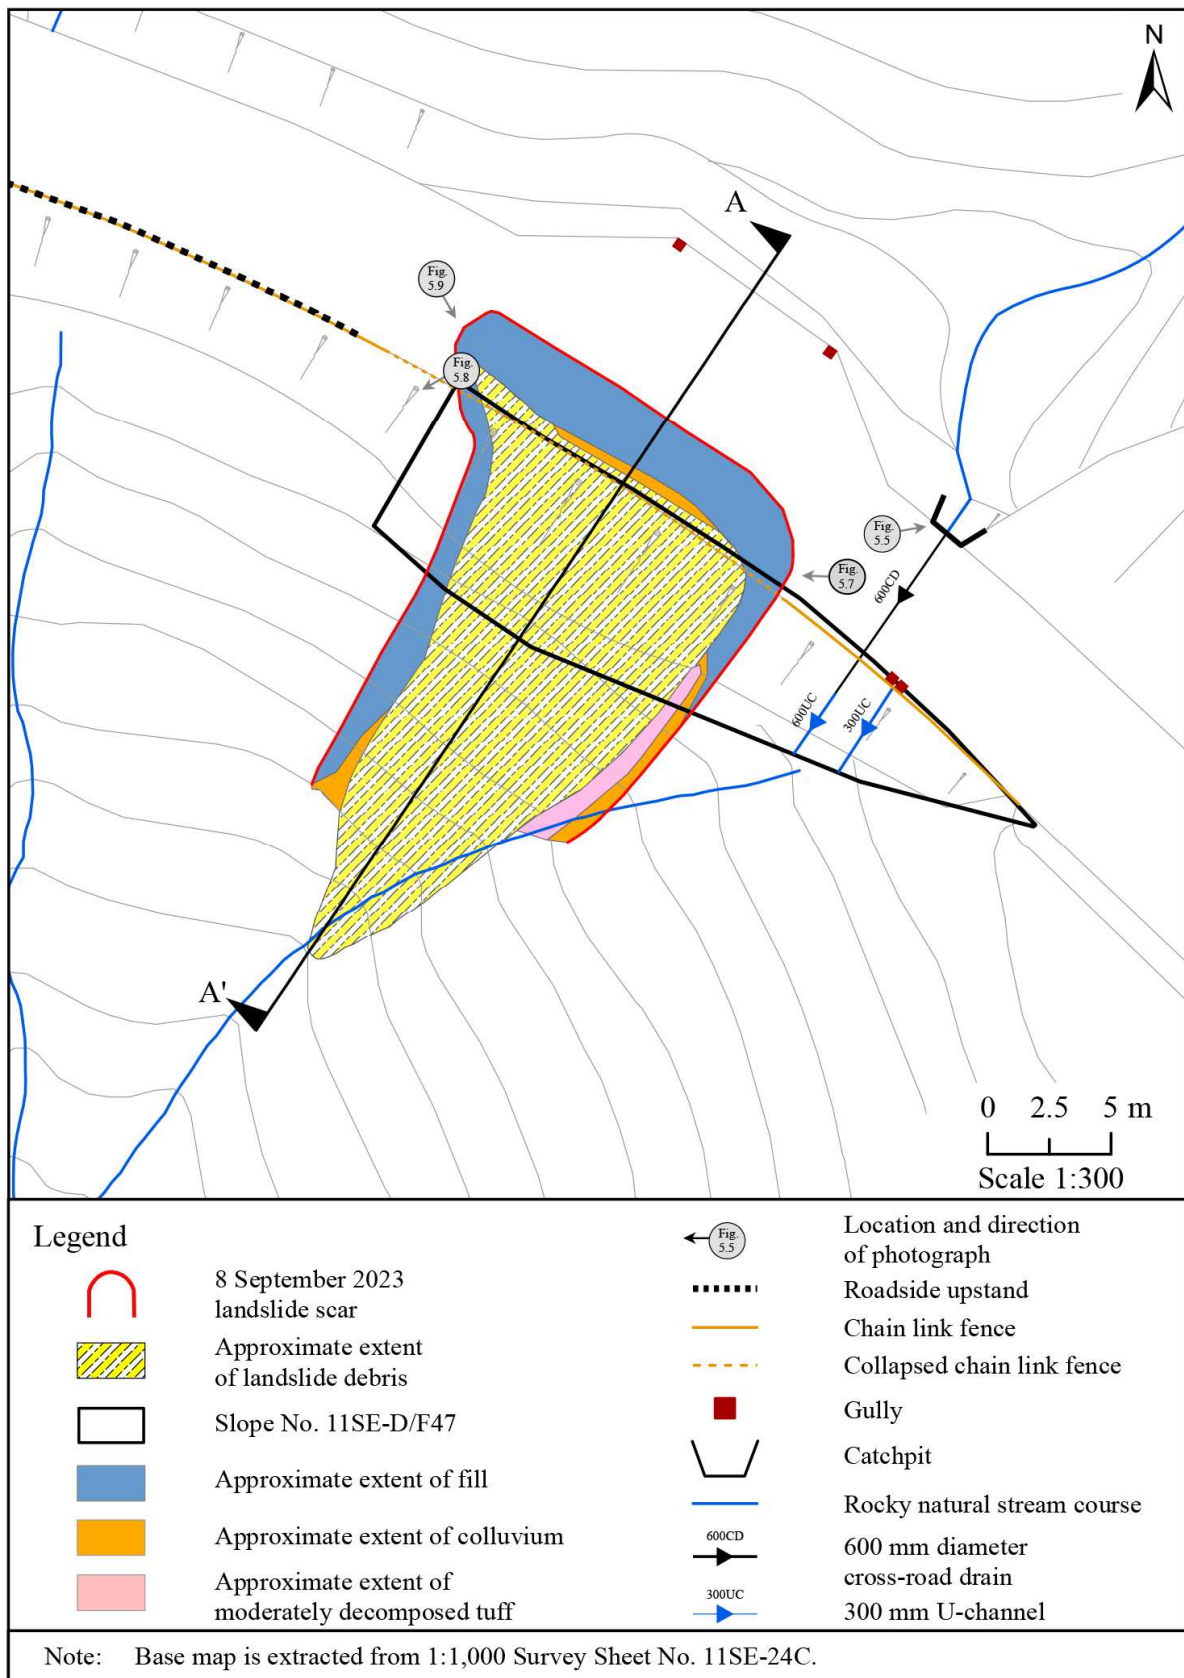
On 8 September 2023, a landslide occurred at the fill slope underneath Shek O Road during a severe rainstorm (Figure 5.1). A section of the northbound lane of Shek O Road collapsed due to a sliding failure of the fill slope (Figure 5.2).

**Figure 5.1 Post-landslide Observations of the Landslide on 8 September 2023**

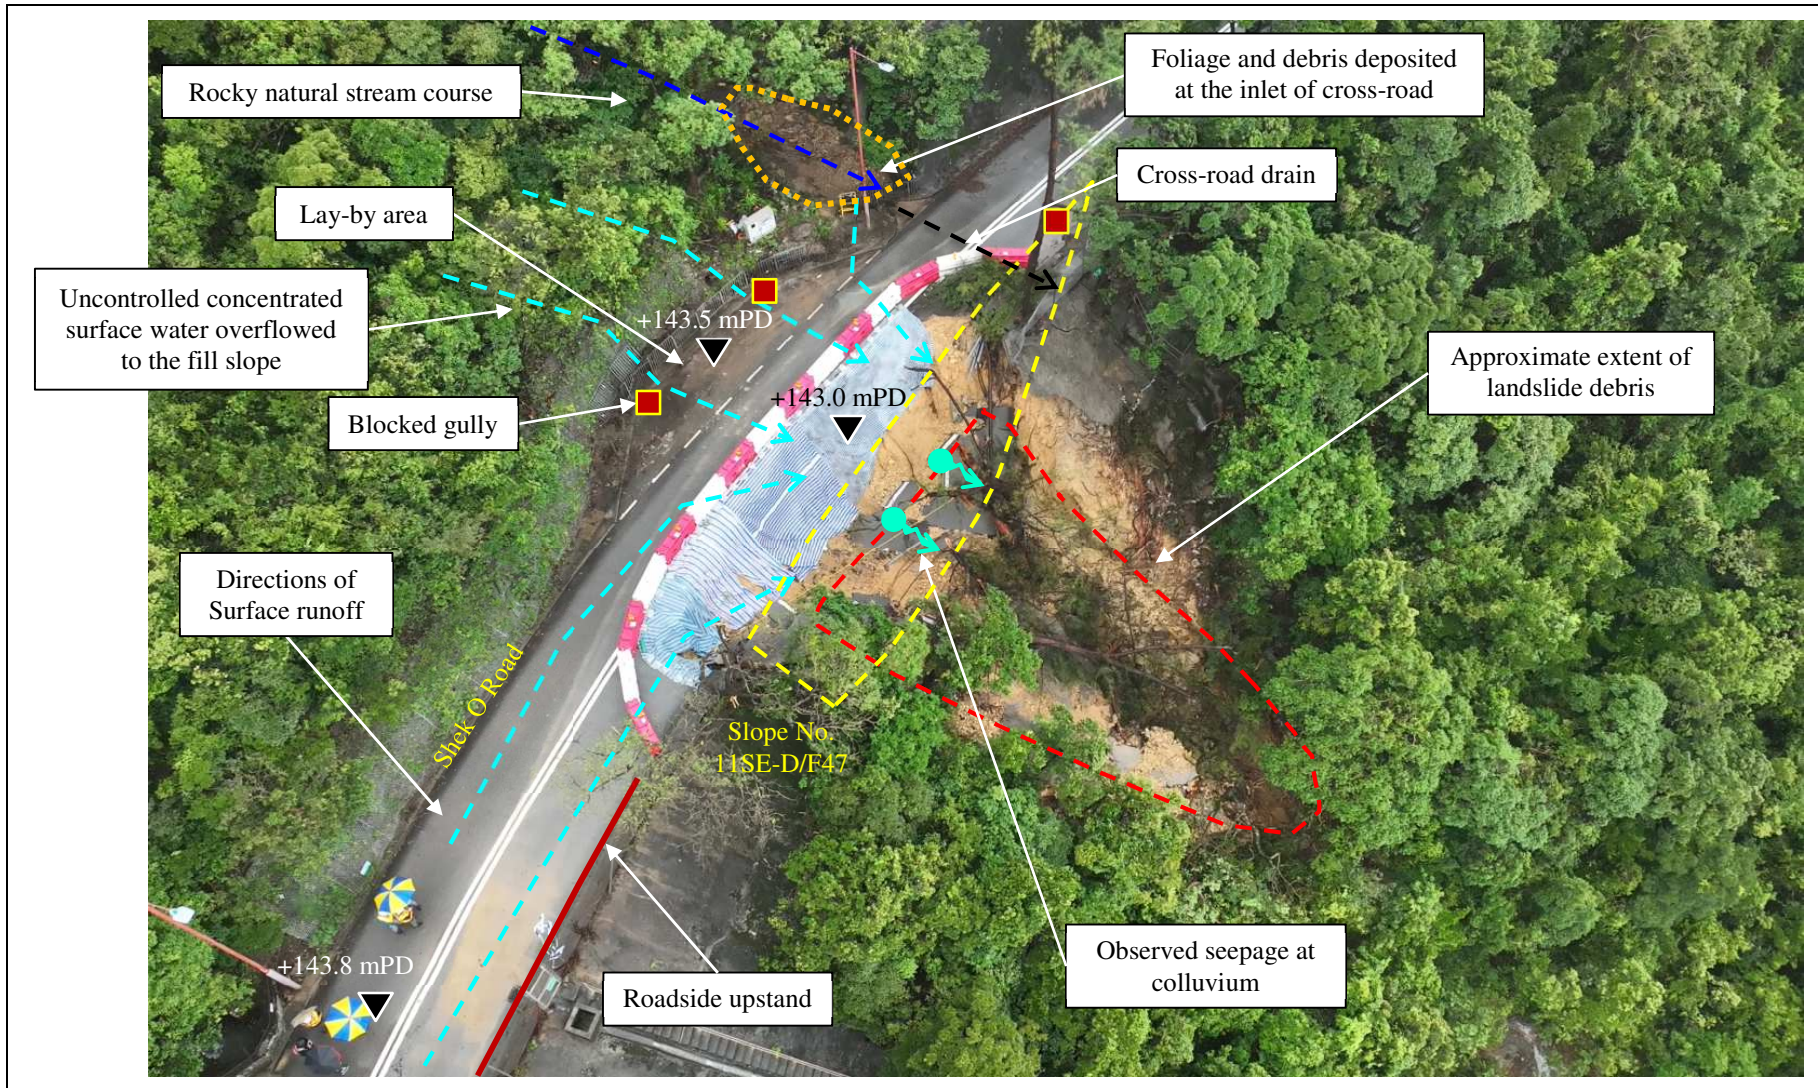
The landslide scar was estimated to be about 20 m long and 16 m wide. The landslide was deep-seated, with a maximum depth of 5 m below the pre-failure slope surface and an estimated failure volume of about 650 m<sup>3</sup>. The main scarp had an inclination of around 60° to 65°, and exposed mainly fill and locally colluvium above the bedrock on the southeastern flank of the landslide scar (Figures 5.3 and 5.4). The lower part of the main scarp was covered up by the landslide debris. As inferred from the flanks of the landslide scar, the source floor was close to the interface between colluvium and bedrock with a gradient of about 28° to 30°. While several broken uPVC pipes were exposed on both flanks of the landslide scar, no water flows from the pipe outlets were observed.

**Figure 5.2 Aerial View of the Landslide on 8 September 2023 (Photograph Taken on 9 September 2023)**

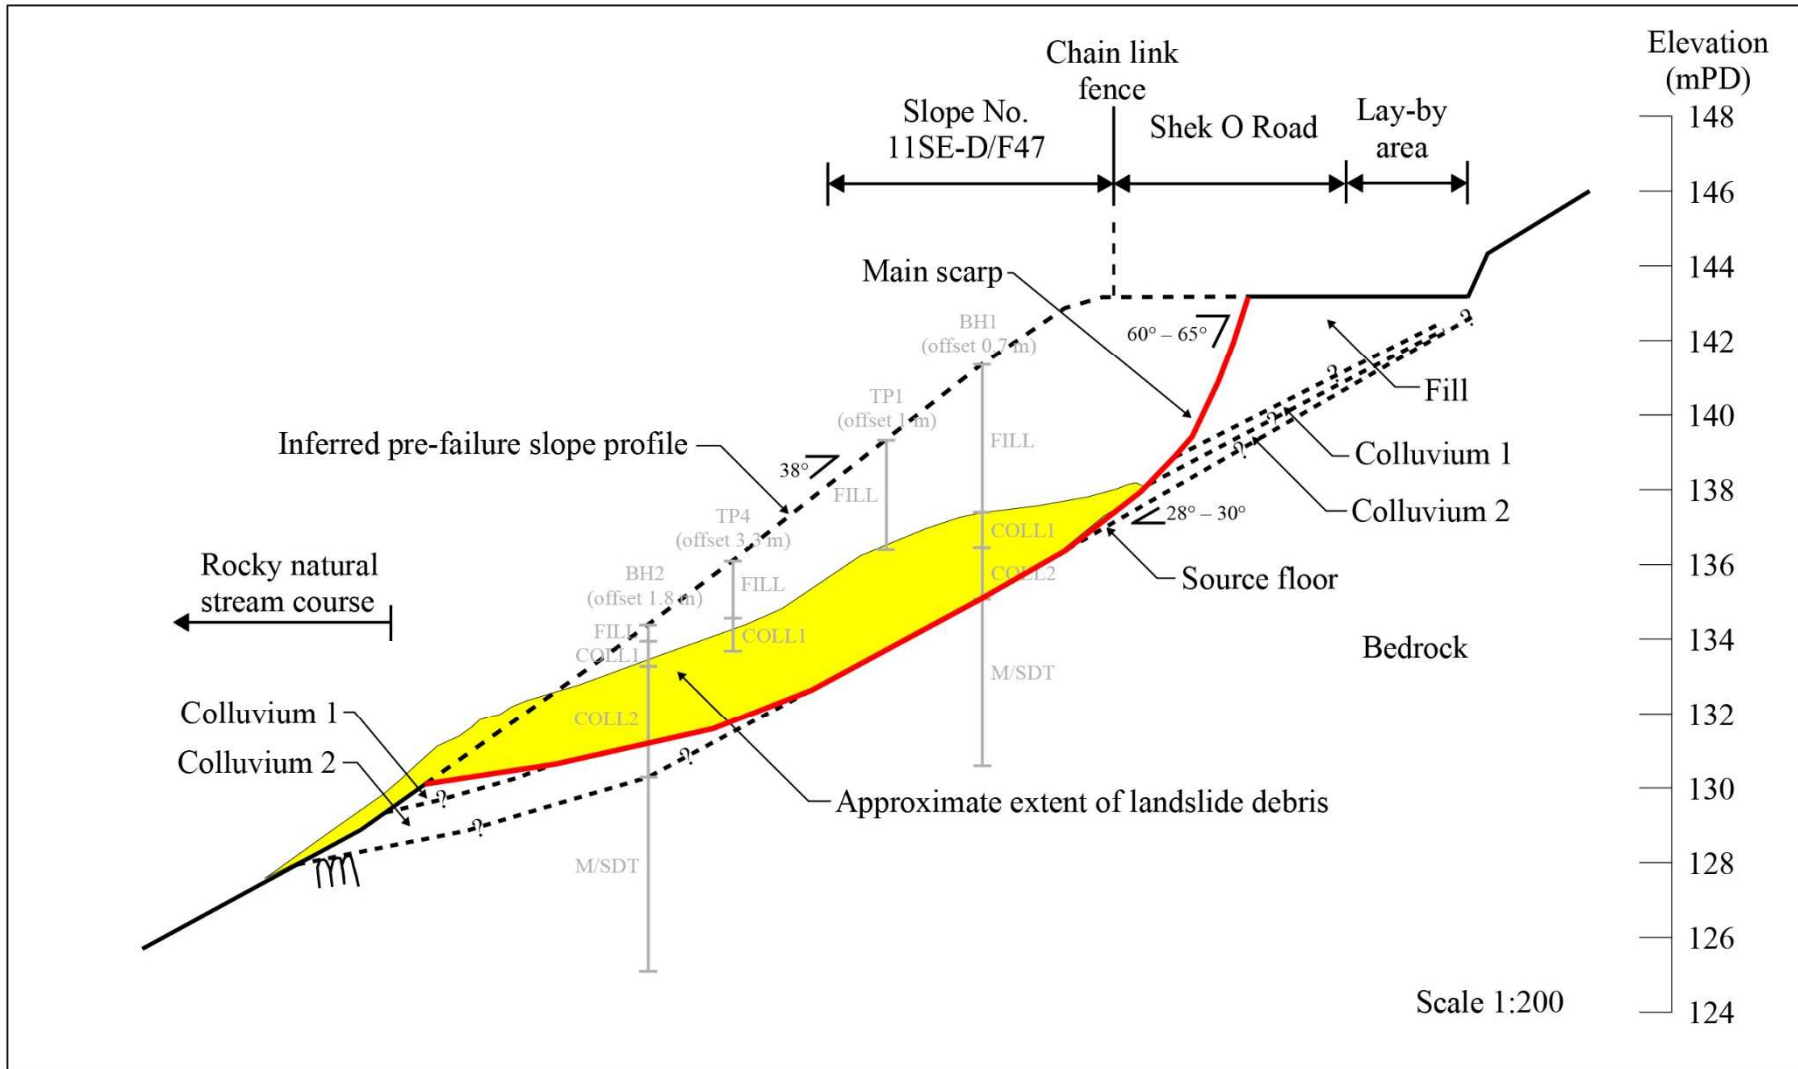
Figure 5.3 Cross-section A-A' through the Landslide Scar on 8 September 2023

Figures 5.3 and 5.12 illustrate the geological profiles of the site along two representative cross-sections A-A' and B-B' through the landslide scar. Fill was encountered in drillholes (BH1 and BH2) and trial pits (TP1, TP3 and TP4), which were within the landslide scars. The fill comprises clayey, silty SAND to sandy, silty CLAY with angular to subrounded gravel, cobbles of rock fragments, boulders and concrete fragments. This unit has a thickness of up to 3.5 m, followed by a layer of colluvium up to 3 m thick.

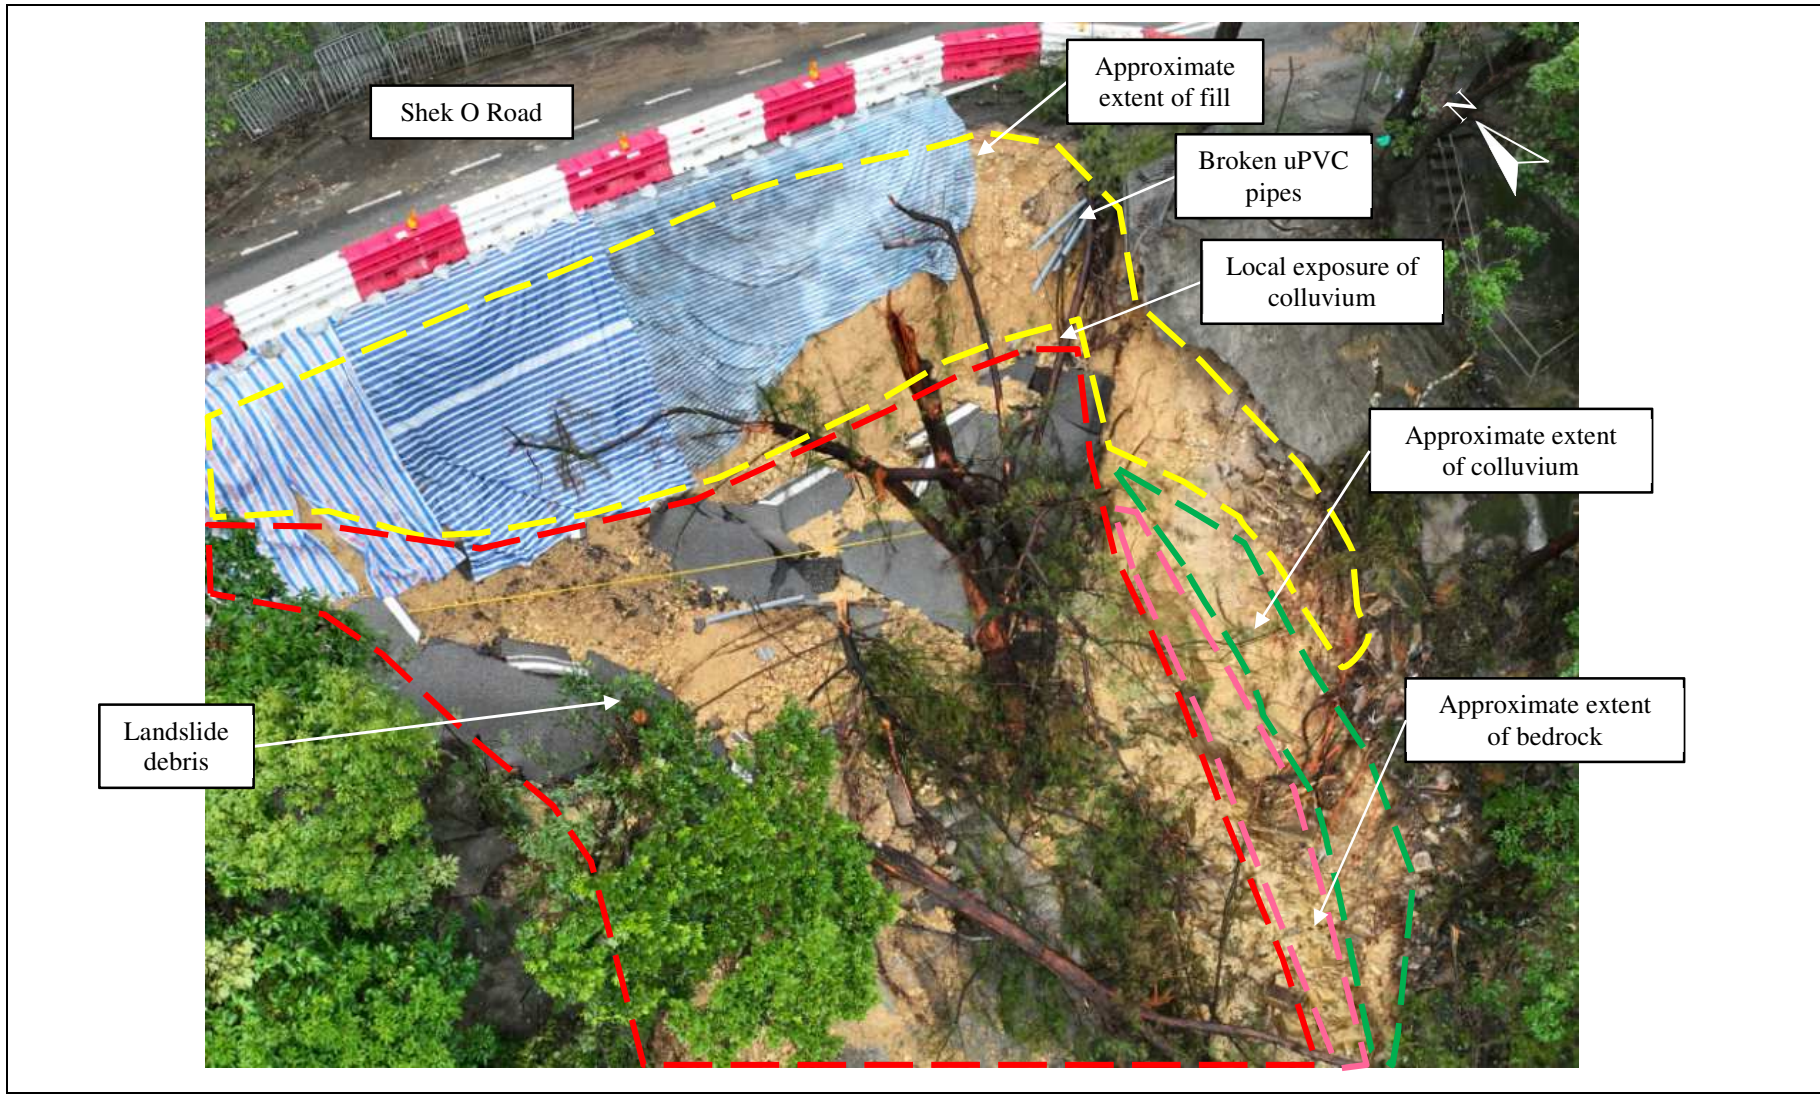
**Figure 5.4 General View of the Landslide Scar (Photograph Taken on 9 September 2023)**

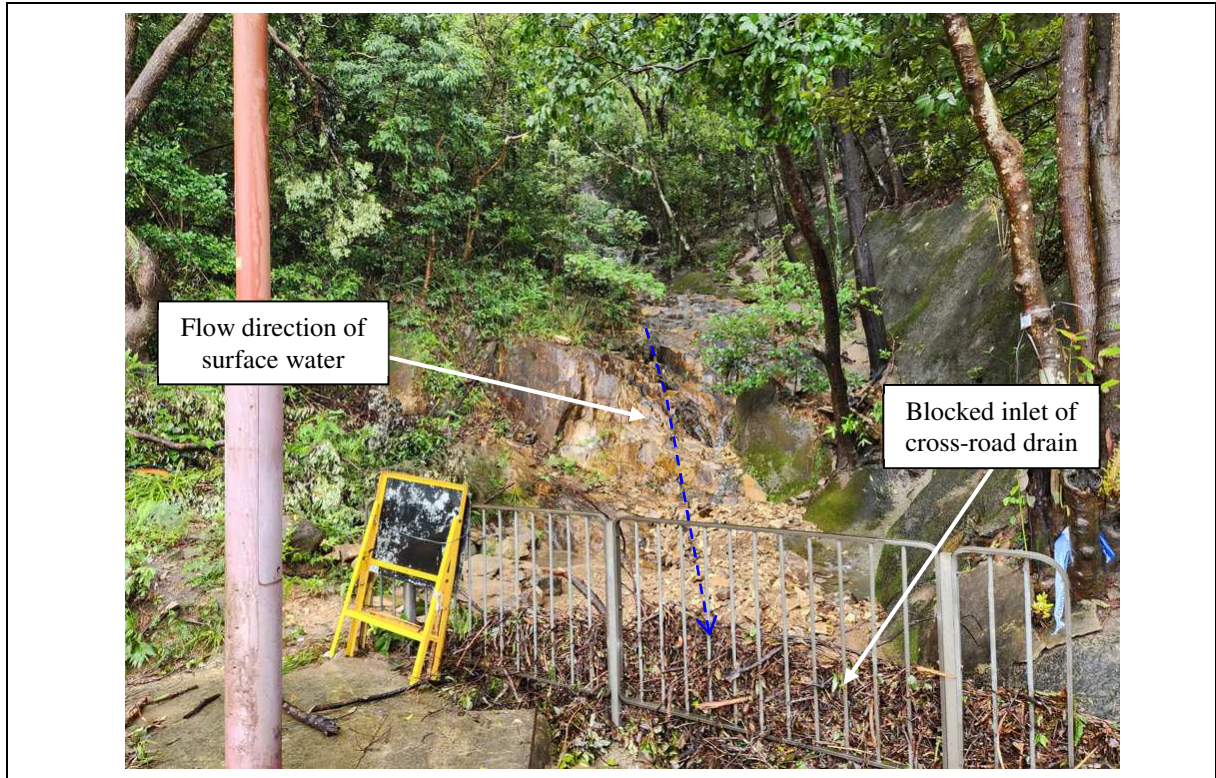
The 600 mm diameter cross-road drain was intended to divert surface water from the natural hillside uphill across the fill slope into the rocky natural stream course downhill. However, at the time of the incident, the upslope catchpit, inlet of the cross-road drain and roadside gullies were substantially blocked by foliage and debris (Figure 5.5). This caused surface water from the natural hillside to overflow onto Shek O Road and the lay-by area above the fill slope, as suggested by the ponding of muddy water observed the day after the landslide (Figure 5.6).

**Figure 5.5 Blocked Catchpit of the Upslope Rocky Natural Stream Course  
(Photograph Taken on 9 September 2023)**

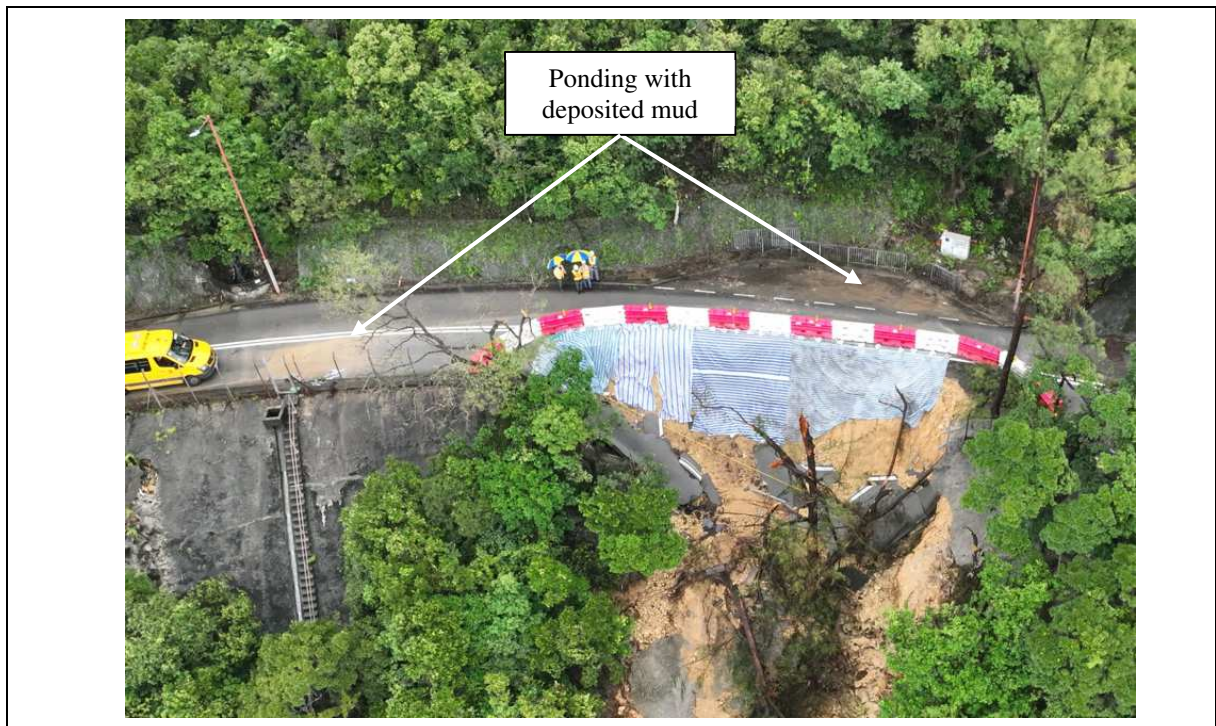
**Figure 5.6 Ponding on Shek O Road  
(Photograph Taken on 9 September 2023)**

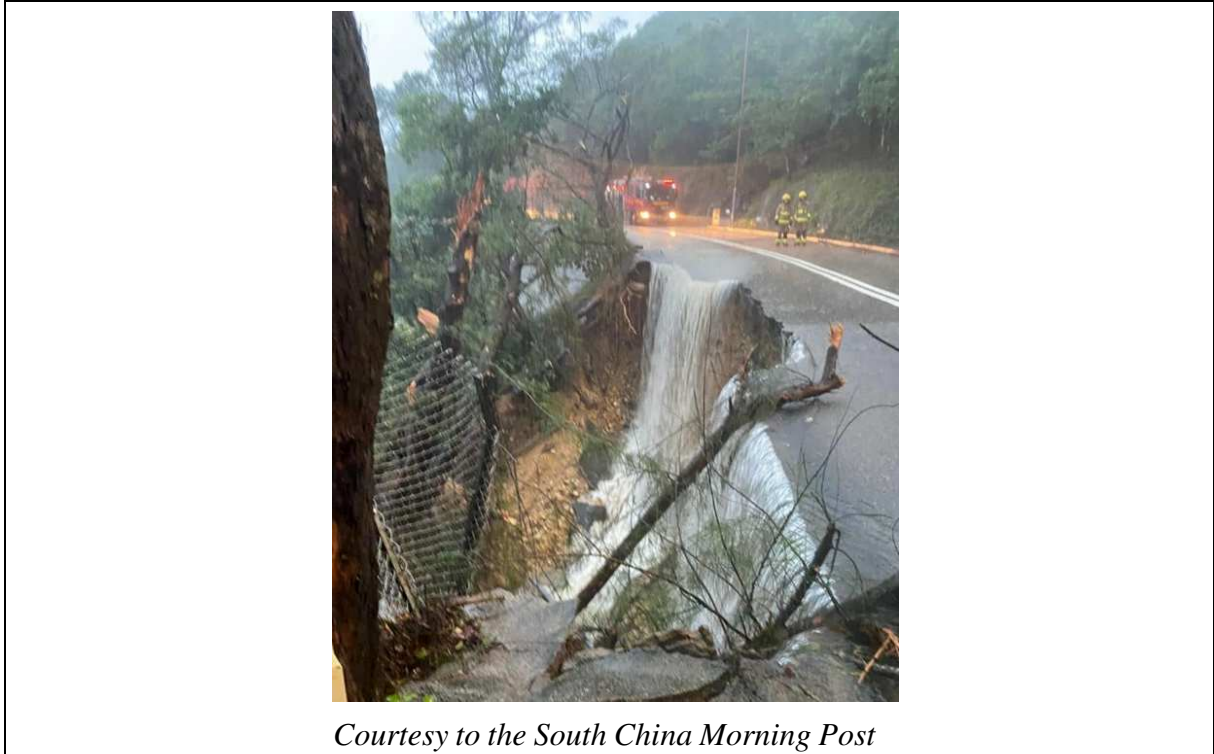
Due to the slightly sloping gradient of Shek O Road, absence of the roadside upstand and blocked roadside gullies, uncontrolled concentrated surface water flowed along Shek O Road towards the fill slope that was located at a topographical low point (Figure 5.7). Cracked shotcrete cover was evident on the adjacent slope No. 11SE-D/F174 (Figure 5.8).

**Figure 5.7 Significant Overland Flow from Shek O Road towards the Fill Slope  
(Photograph Taken on 8 September 2023)**

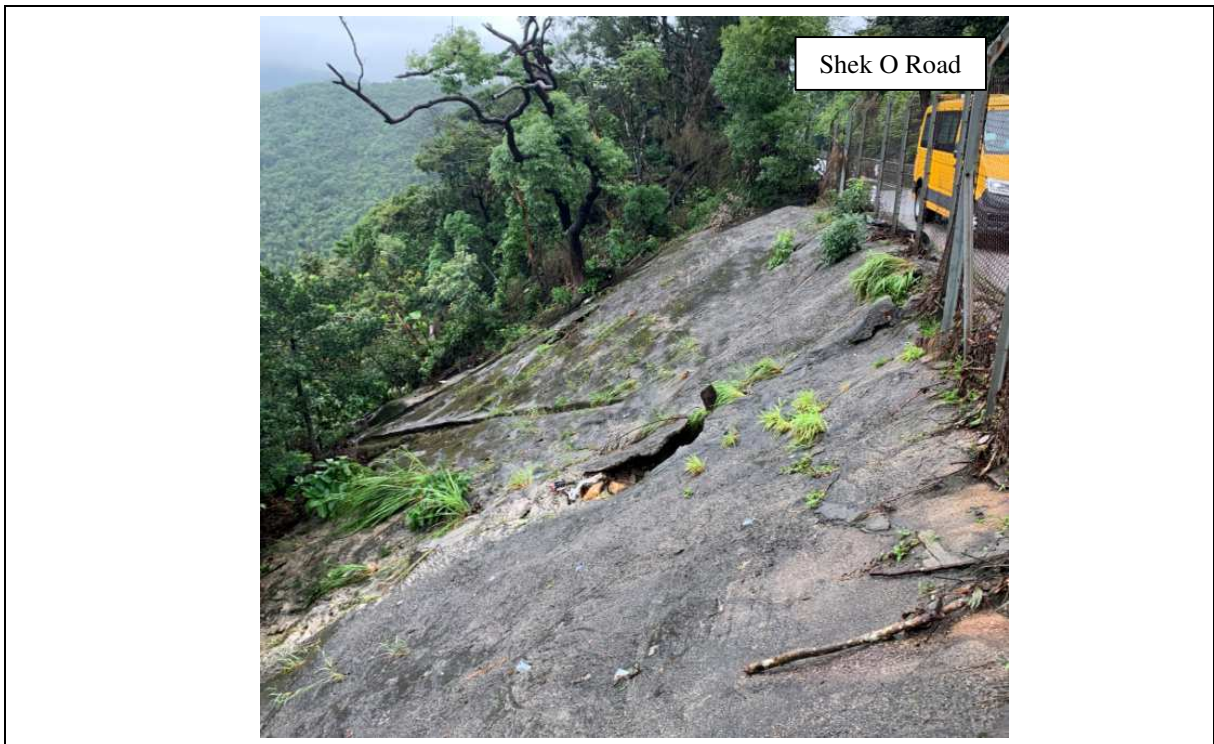
**Figure 5.8 Cracked Shotcrete Cover on Slope No. 11SE-D/F174  
(Photograph Taken on 9 September 2023)**

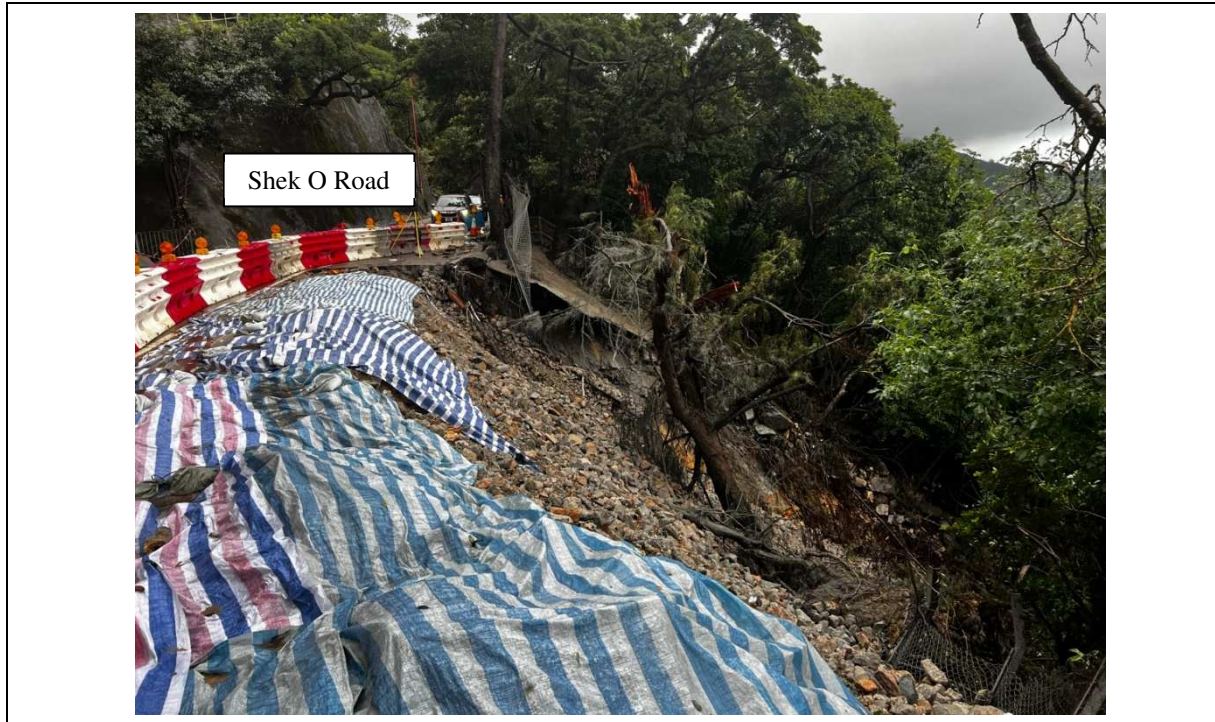
**Figure 5.9 Rockfill on the Landslide Scar  
(Photograph Taken on 11 September 2023)**

As part of the emergency repair works, the landslide scar was later covered by the rockfill (Figure 5.9).

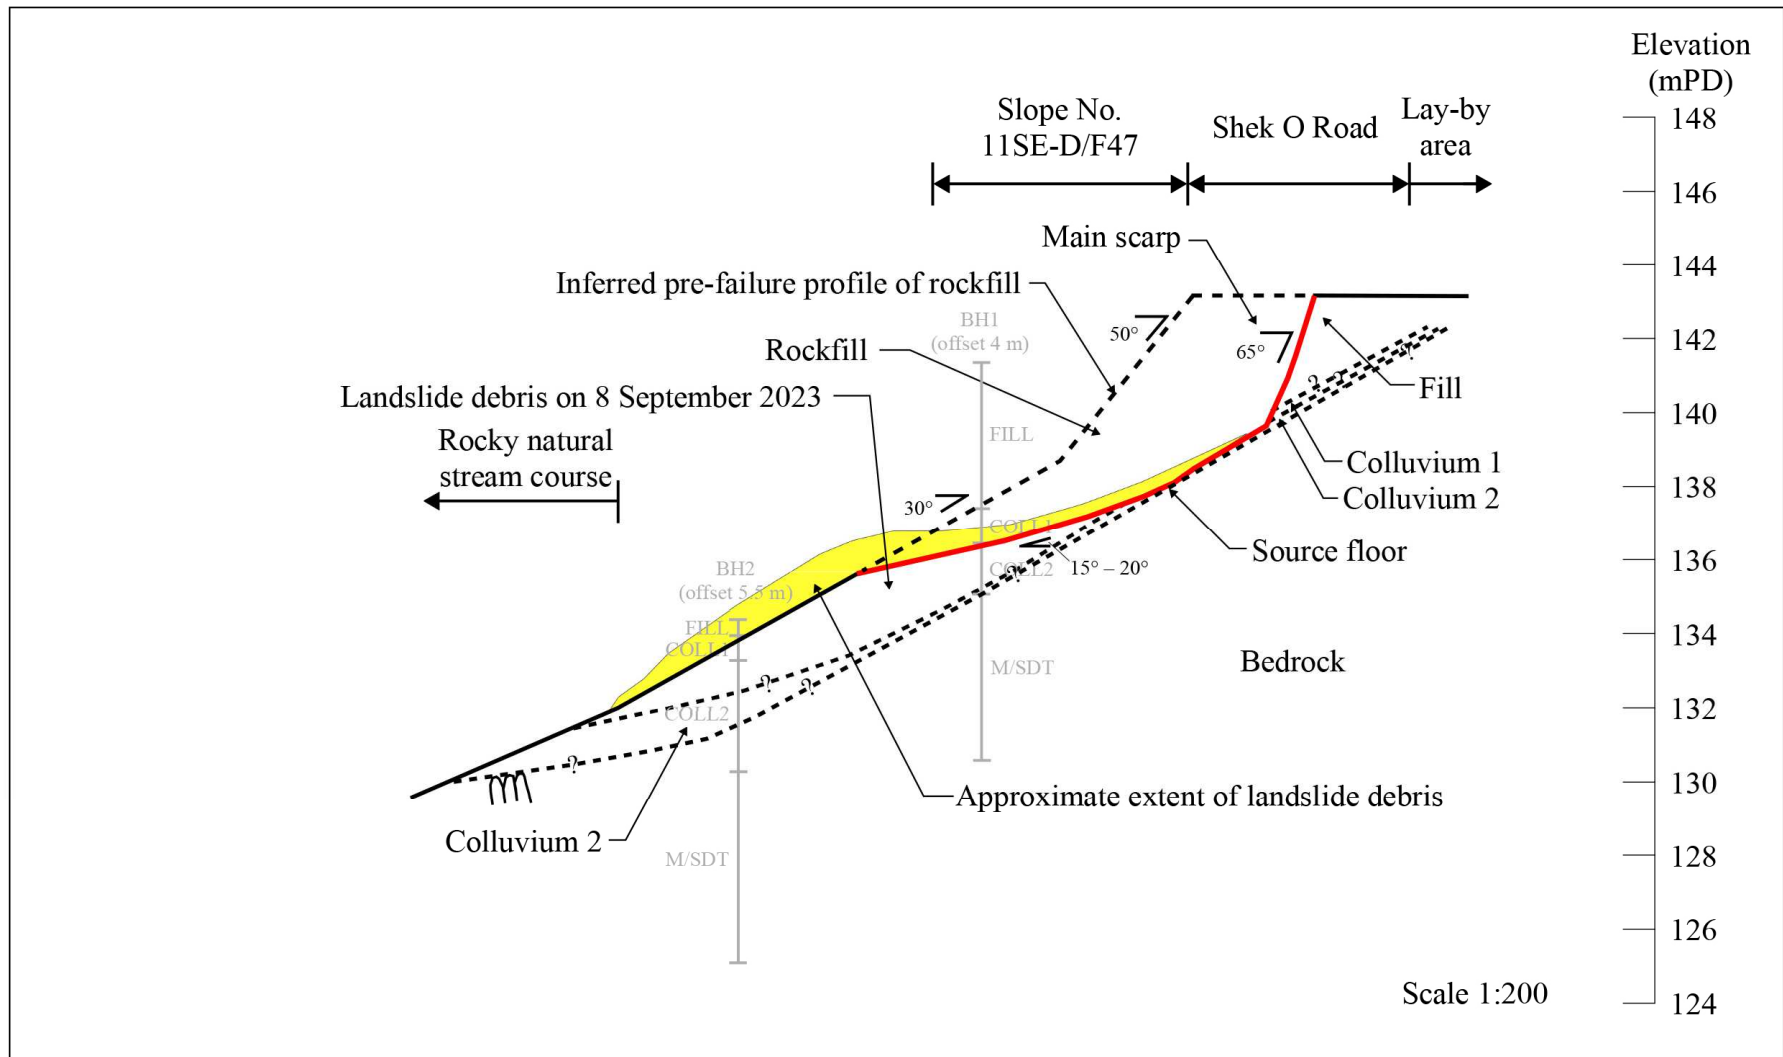
Figure 5.12 Cross-section B-B' through the Landslide Scar on 14 September 2023
