# **Detailed Study of the 8 and 14 September 2023 Landslides on Slope No. 11SE-D/F47 at Shek O Road, Shek O**

**GEO Report No. 376**

**Fugro (Hong Kong) Limited**

**Geotechnical Engineering Office  
Civil Engineering and Development Department  
The Government of the Hong Kong  
Special Administrative Region**

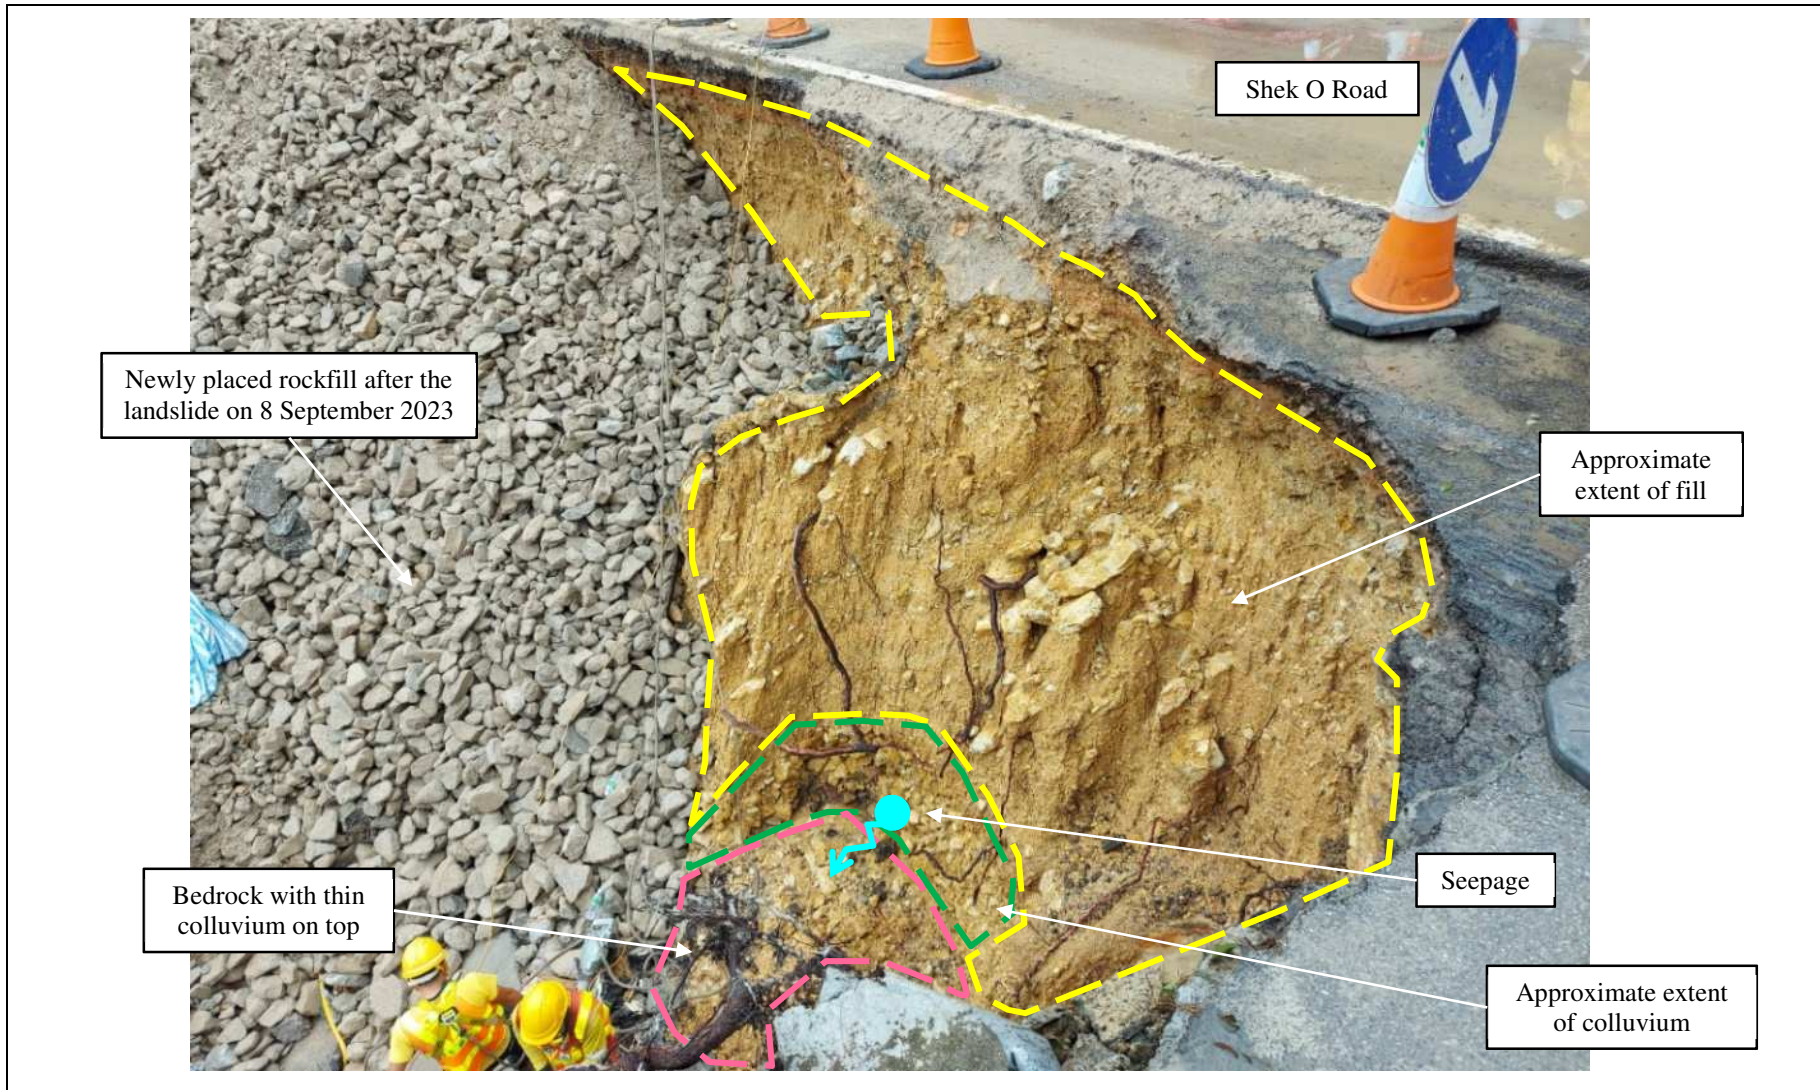
**Figure 5.13 General View of the Landslide Scar (Photograph Taken on 14 September 2023)**

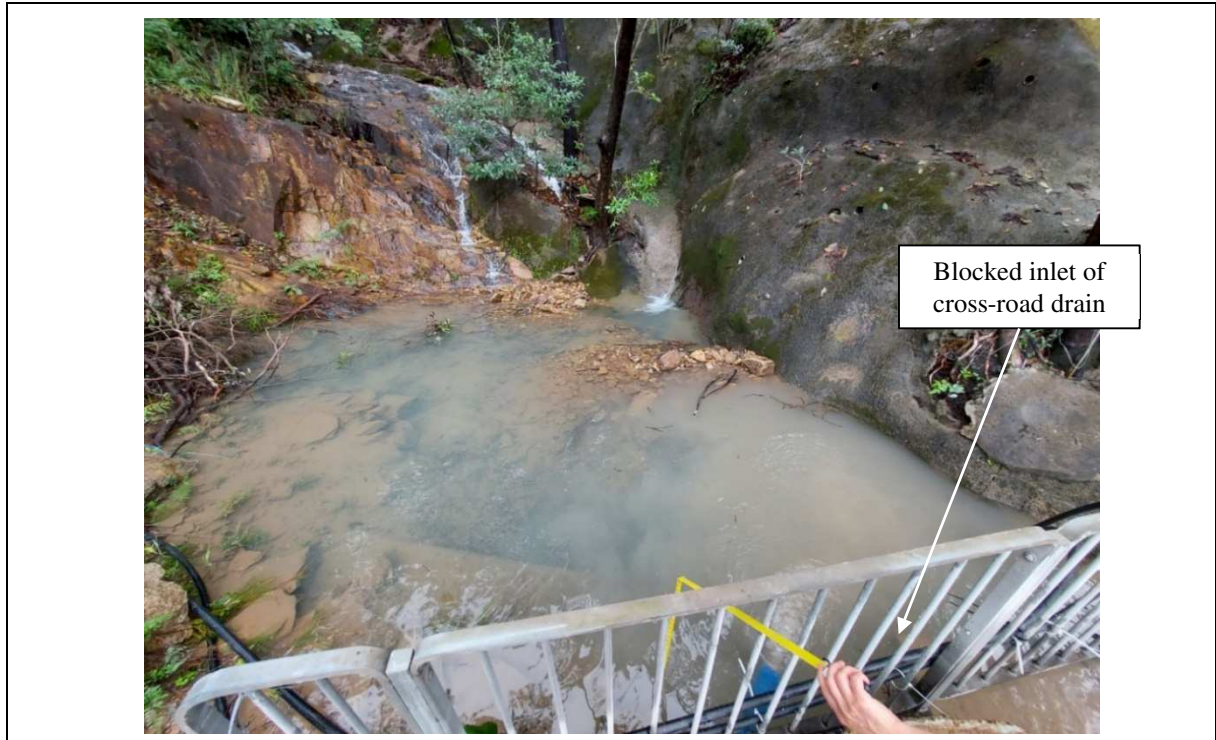
The blockage of the cross-road drain caused significant ponding on the catchpit of the upslope rocky natural stream course (Figure 5.14). On the morning of 14 September 2023, the ponding water was observed overspilled and flooded Shek O Road, as shown in Figure 5.15 and Video B1 of Appendix B. The area near the crest of the landslide scar was situated at the topographical low point, and no roadside upstand was built at this location. With the blocked

**Figure 5.14 Ponding on the Catchpit of the Upslope Rocky Natural Stream Course (Photograph Taken on 14 September 2023)**

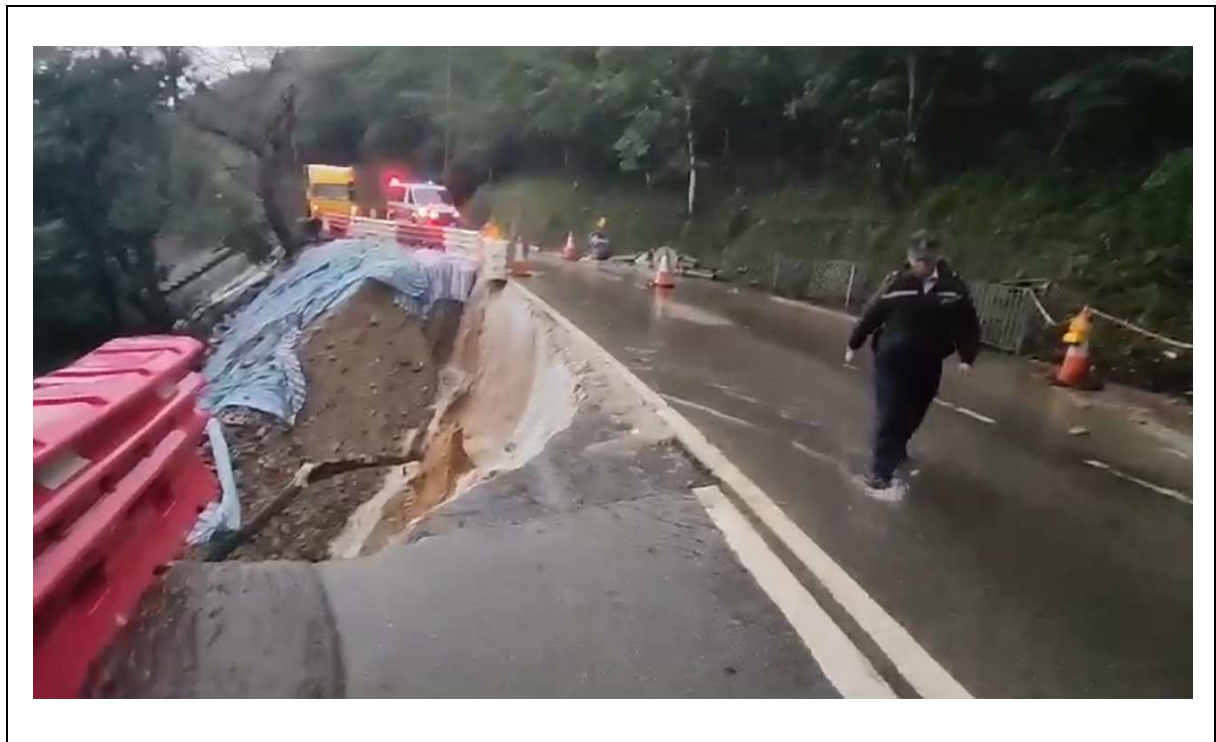
**Figure 5.15 Significant Overland Flow from Shek O Road towards the Fill Slope (Photograph Taken on 14 September 2023)**

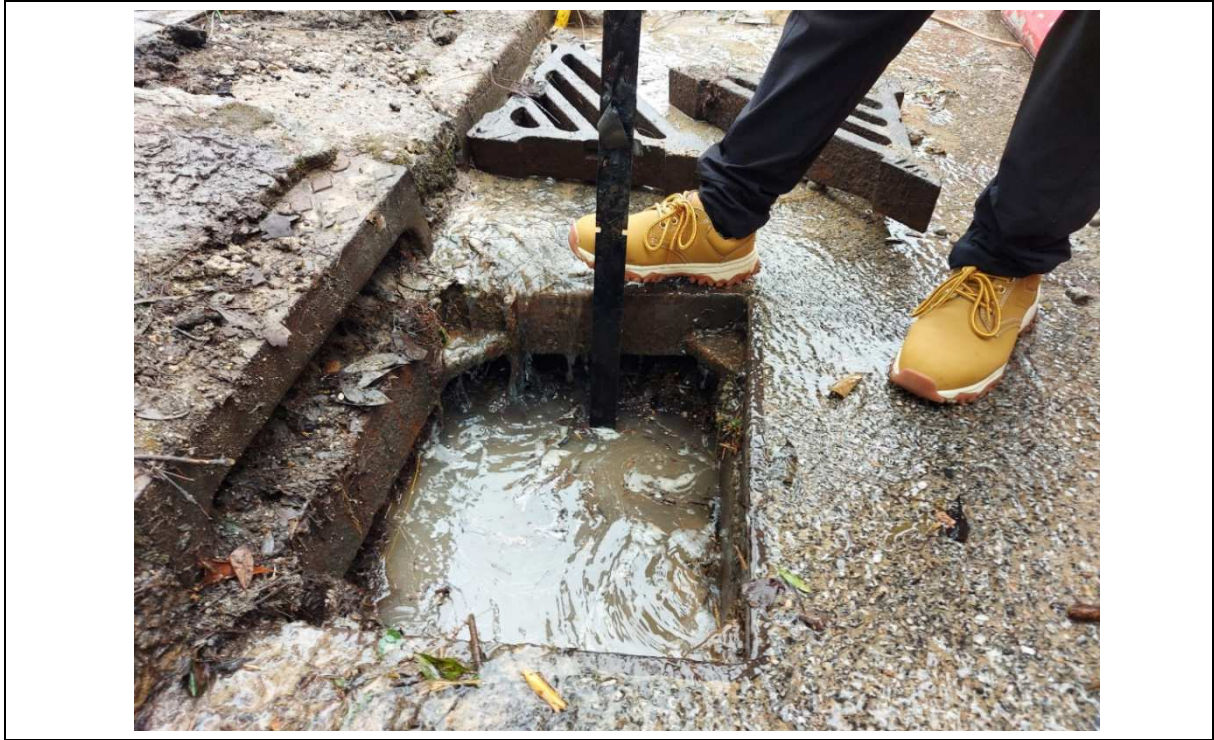
roadside gullies (Figures 5.16 and 5.17), surface water overflowed onto the repaired fill slope and eroded the rockfill.

**Figure 5.16** Blocked Roadside Gully on Shek O Road  
(Photograph Taken on 14 September 2023)

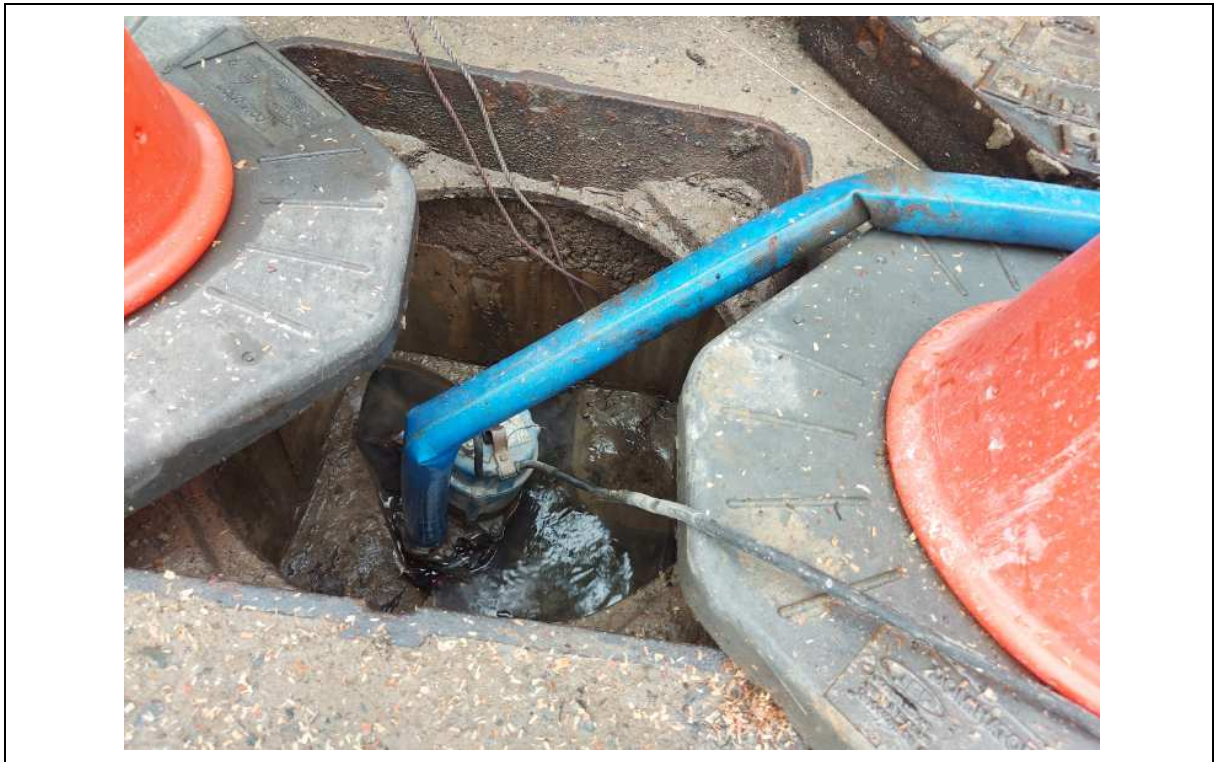
**Figure 5.17** Blocked Roadside Gully on Lay-by Area  
(Photograph Taken on 14 September 2023)

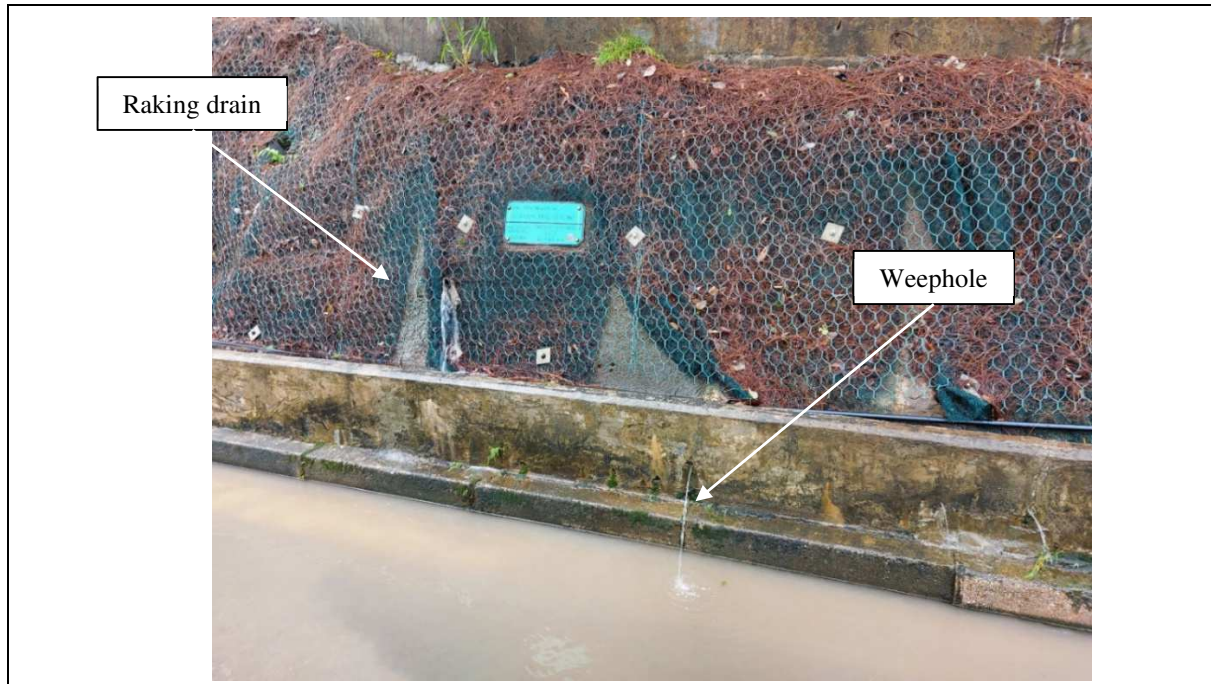
Persistent water flow from the weepholes and raking drains was observed on nearby cut slopes along the southbound lane of Shek O Road (Figure 5.18).

**Figure 5.18 Persistent Water Flow on Nearby Cut Slopes  
(Photograph Taken on 14 September 2023)**
