# **REPORT ON THE RAINSTORM OF MAY 1982**

**GEO REPORT No. 25**

**M.C. Tang**

**GEOTECHNICAL ENGINEERING OFFICE  
CIVIL ENGINEERING DEPARTMENT  
HONG KONG**

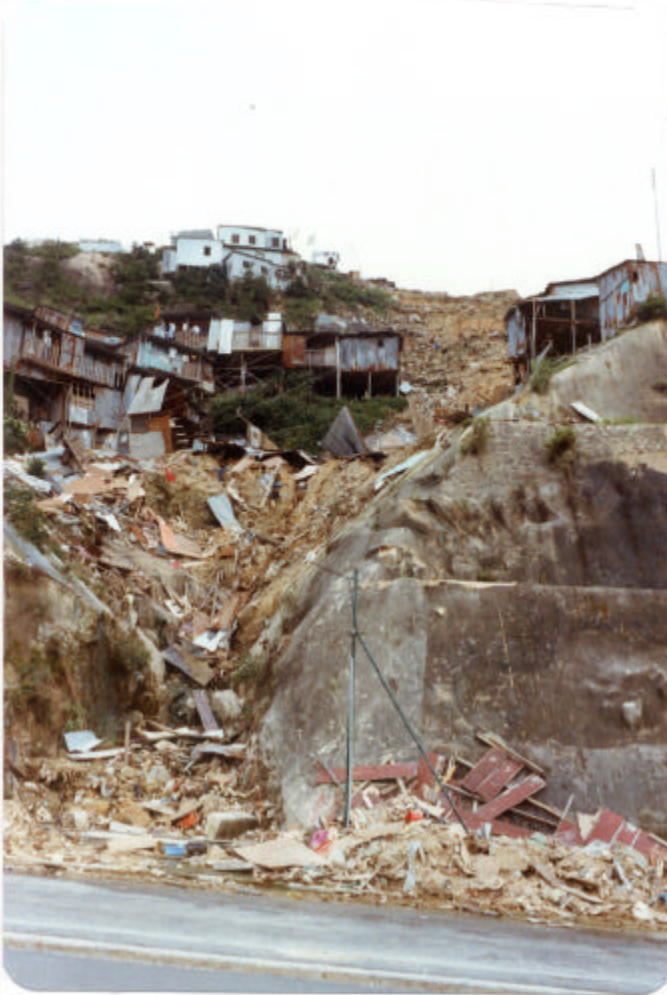
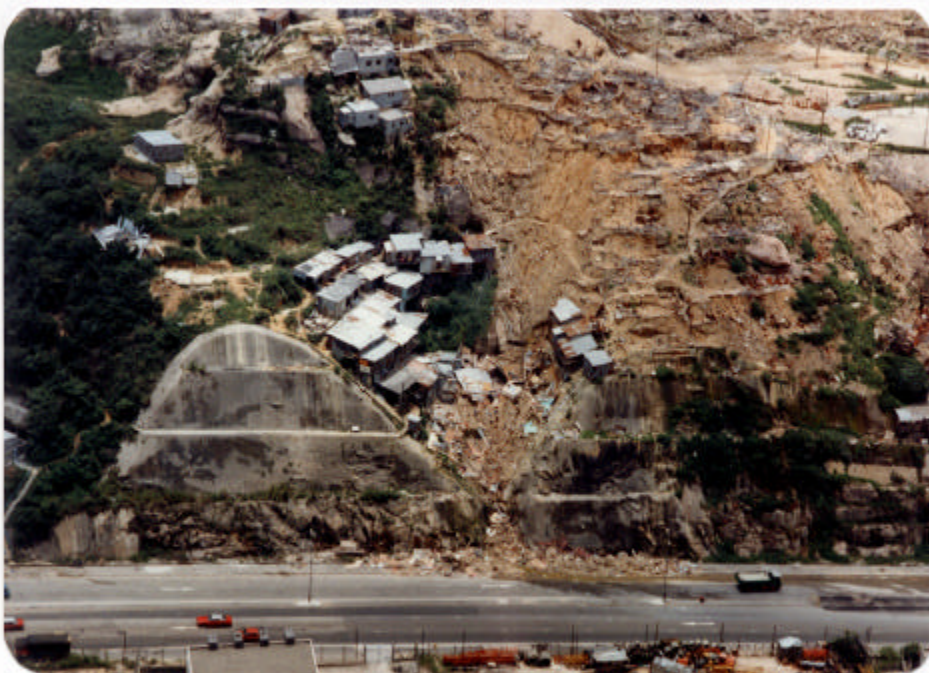
Plate 1 & Plate 2

Landslip at Yuen Mo  
Village, Lam Tin.  
- 3 deaths  
(Incident No. K13)

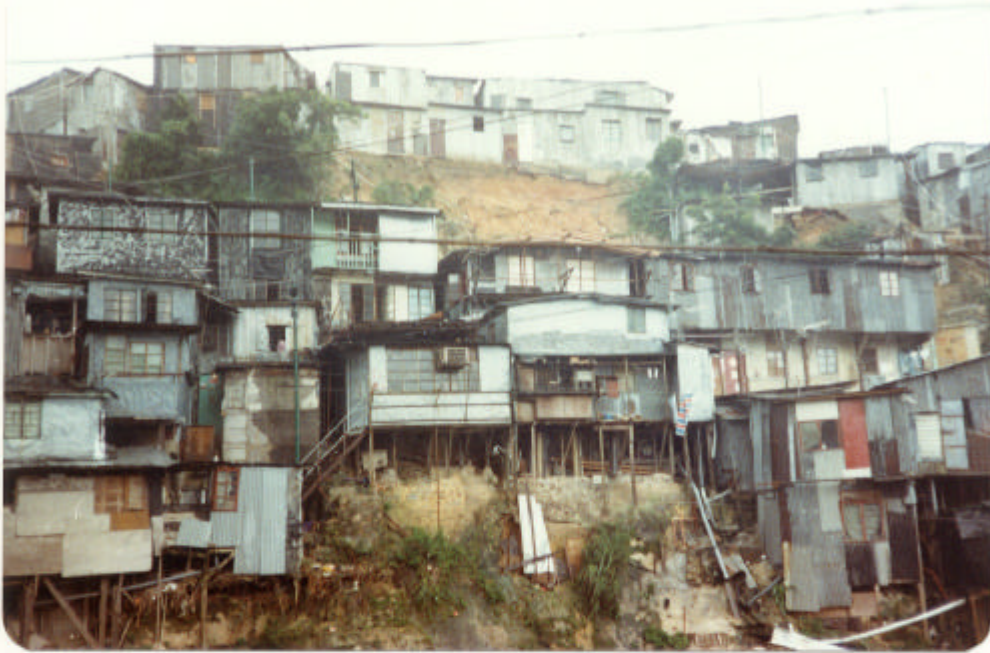
Plate 3

Landslip at Lam Tin 1st Village, Kwun Tong  
- 2 deaths  
(Incident No. K14)

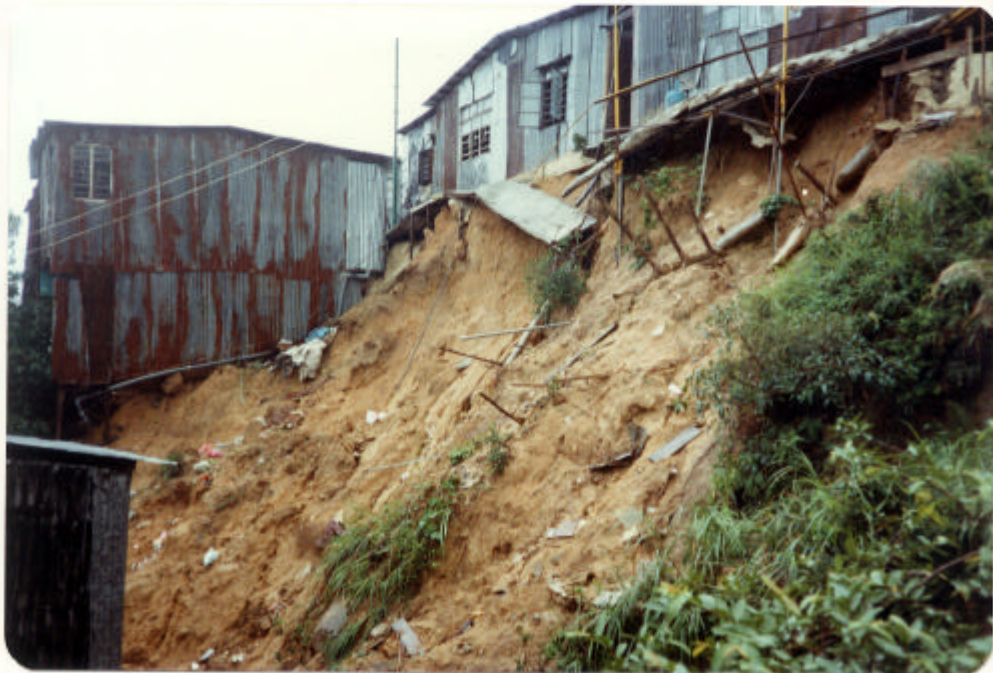
Plate 4

Landslip at Lam Tin 3rd Village, 2nd Section  
- 2 deaths at this incident  
(3 deaths at incident about 30 m away)  
(Incident No. K31)

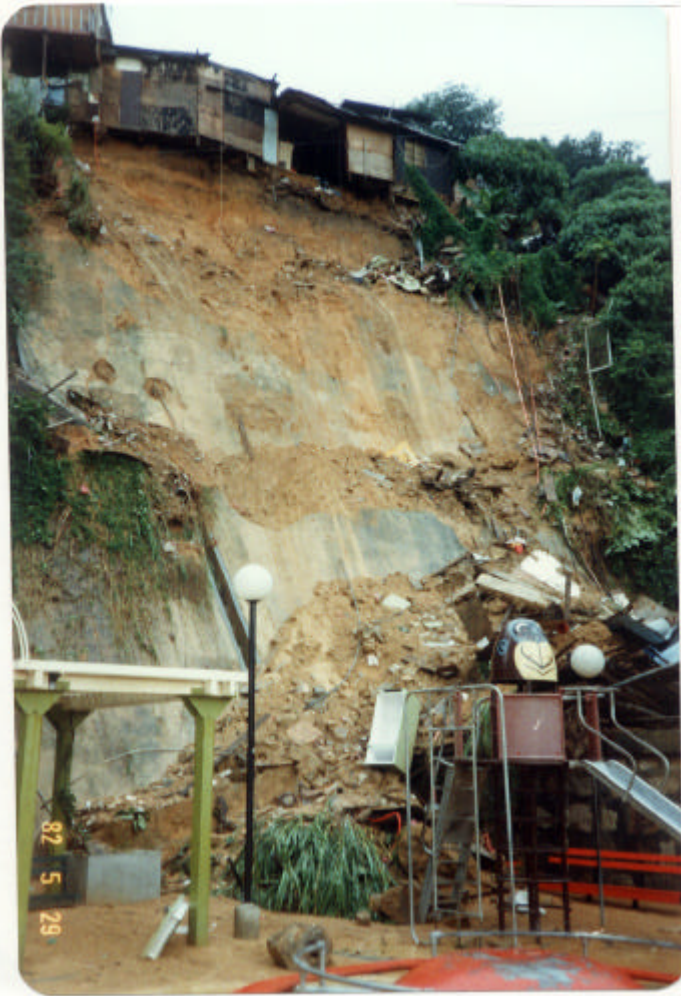
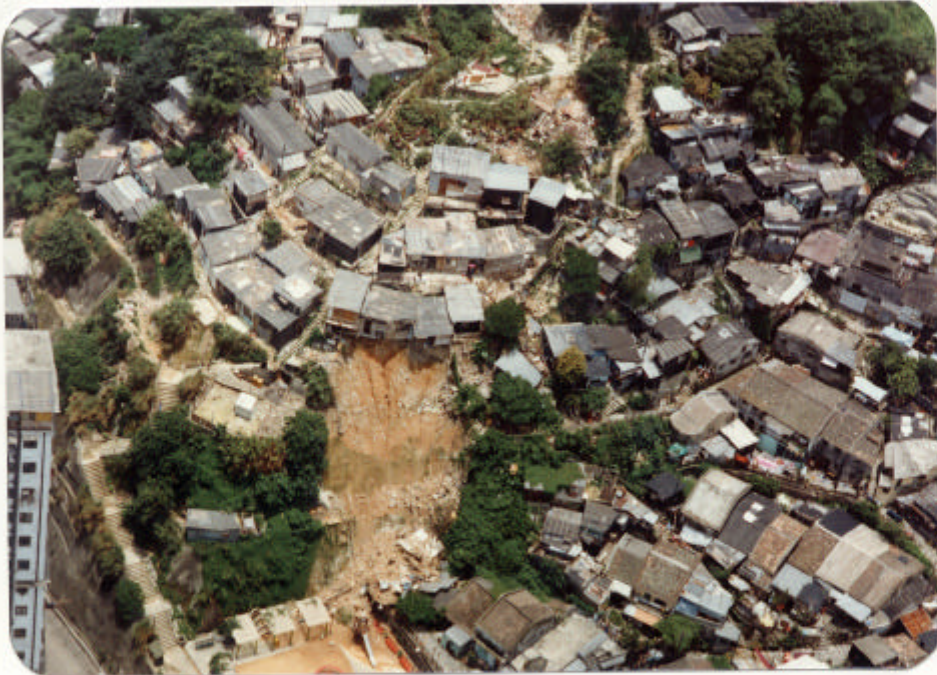
It should be noted that the number of soil cut failures reported as incidents represents only a proportion of the total number which occurred in the rainstorm. Many other failures are known to have occurred, including more than one hundred cut slopes on catchwaters. Two notable incidents of soil cut slope failures occurred at Tsin Tsui Ma Tau Village in Shau Kei Wan (Incident No. HK 2) and Yuen Mo Village, Junk Bay Road in Lam Tin (see Section 5.1).

Plate 5 & Plate 6  
Soil cut slope failure  
at Tsin Shui Ma Tau  
Village, Shau Kei Wan.  
(Incident No. HK2)

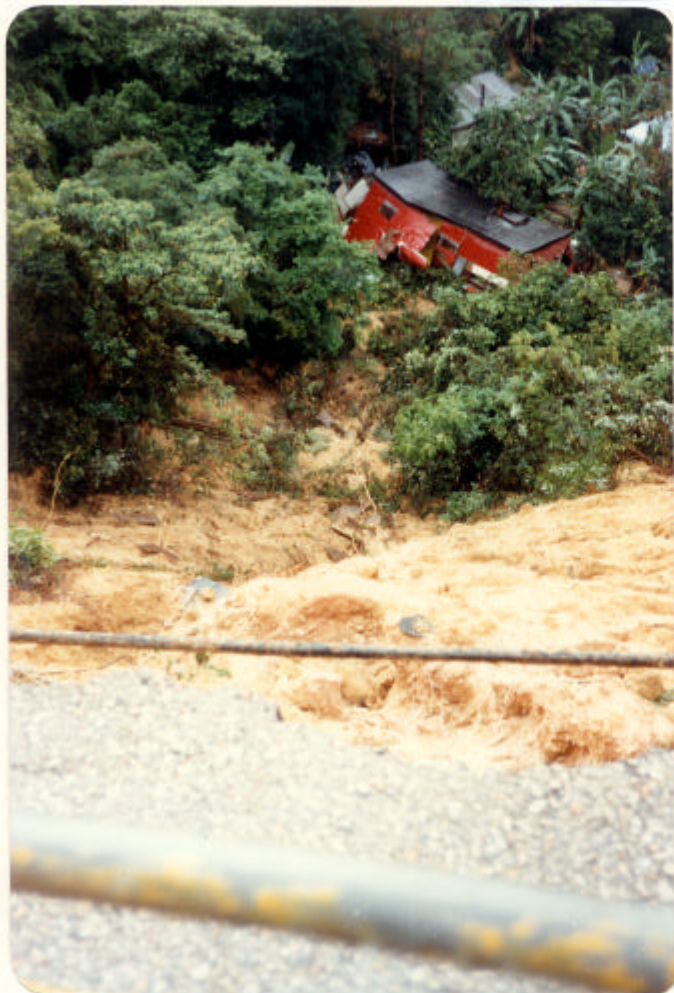
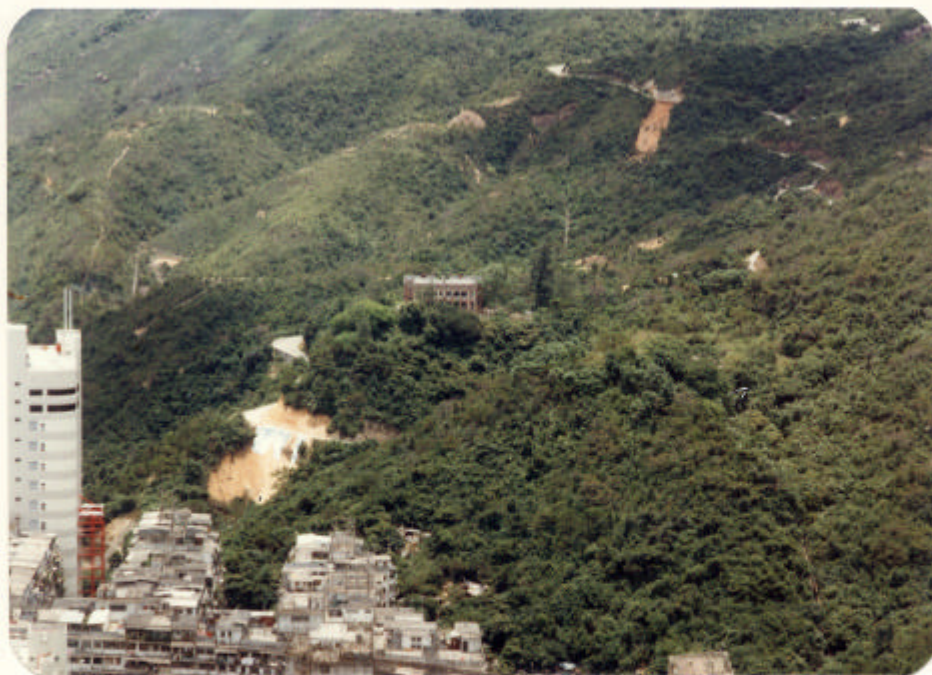
Plate 7 & Plate 8

Natural slope failure  
at Mt. Parker Road,  
above Quarry Bay Street,  
Shau Kei Wan.  
- 2 deaths  
(Incident No. HK82)

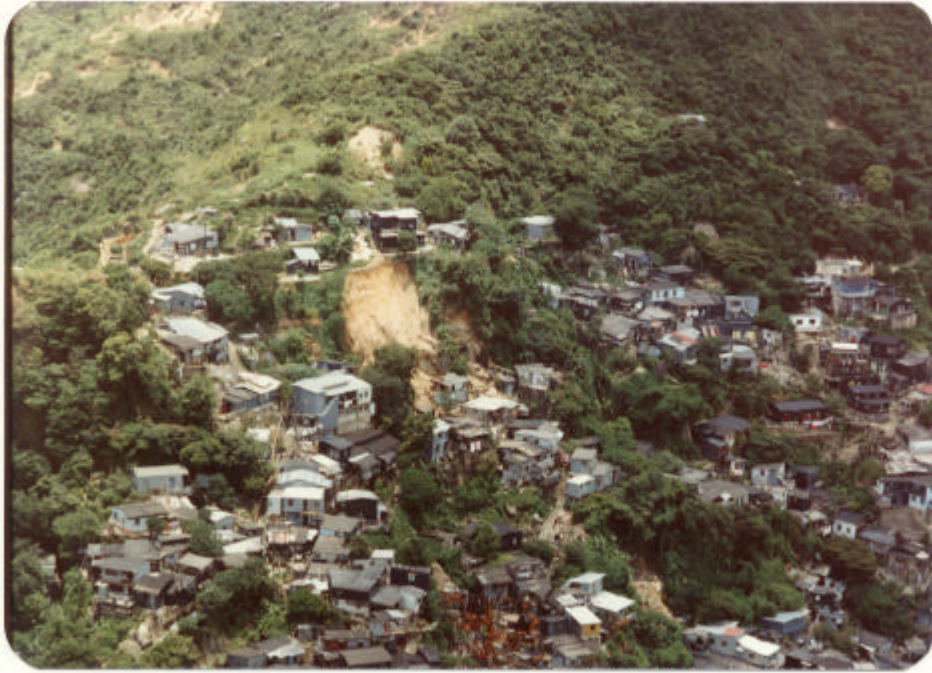
Plate 9

Soil/rock cut slope failure at Holy Cross  
Path Village, Shau Kei Wan.  
(Incident No. HK74)

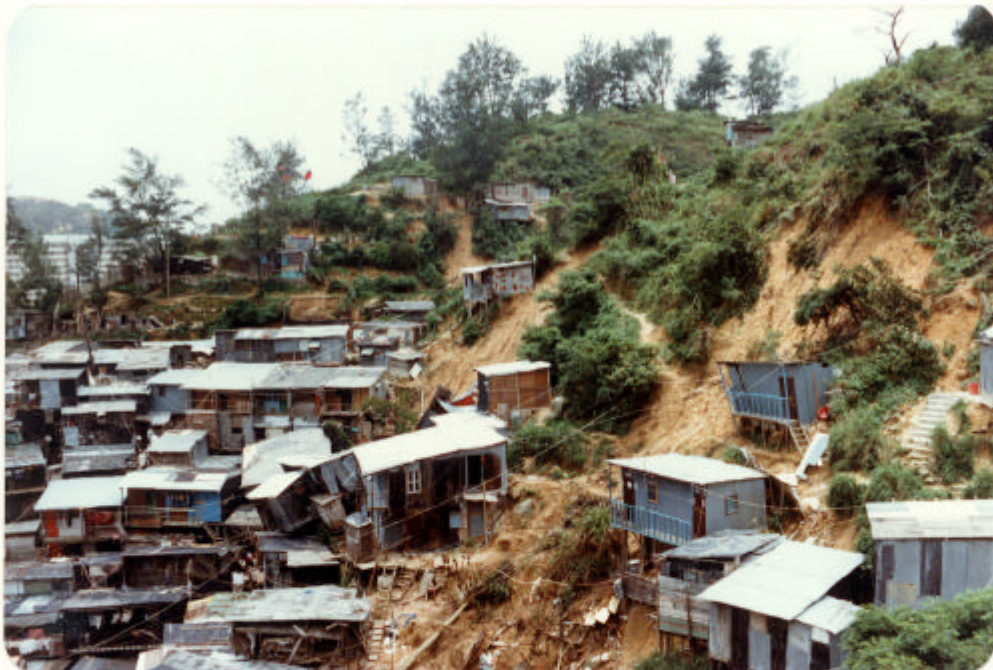
Plate 10

Landslips affecting squatter huts

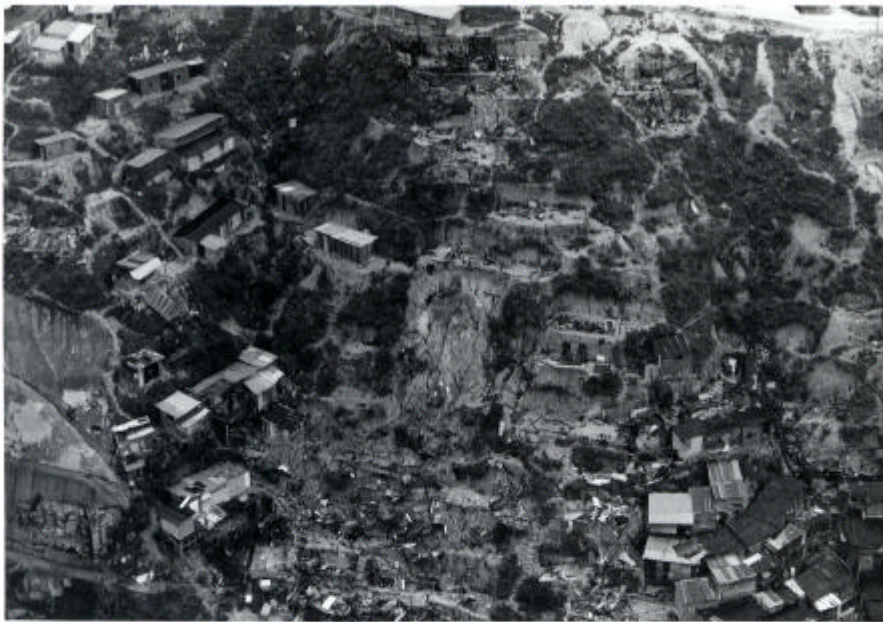
Plate 12

Scene of squatter area after rainstorm  
(Kowloon east)

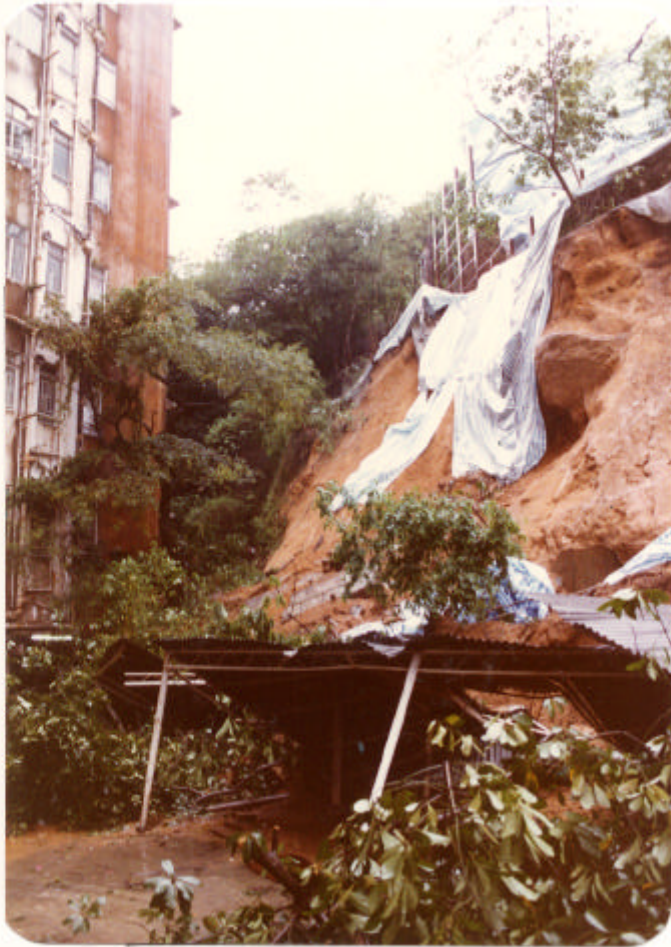
Plate 13

Soil/rock cut slope failure  
at 90, Kennedy Road  
(Incident No. HK10/  
GCB 6 & 34)

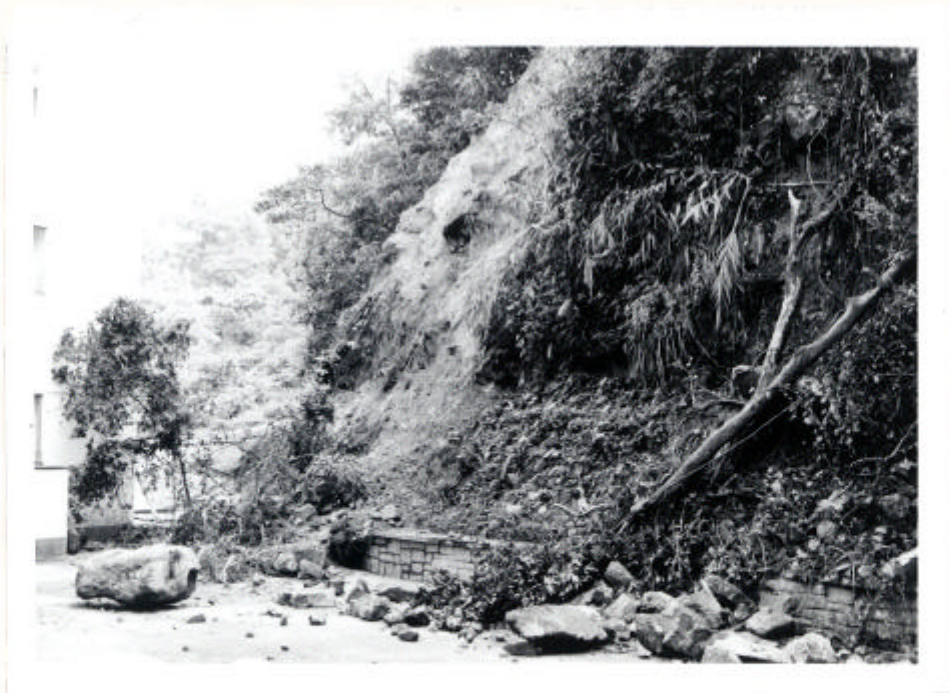
Plate 14

Soil/rock cut slope failure behind  
1, Conduit Road, Chater Hall  
(Incident No. HK32/GCB26)

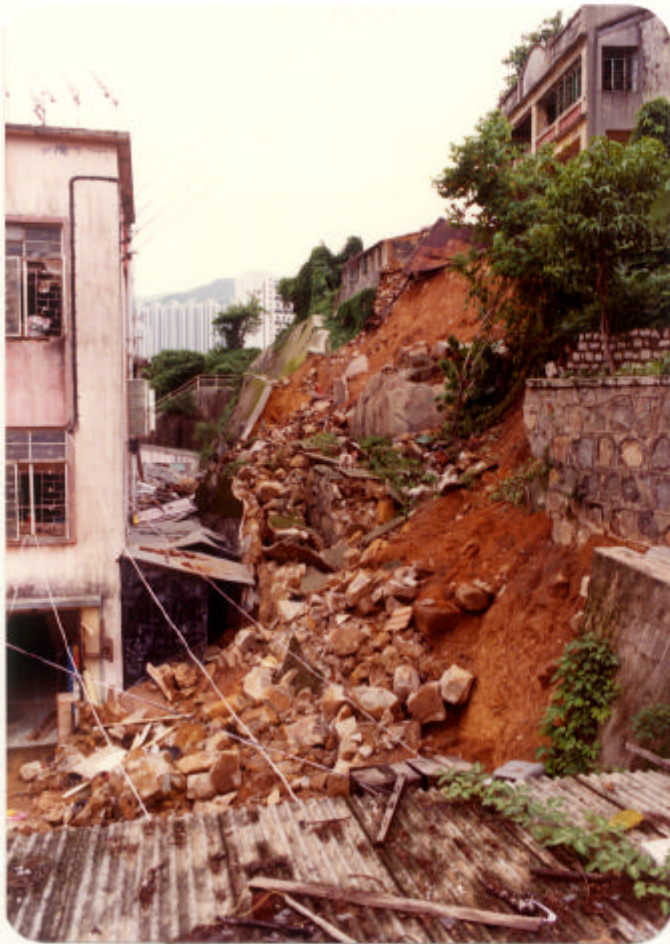
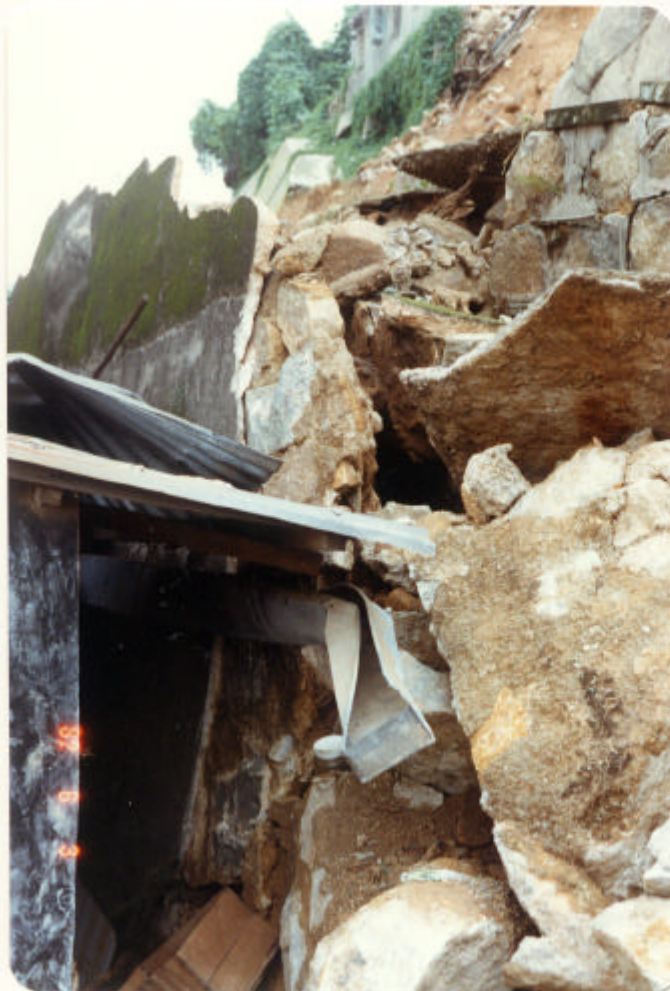
Plate 15 & Plate 16

Soil cut slope & retaining  
wall failure at Wan On  
Terrace, Tsuen Wan  
(Incident No. NT23)

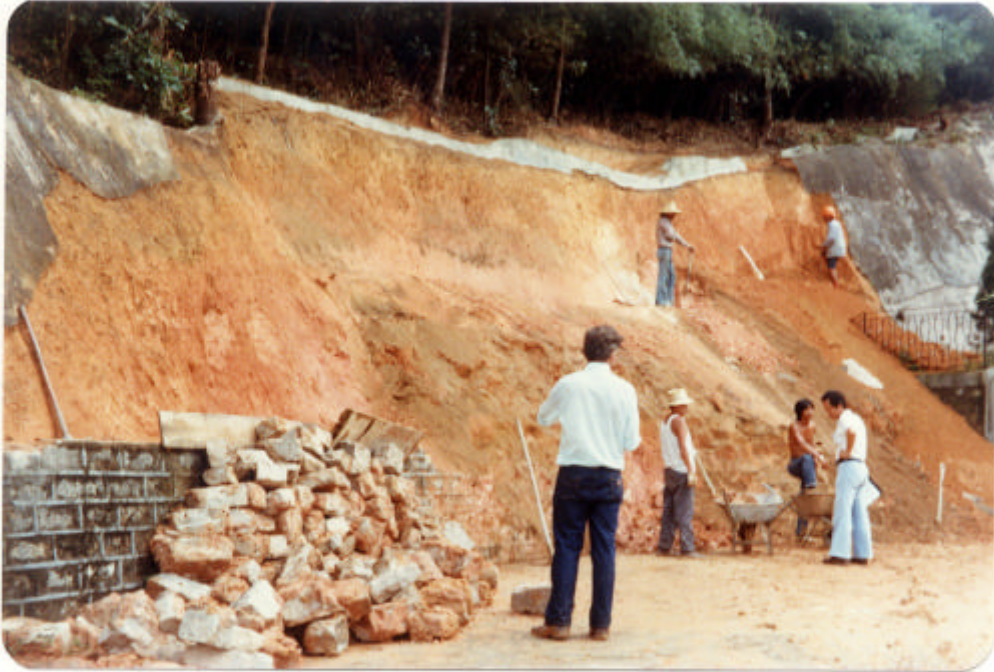
Plate 17

Soil cut slope & retaining wall failure  
at Man King Toi, 6 $\frac{1}{2}$  m Clear Water Bay Road  
(Incident No. NT210)

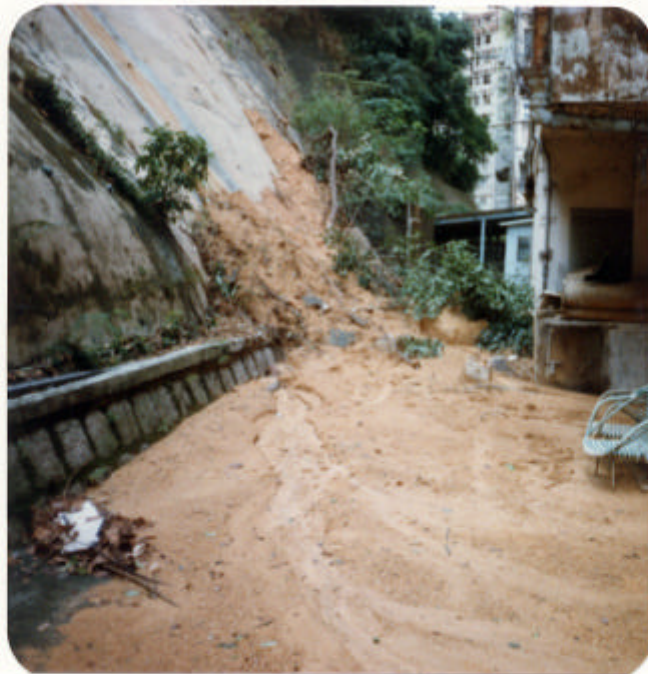
Plate 18

Failure of the natural slope  
above a cut slope at 21 Ventris  
Terrace, Hong Kong  
(Incident No. HK58/GCB45)

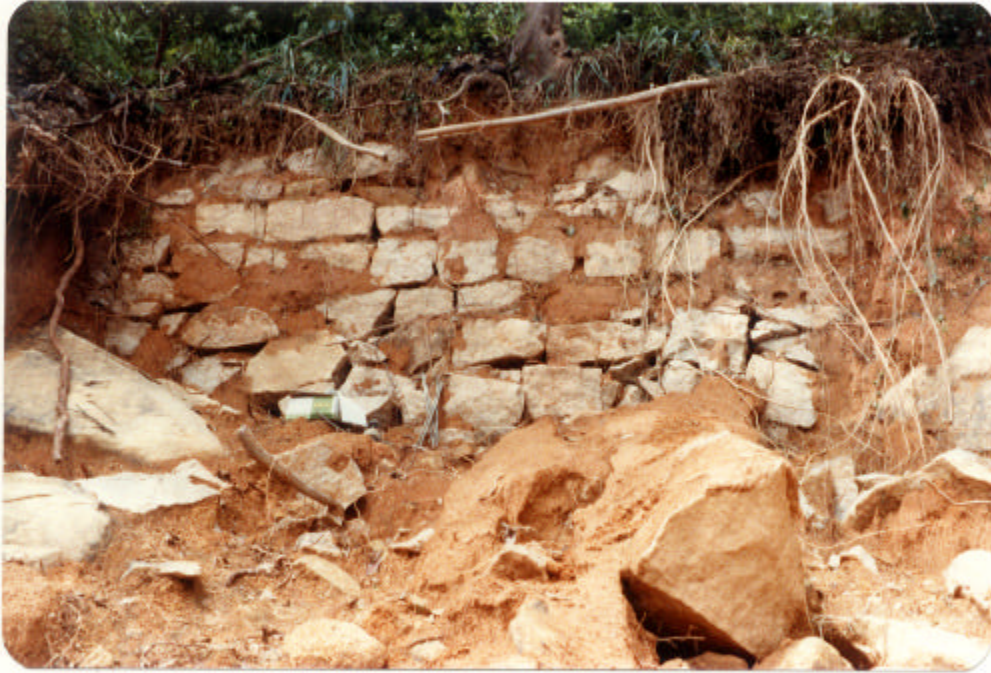
Plate 19

Retaining wall failure at junction of  
Mt. Nicholson & Stubbs Road,  
No. 50, Stubbs Road.  
(Incident No. HK36)

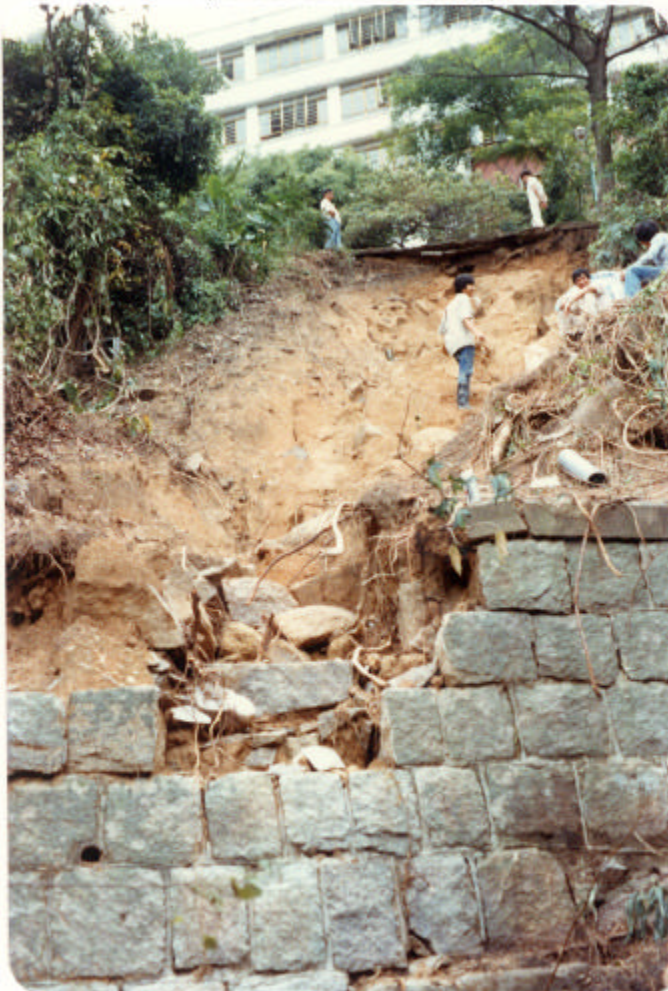
Plate 20

Retaining wall failure at  
Stubbs Road, near  
Lingnam College.  
(Incident No. HK34)

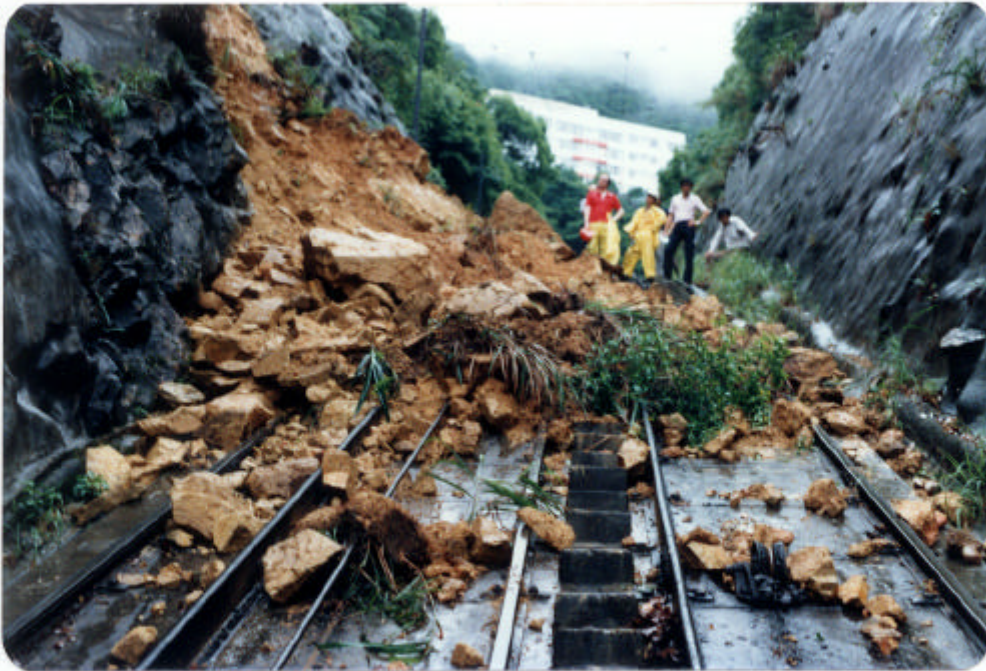
Plate 21  
soil/rock cut slope failure  
at Tramway near May Road Station.  
(Incident No. HK 6)

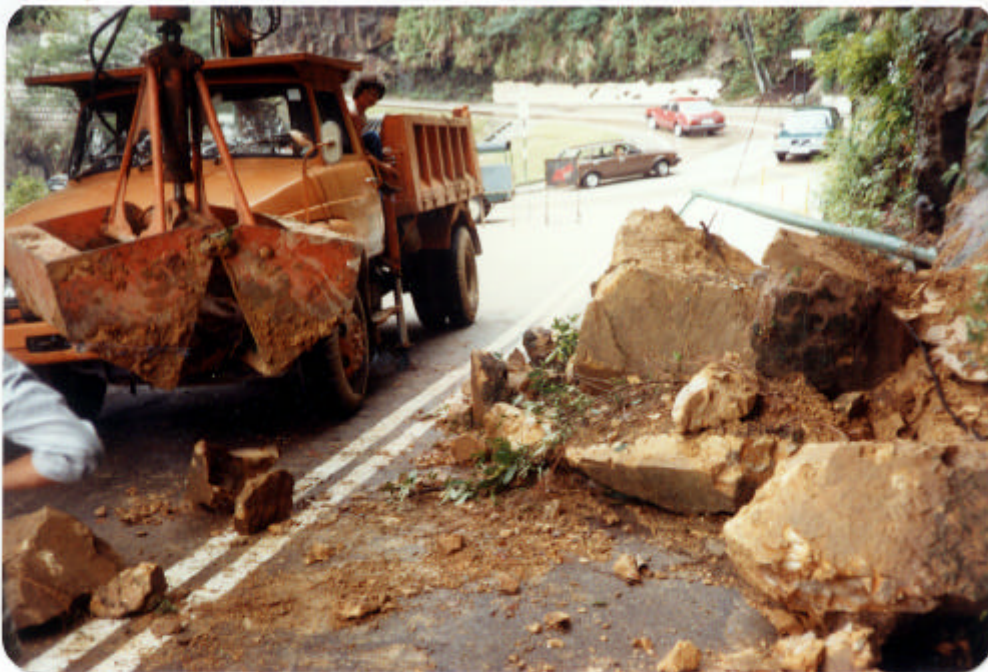
The incident at the Junction of May Road and Magazine Gap Road in Northern H.K. Island (Incident No. HK 84, Plate 22) is typical. Plane failure took place on a joint plane dipping out of the rock face at an angle of between 65° and 70°. Three large blocks 0.8 m<sup>3</sup> to 1.0 m<sup>3</sup> had fallen from a scar 2 m to 5 m above the road surface onto the road. Numerous small blocks were also associated with the failure. Most of the debris fell within the inner (slope side) carriageway. The road surface did not sustain any damage but a lamp post was destroyed. The road was closed for removal of the debris and then reopened.

Plate 22  
Rock cut slope failure at junction  
of May Road & Magazine Gap Road.  
(Incident No. HK 84)

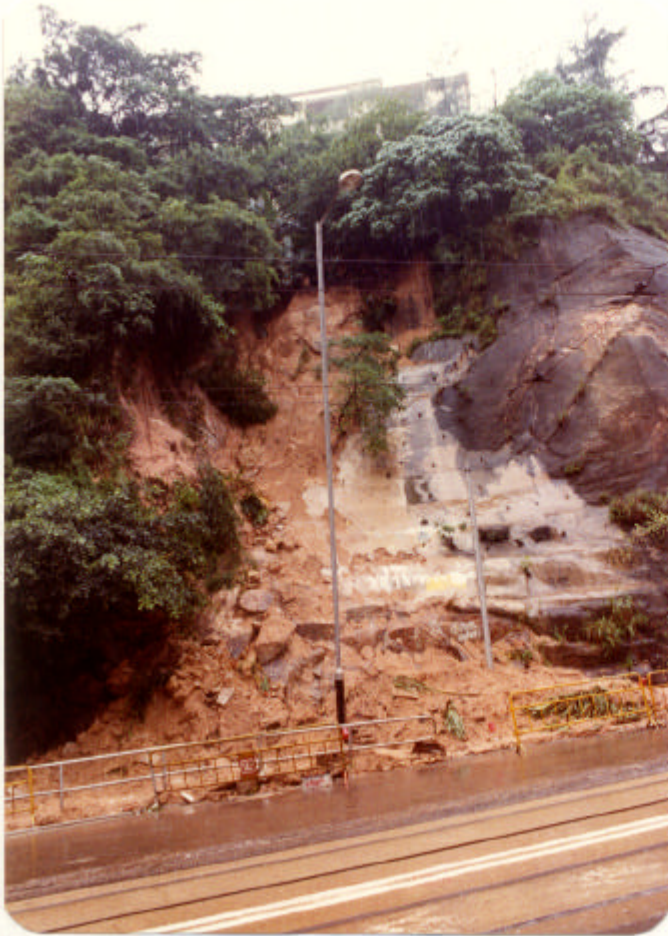
Plate 23

Soil/rock cut slope failure  
at King's Road near Tai Koo  
Shing Road Junction.  
(Incident No. HK61)

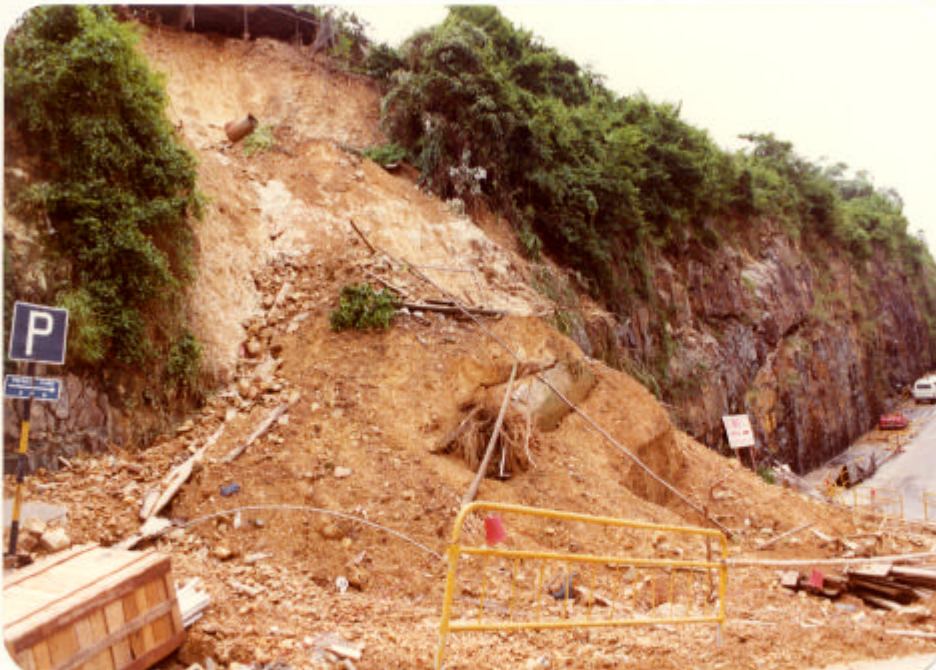
Plate 24

Soil/rock cut slope failure at Tong Bin Lane,  
behind Fire Station, Aberdeen.  
(Incident No. HK83)

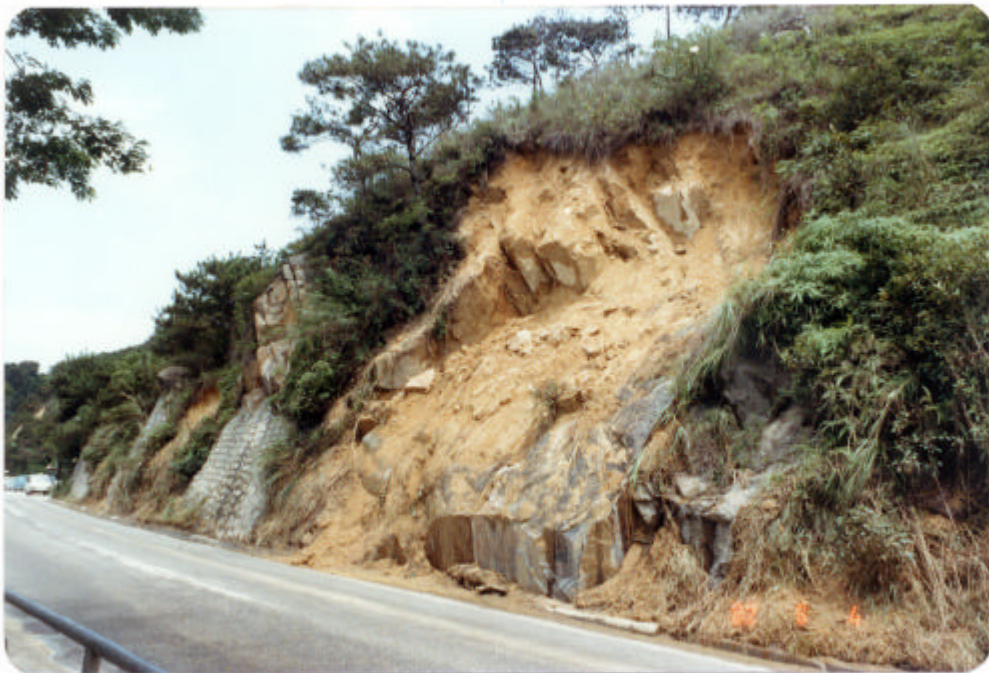
Plate 25

Soil/rock cut slope failure at  
13ms Castle Peak Road

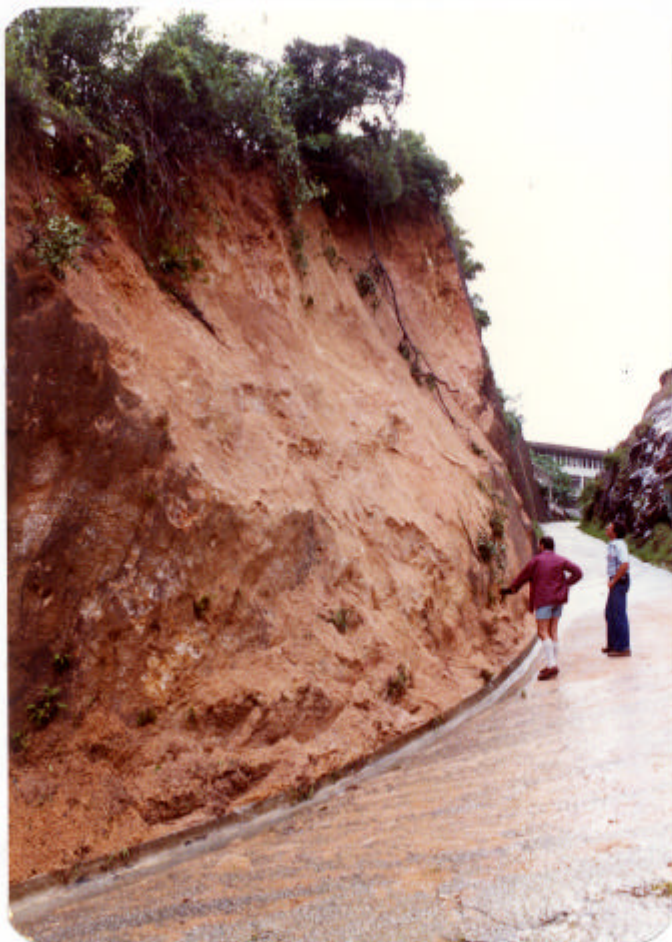
Plate 26

Cut slope failure at  
Chung Hom Kok  
(Incident No. HK42)

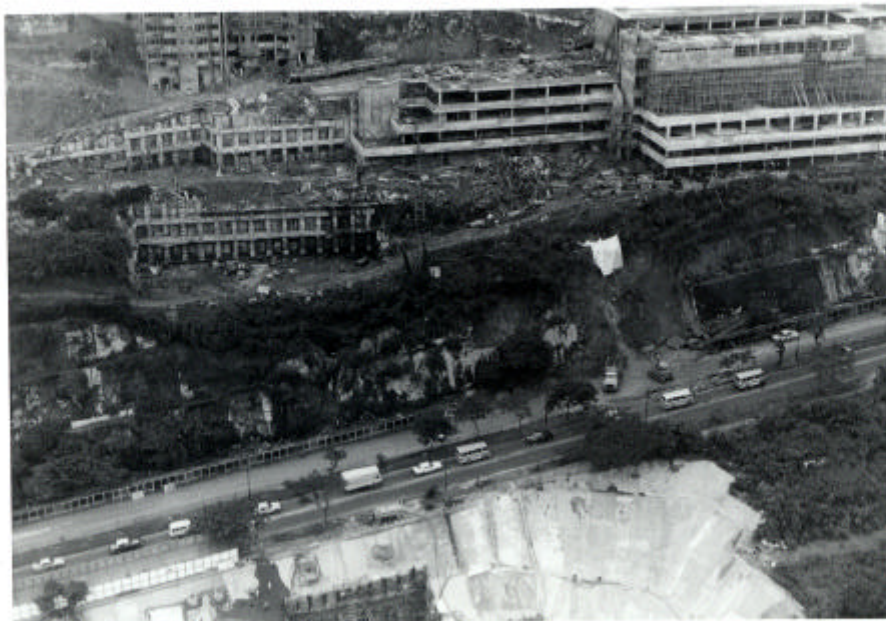
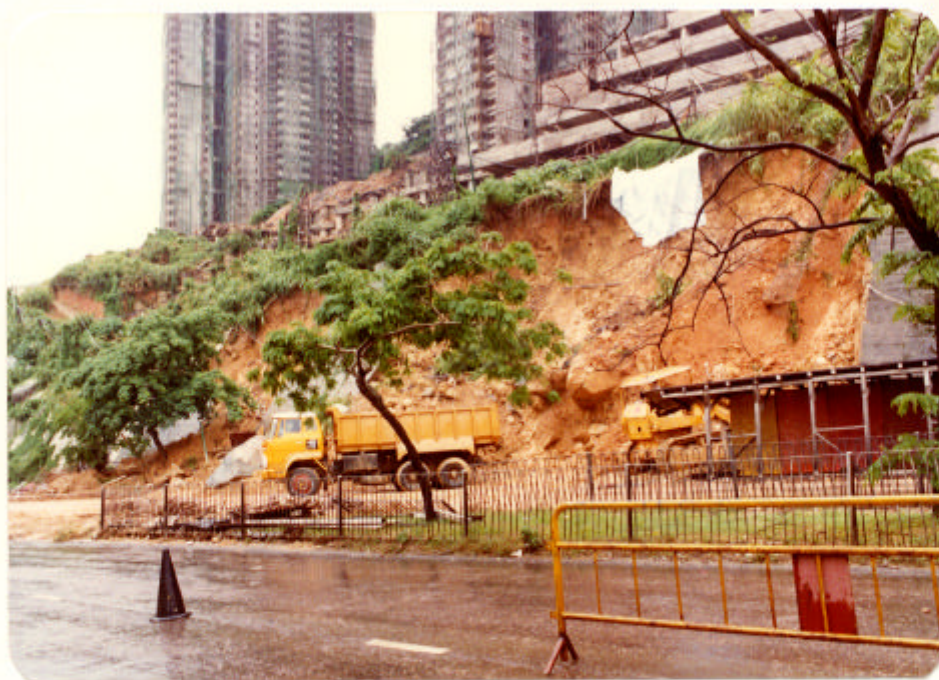
Plate 27 & 28

Soil cut slope failure at Chai Wan Road  
near junction with Lok Man Road.  
(Incident No. HK24)

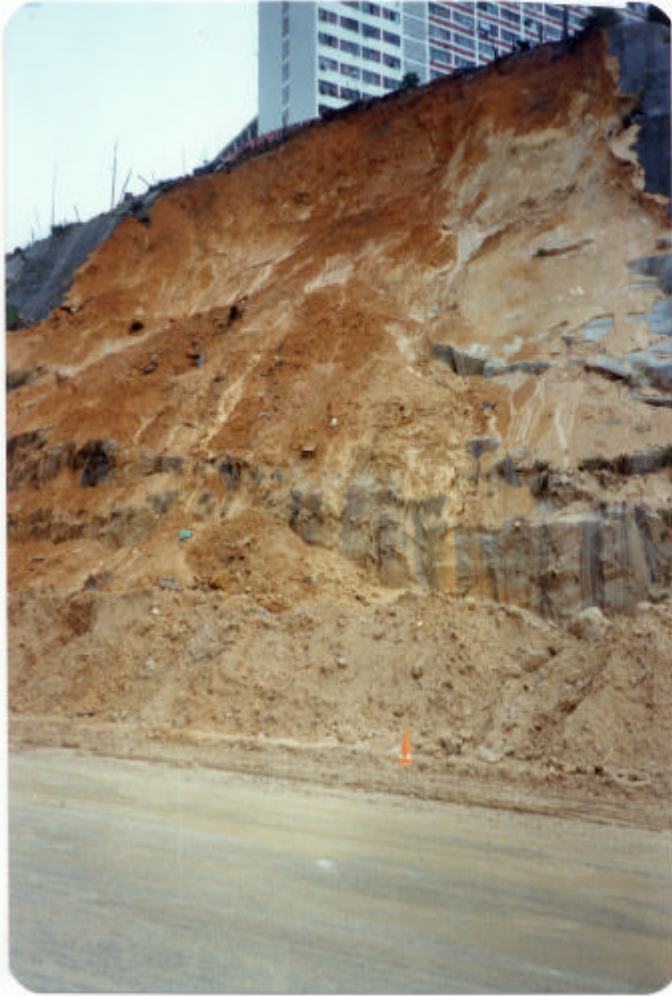
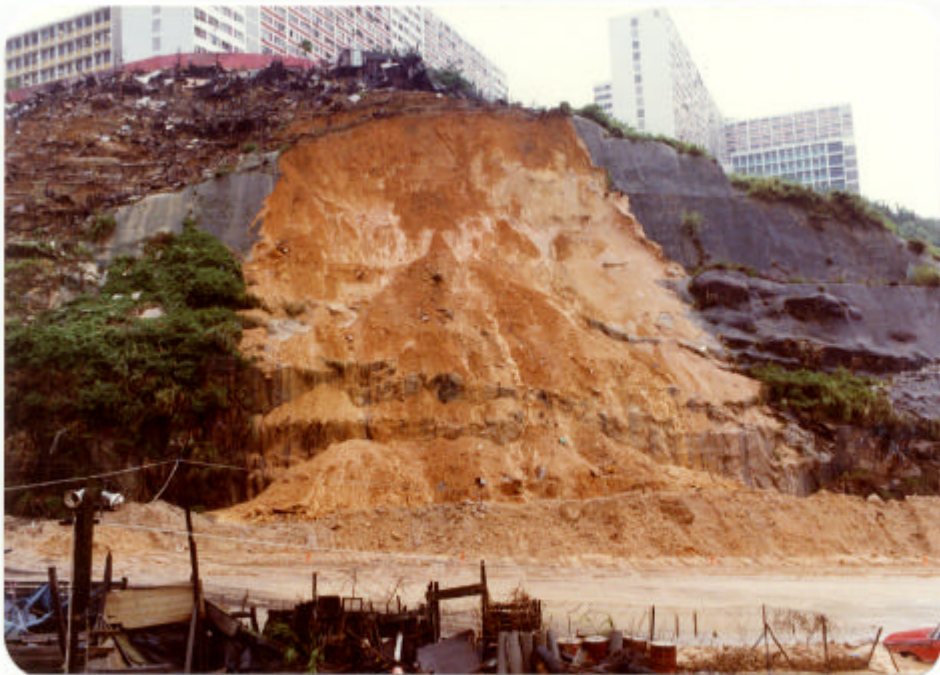
Plate 29 & 30

Soil cut slope failure at  
Junk Bay Road, Lam Tin.  
(Incident No. K18)

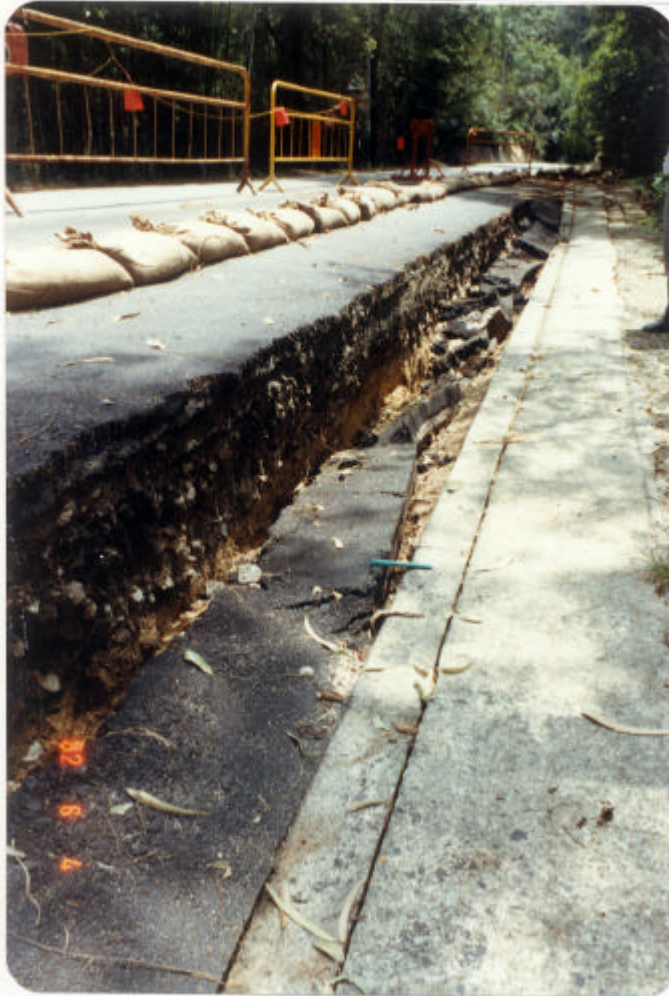
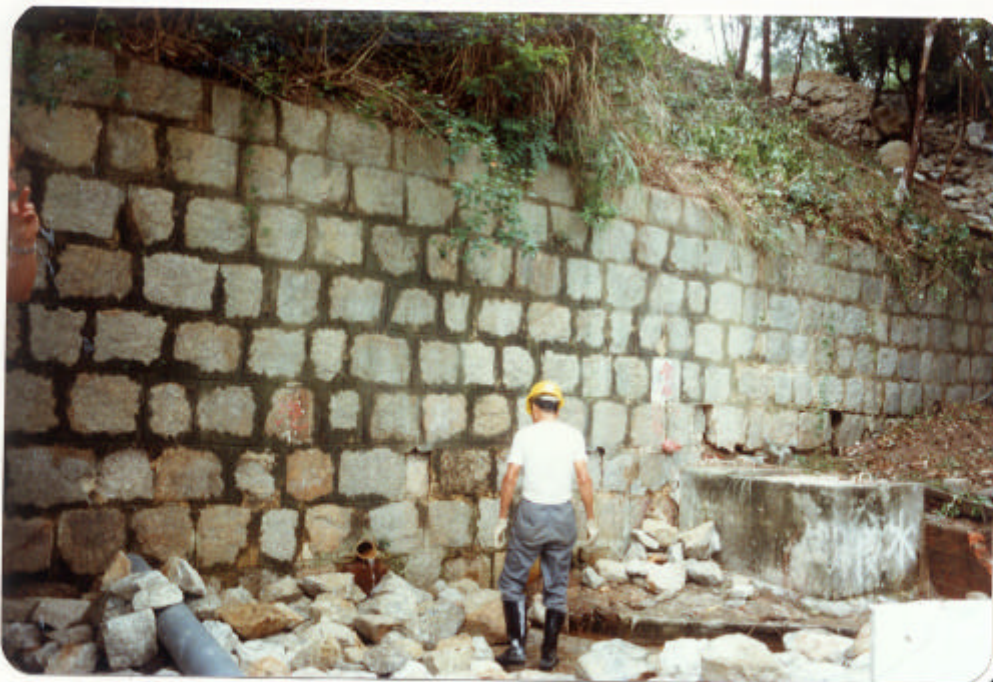
Plate 31 & Plate 32

Fillslope & retaining wall  
failure at 13 $\frac{1}{2}$  ms  
Castle Peak Road.  
(Incident No. NT108/GCB 12A)

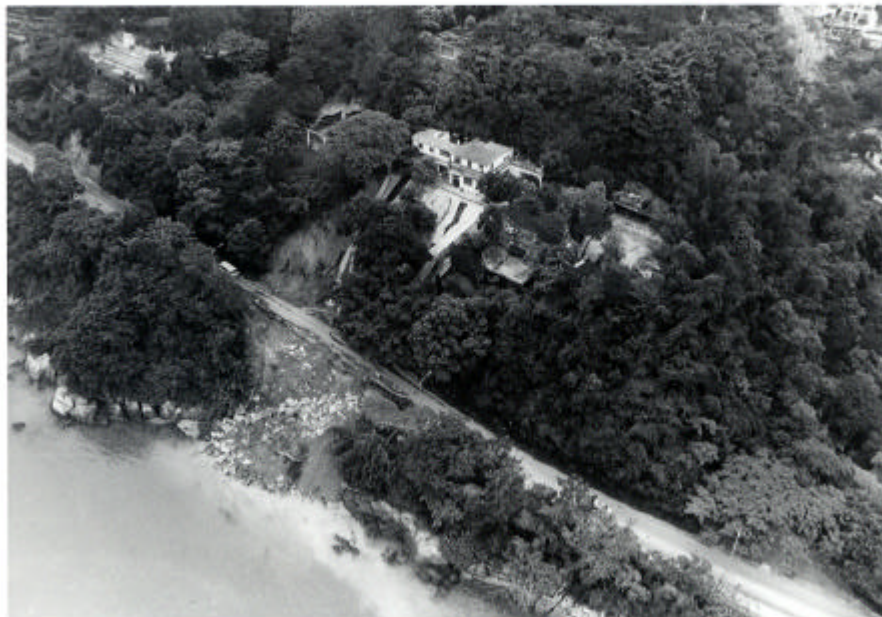
Plate 33

10 failures affected roads, 3 of which were classified as major. All 3 major incidents occurred along Castle Peak Road, two at  $13\frac{3}{4}$  ms (Incident No. NT 7 and GCB 12; Plate 33) and one at  $17\frac{1}{2}$  ms (Incident No. NT 86, Plate 34). These 3 incidents together with some other minor cases, led to the closure of the road from 29 May to 10 June.

Fill slope failure at 13 $\frac{1}{4}$  ms Castle Peak Road,  
opposite Lai Shum Villa.  
(Incident No. NT7)

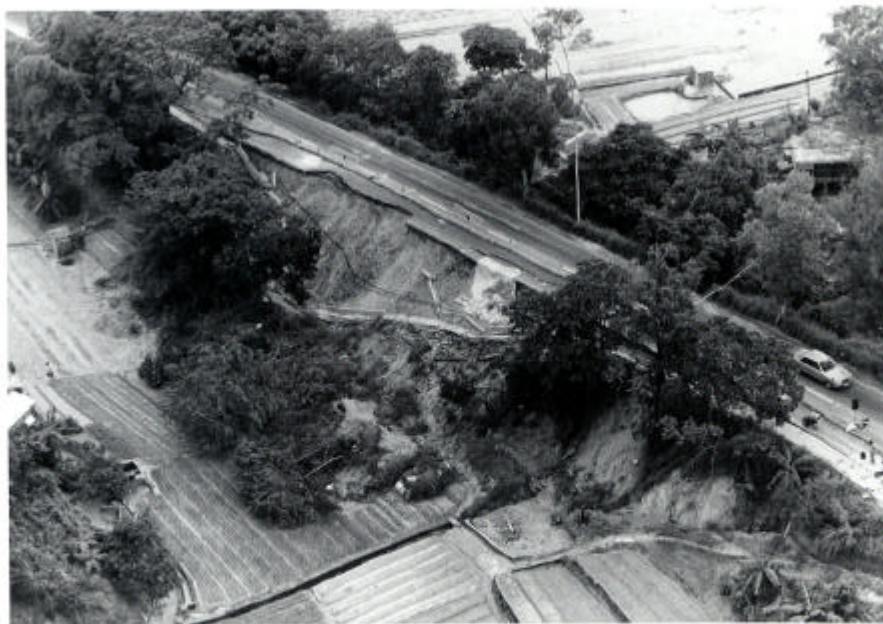
Plate 34

Fill slope failure at 17 $\frac{1}{2}$  ms Castle Peak Road  
near Siu Wo Village  
(Incident No. NT86)

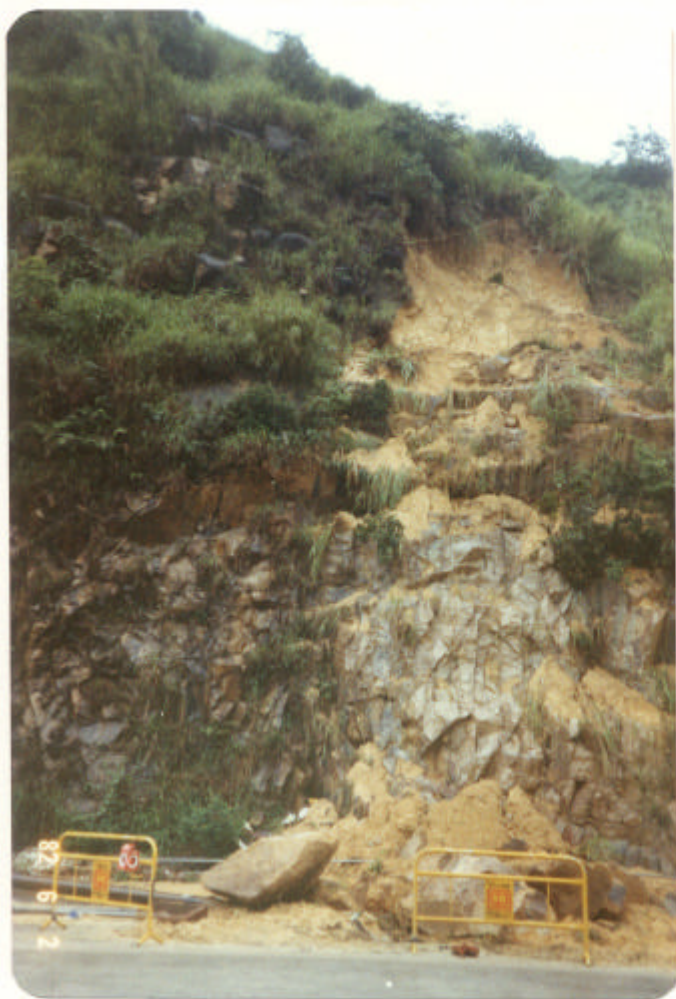
Plate 35

This small failure occurred in a cut slope on Hong Ning Road, Kwun Tong on the evening of 31 May and is shown in Plate 35. The material involved in the failure was highly to completely decomposed granite containing large core-stones of stronger rock (grades III - IV) up to 1.5 m diameter. The lower part of the failure plane was covered by debris but appeared to be a well-defined joint, dipping directly out of the slope. No casualties were reported and the slip blocked the pavement only.

Soil/rock cut slope failure  
at Hong Ning Road,  
Kwun Tong.  
(Incident No. K28)
