# **REPORT ON THE RAINSTORM OF MAY 1982**

**GEO REPORT No. 25**

**M.C. Tang**

**GEOTECHNICAL ENGINEERING OFFICE  
CIVIL ENGINEERING DEPARTMENT  
HONG KONG**

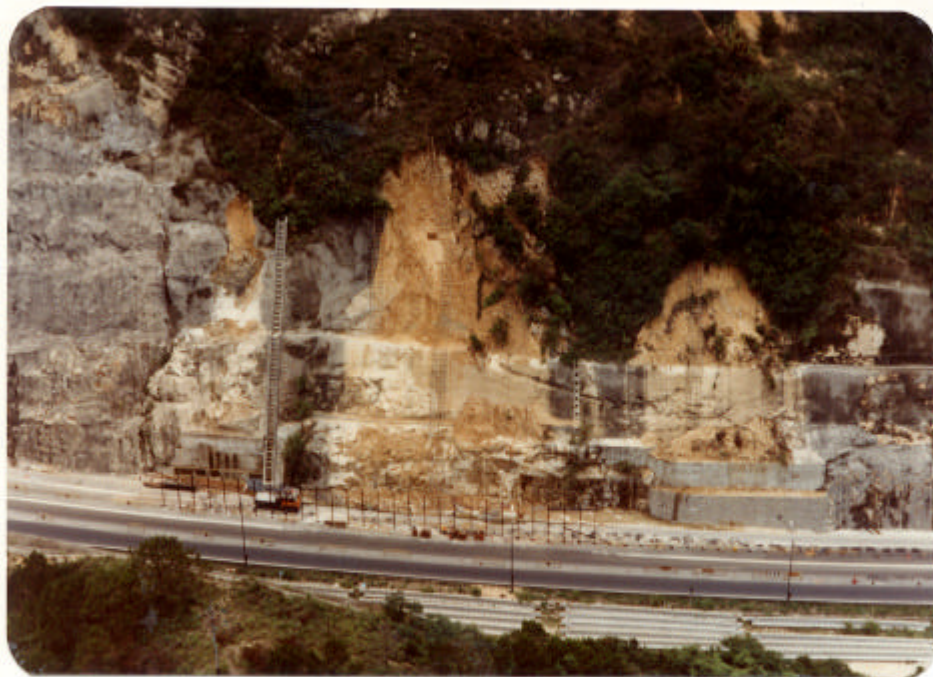
Plate 36

Soil cut slope failures at CH 6750,  
Tuen Mun Highway.  
(Incident No. NT79)

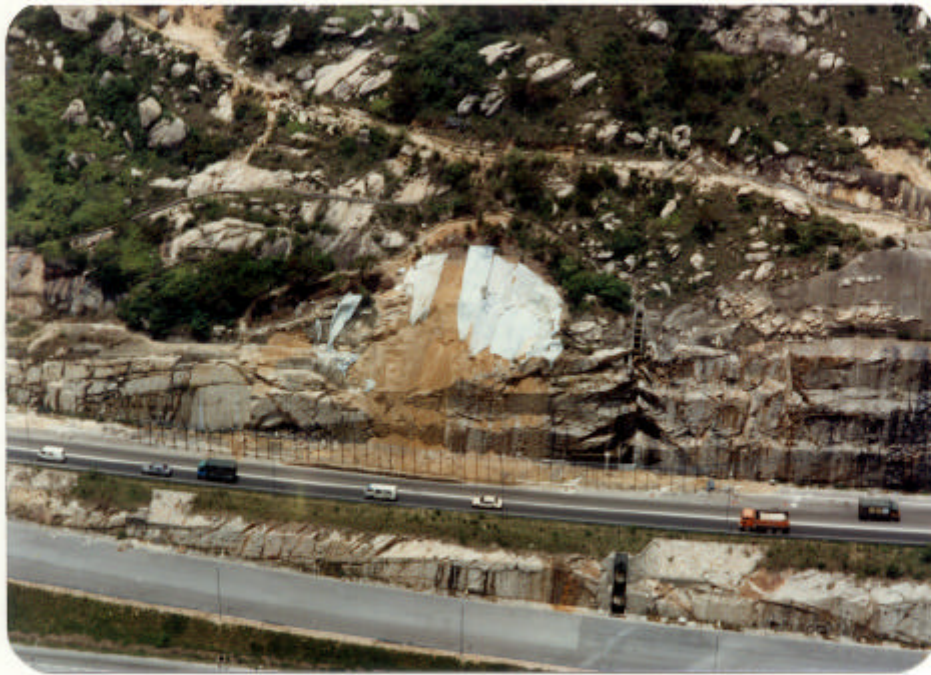
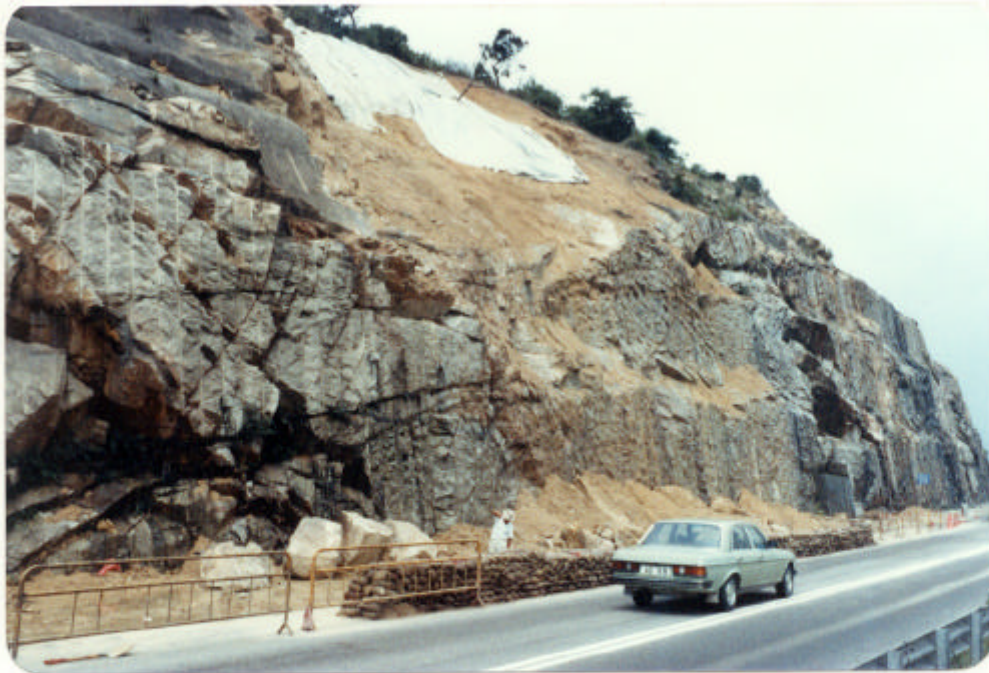
Plate 37 & Plate 38

In contrast to (a) above, the soil/rock cut slope failure at CH10050 on the Tuen Mun Highway was one of the biggest failures to be reported. Aerial and ground views of this failure are shown in Plates 37 and 38. The failure was approximately 20 m wide x 30 m long and involved the removal of a 1 to 3 m thick layer of highly to completely decomposed granite in the upper part of the slope and several large blocks of stronger rock, up to 2 m diameter, lower down near the top of the rock face forming the bottom part of the slope. On the right hand edge of the scar (looking upslope) the failure plane occurred on a persistent sheeting joint dipping obliquely out of the slope face. In the main body

of the scar, failure occurred through the decomposed granite matrix. During the site inspections, water seepage was observed at several points in the rock face, in the lowest 10 m of the failure scar and adjacent to the old access track some 20 m above the scar on the natural slope (see Plate 37).

The failure did not result in any casualties but blocked the Tuen Mun Highway. One lane of the road was closed for a period of approximately 2 months after the failure in order to complete the remedial work.

Soil/rock cut slope failure at CH 10050  
Tuen Mun Highway.  
(Incident No. NT8)

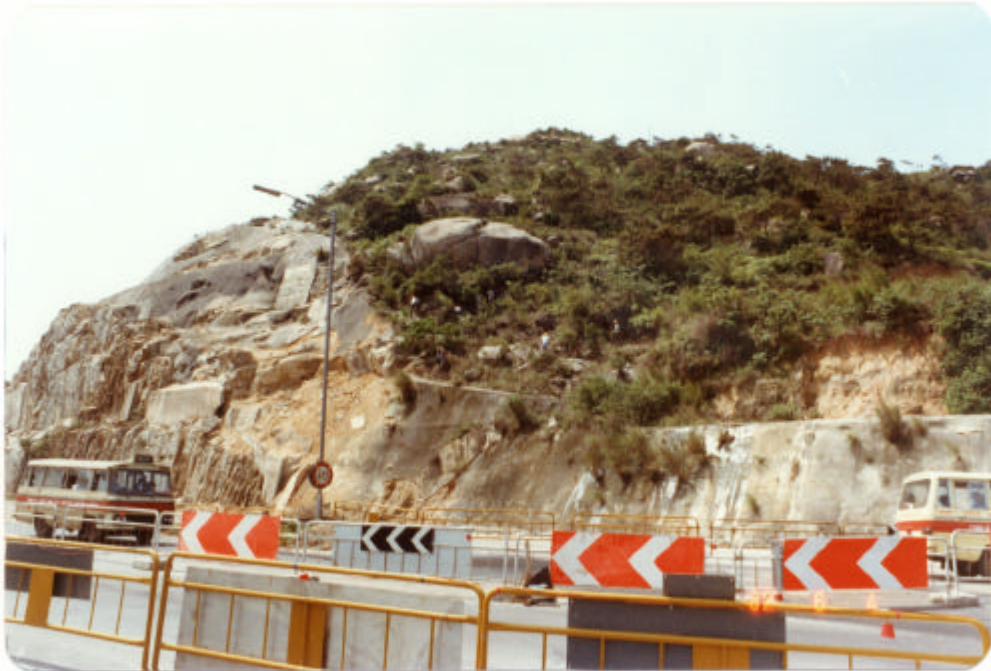
Plate 39

Soil/rock cut slope failure at CH 10350  
Tuen Mun Highway. Failure of big boulder  
was imminent. (See also Plate 44 for close  
up view)  
(Incident No. NT70)

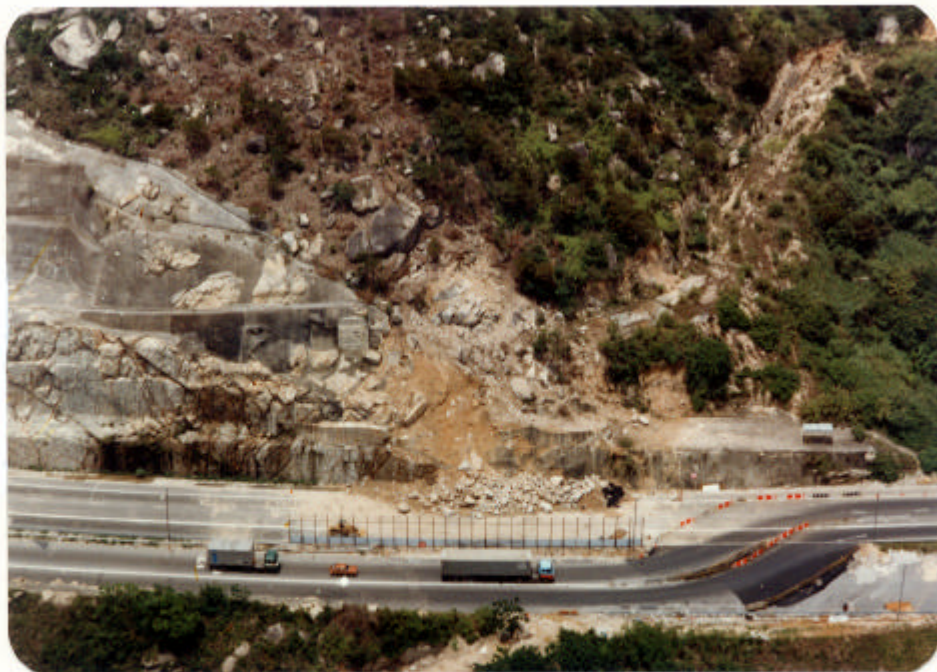
Plate 40

Soil/rock cut slope failure at CH 10350  
Tuen Mun Highway (Boulder destroyed by blasting)  
(Incident No. NT70)

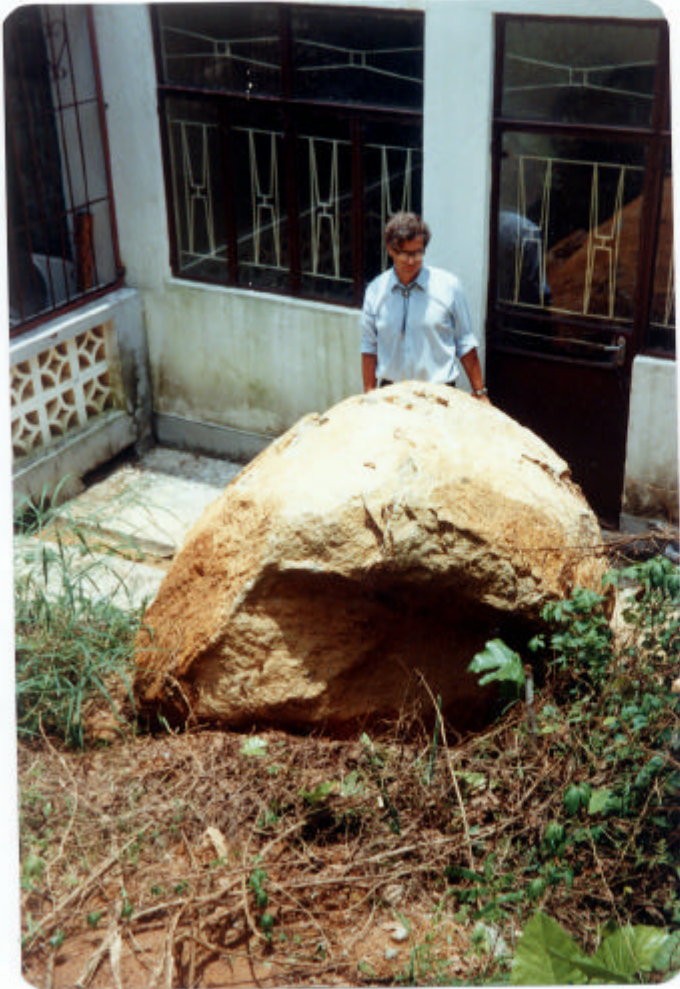
Plate 41

Boulder fall & natural slope failure at Greenwich Garden, Kam Shan Village, Tai Po. (Incident No. NT 159)

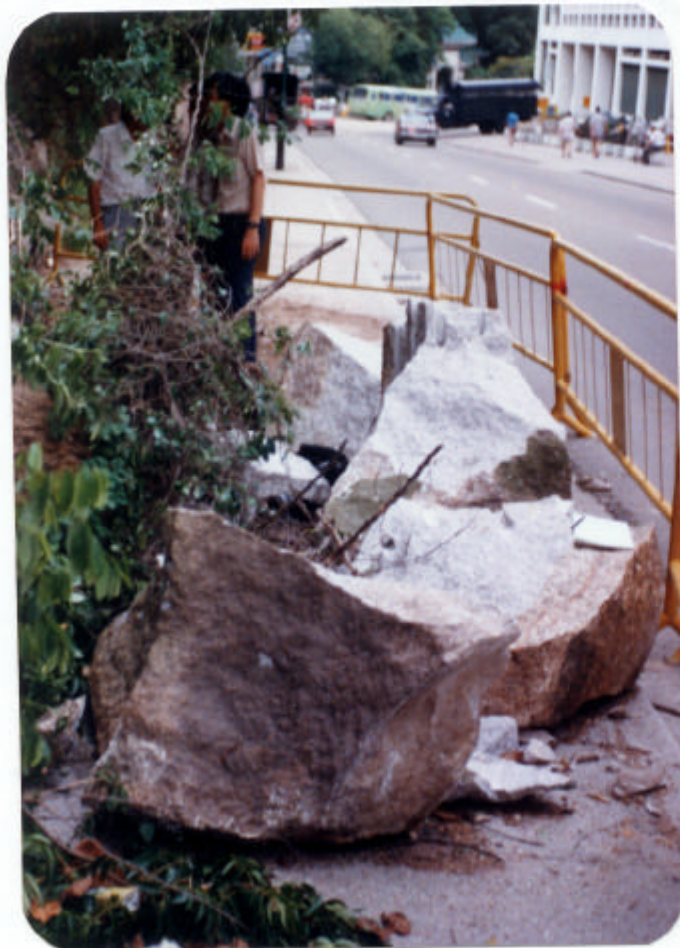
Plate 42

Boulder fall at Caroline Hill Road near New Method College, opposite South China Athletic Association (Boulder split) (Incident No. HK38)

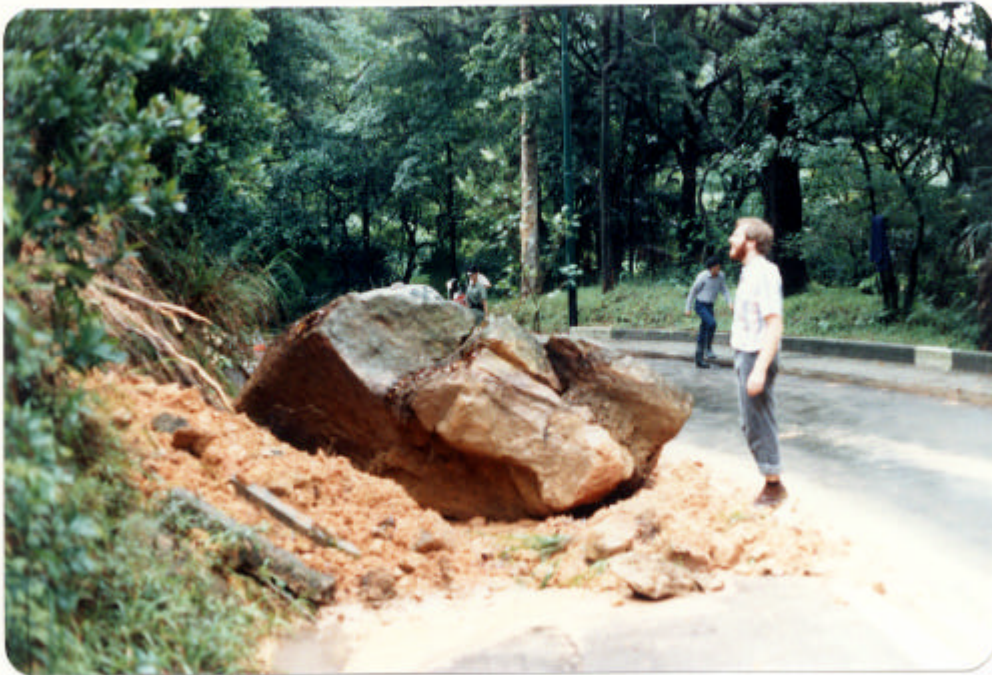
Plate 43

Boulder fall & soil cut slope failure at  
Peak Road  
(Incident No. HK22)

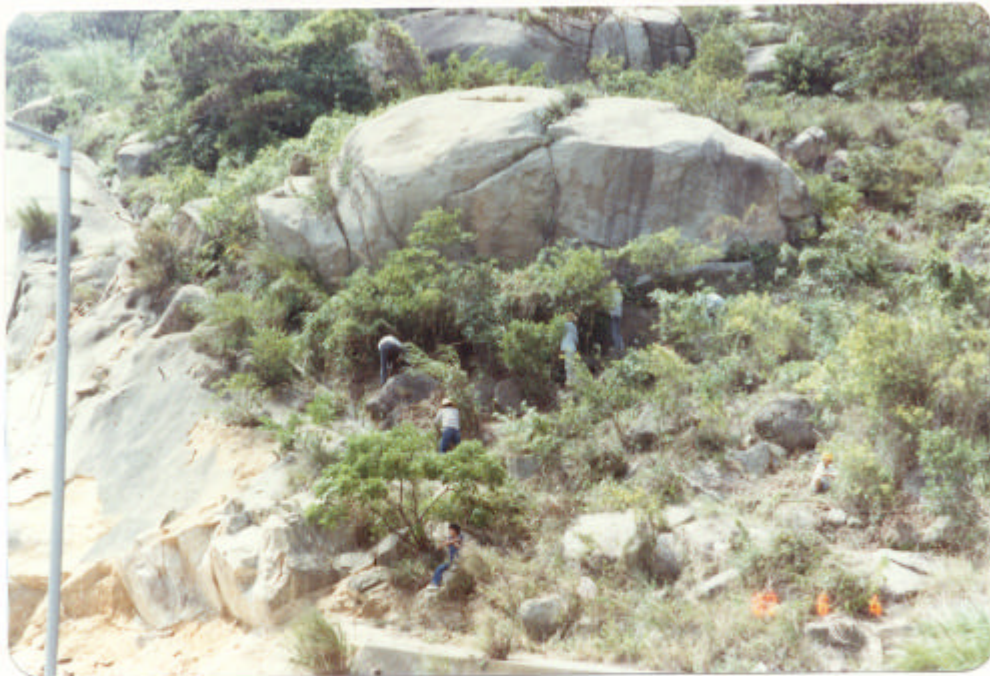
Plate 44

Boulder perched on soil/rock cut slope at  
CH 10350 Tuen Mun Highway - Boulder shown  
subsequently destroyed by blasting  
(See also Plate 39 and Plate 40)  
(Incident No. NT70)

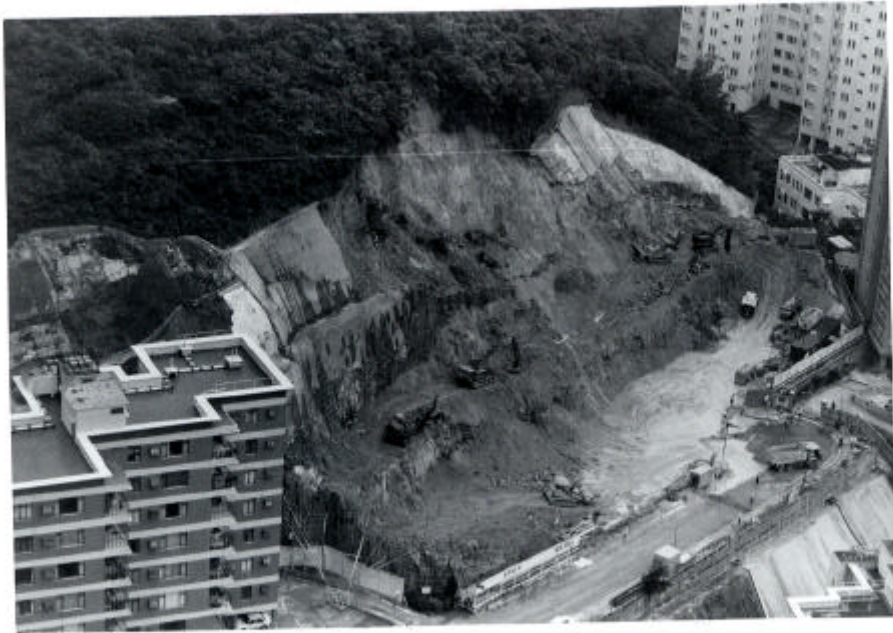
Plate 45

Soil/rock cut slope failure at RBL 1044,  
South Bay Close, H.K.  
(Incident No. HK33/GCB21)

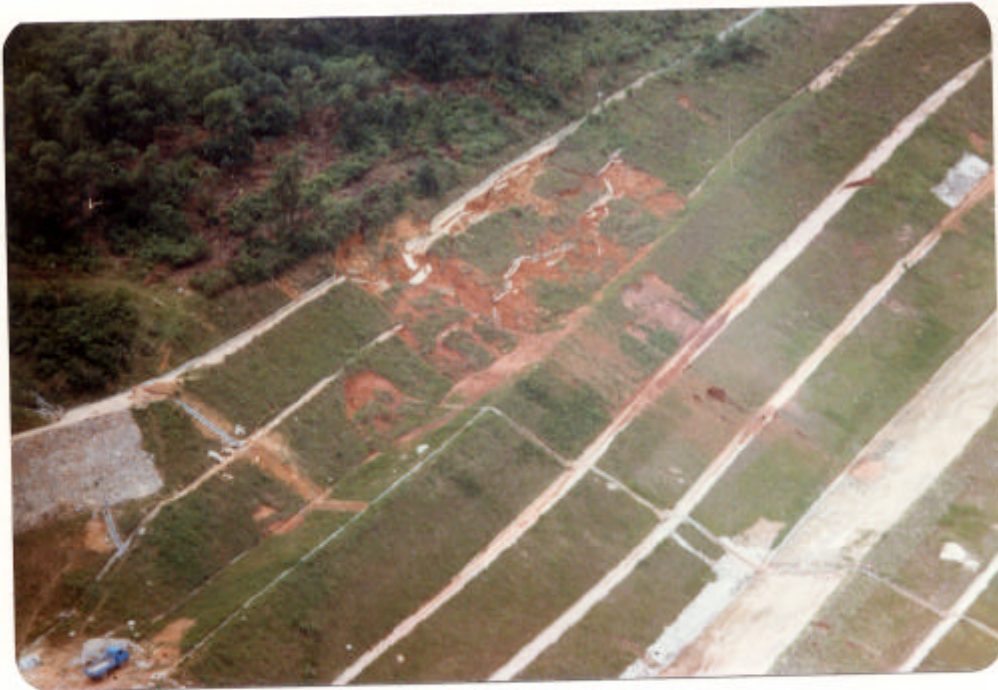
Plate 46

Soil cut slope failure at Kwun Yam Shan  
borrow area near Kadoorie Farm, N.T.

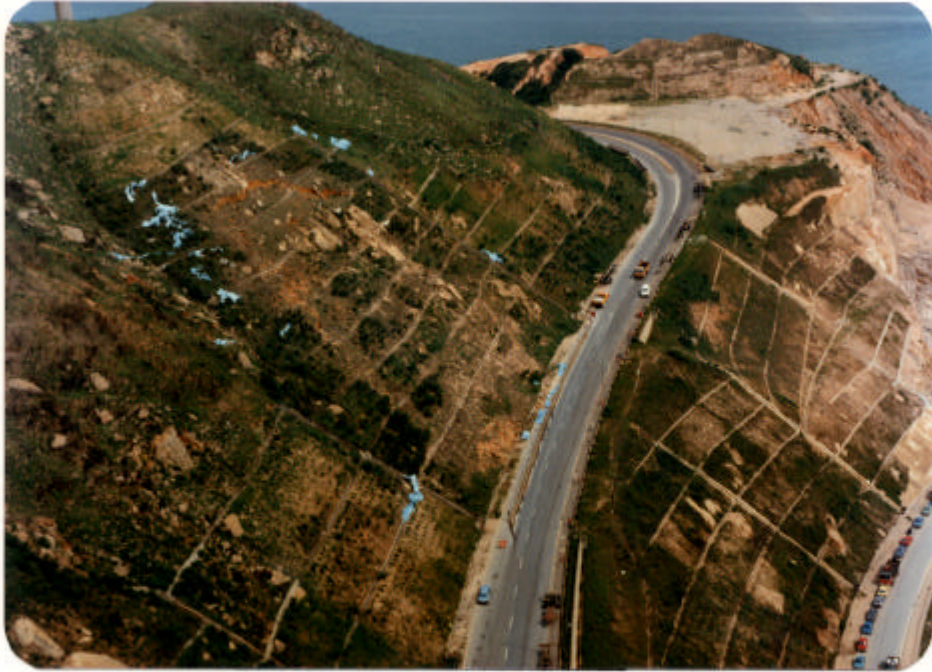
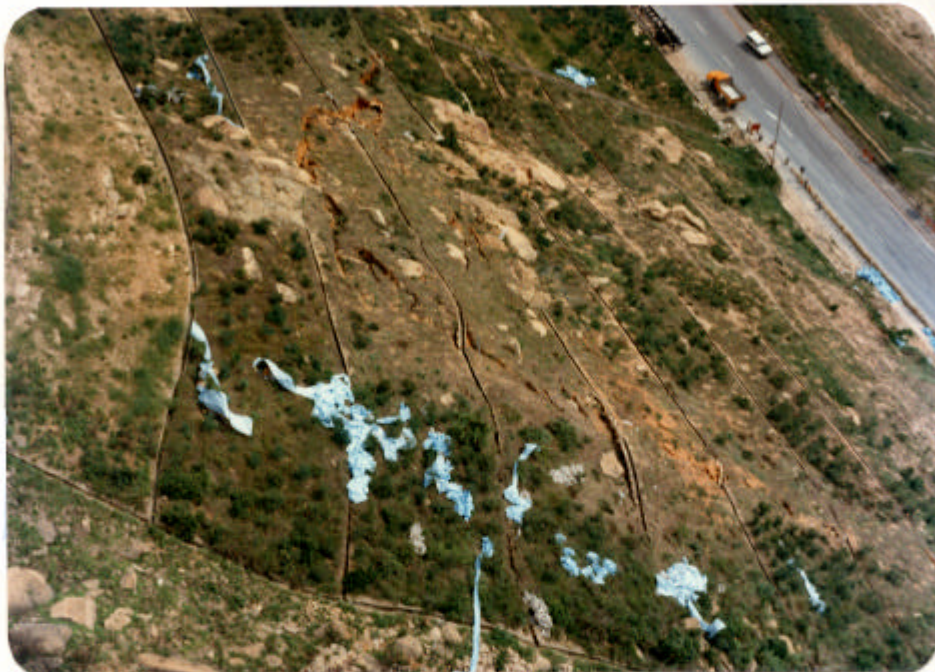
Plate 47 & Plate 48

Movement has taken place on cut slope  
at Road TY1, South West Tsing Yi  
(Incident No. NT231)

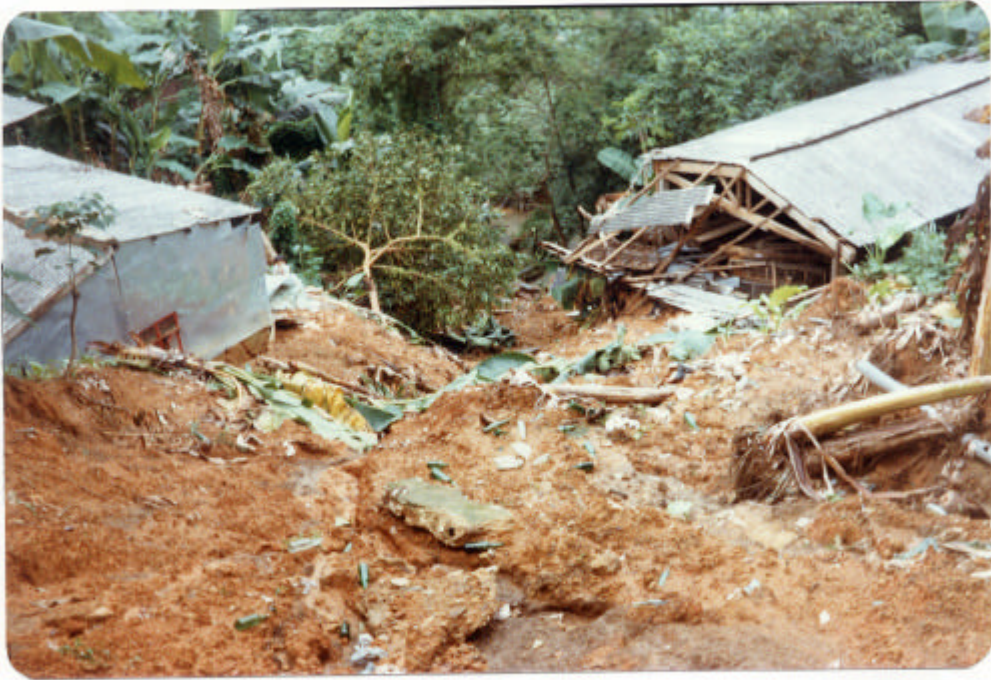
Plate 49

Natural slope failure at Lai Chi Hang Chuen,  
Tai Po.  
(Incident No. NT11)

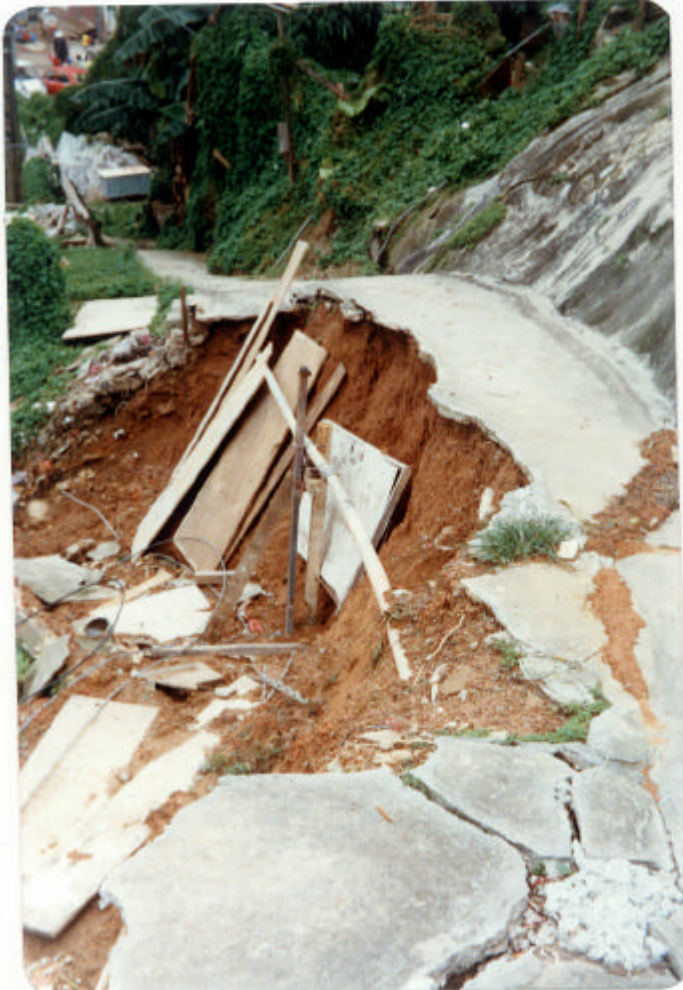
Plate 50

Fillslope failure at  
Nam Hang Tsuen  
(Incident No. NT98)

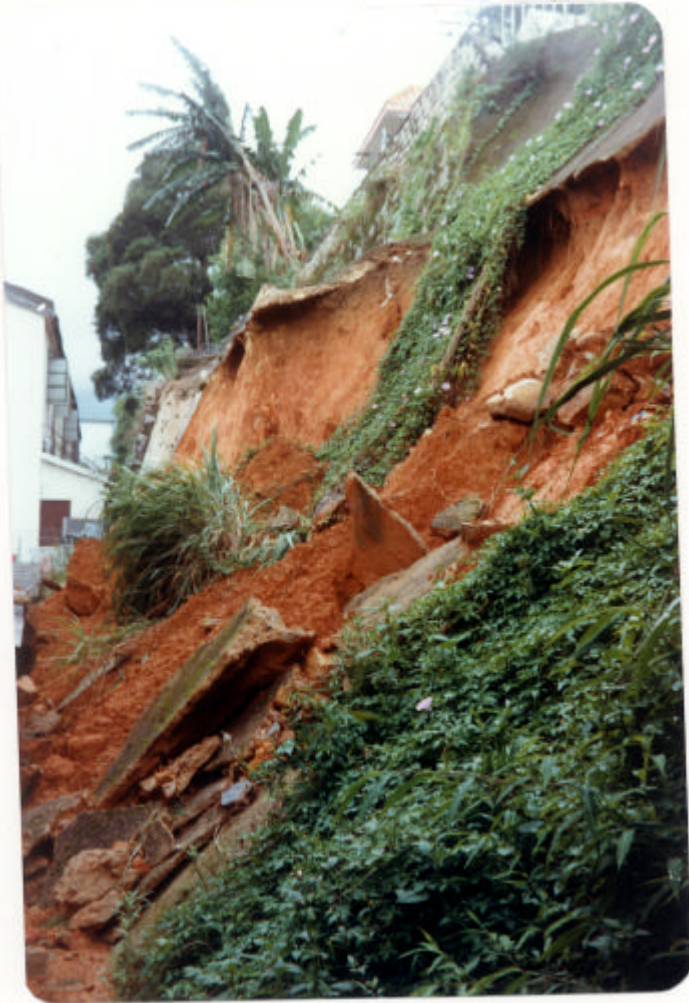
Plate 51

Soil cut slope & retaining  
wall failure at Nos. 26-27  
Sun On Tsuen, Sai Kung.  
(Incident No. NT62)

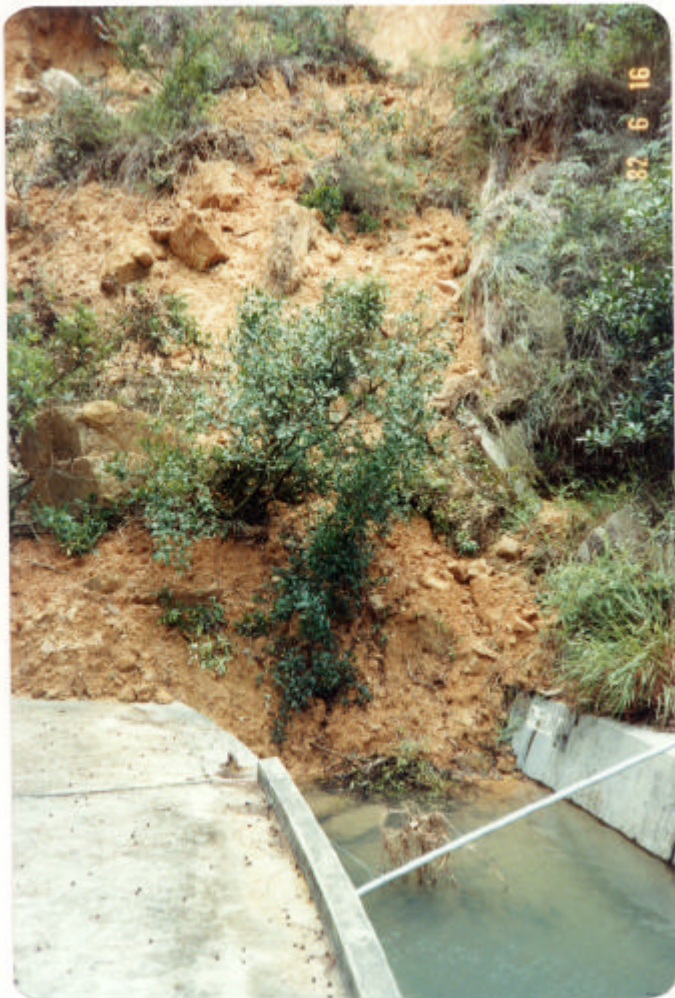
Plate 52

Soil cut slope failure and  
boulder fall at Tai Lam  
Chung Catchwater Section 'K'  
CH 1990-2015 near  
Tsing Lung Tau  
(Incident No. NT245)

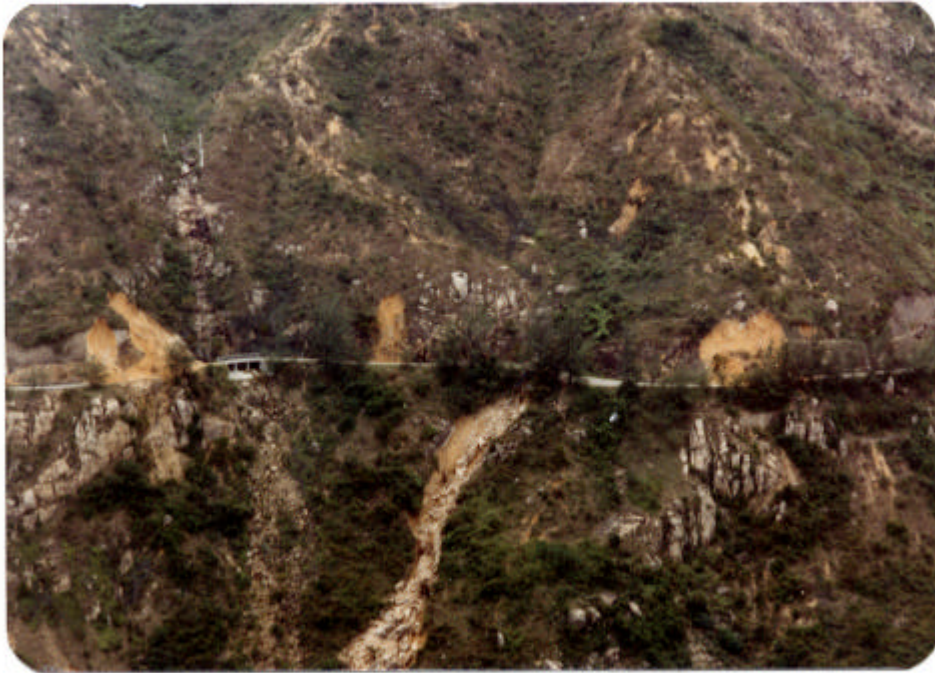
Plate 53

Several failures along Tai Lam Chung  
Catchwater, between CH 680 and CH 770.

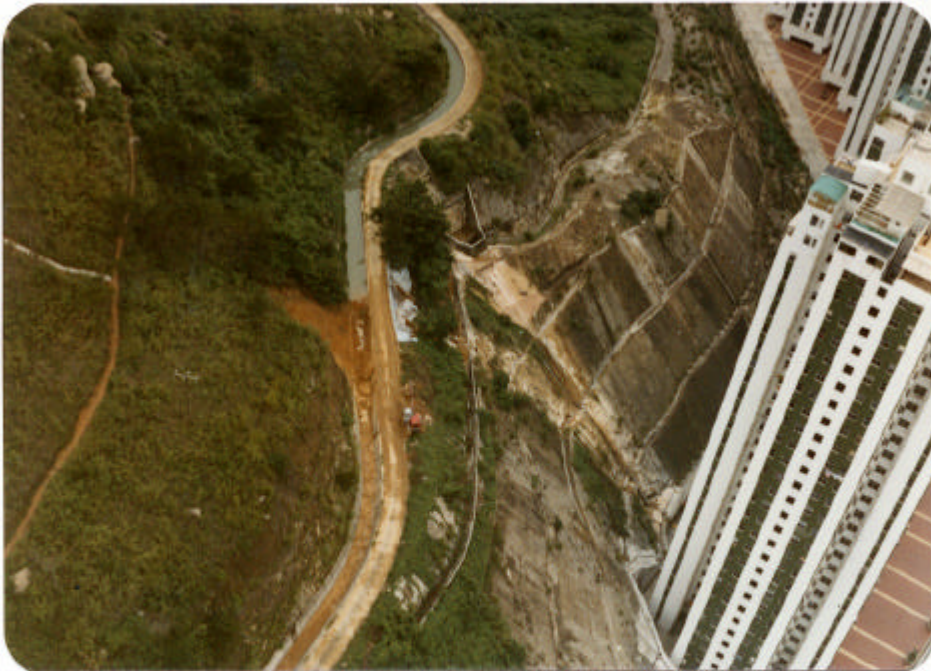
Plate 54

Soil cut slope failure at Tai Lam Chung  
Section 'O' Catchwater above West Tsuen  
Wan  
(Incident No. NT24)

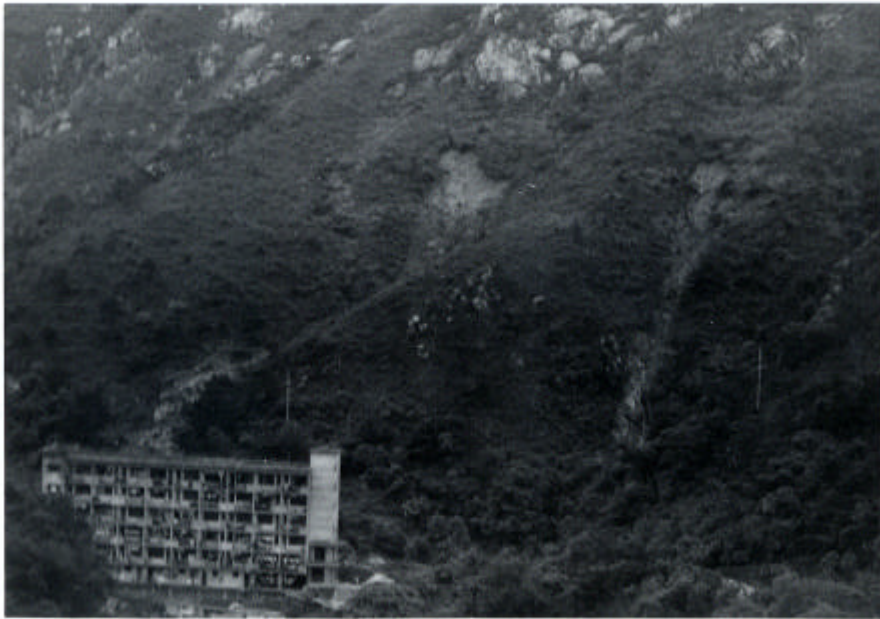
Plate 55

Natural slope failure behind Kowloon Textiles  
Factory Quarters, Sham Tseng, N.T.  
(Incident No. NT10)

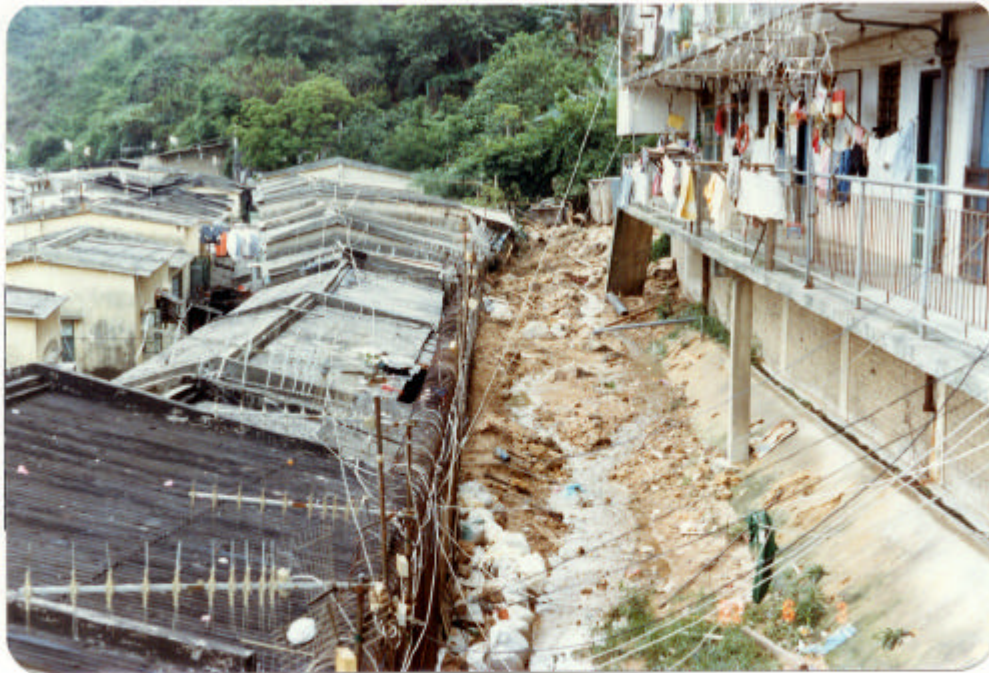
Plate 56

Natural slope failure behind Kowloon Textiles  
Factory Quarters. Landslip debris blocked  
the nullah downslope, causing flooding problem.  
(Incident No. NT10)

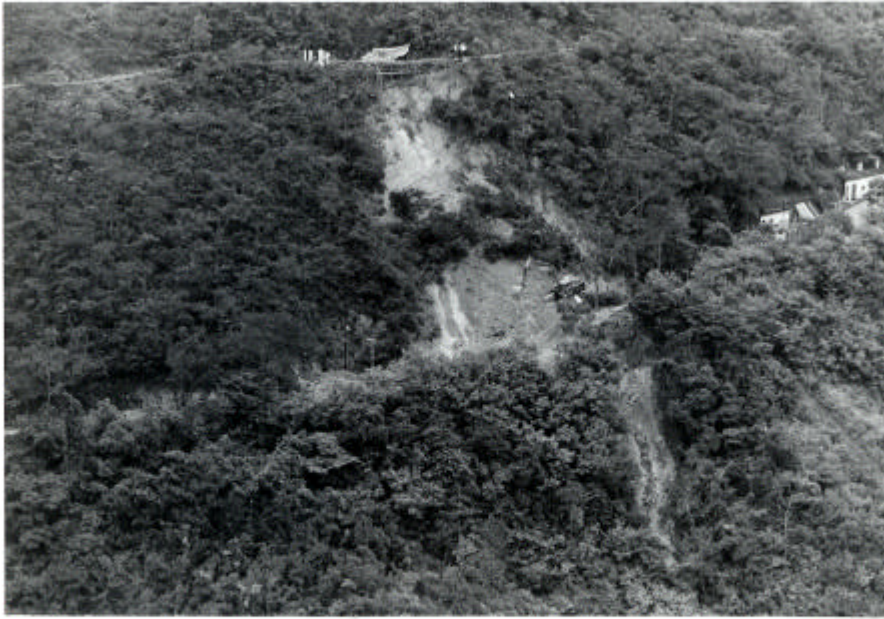
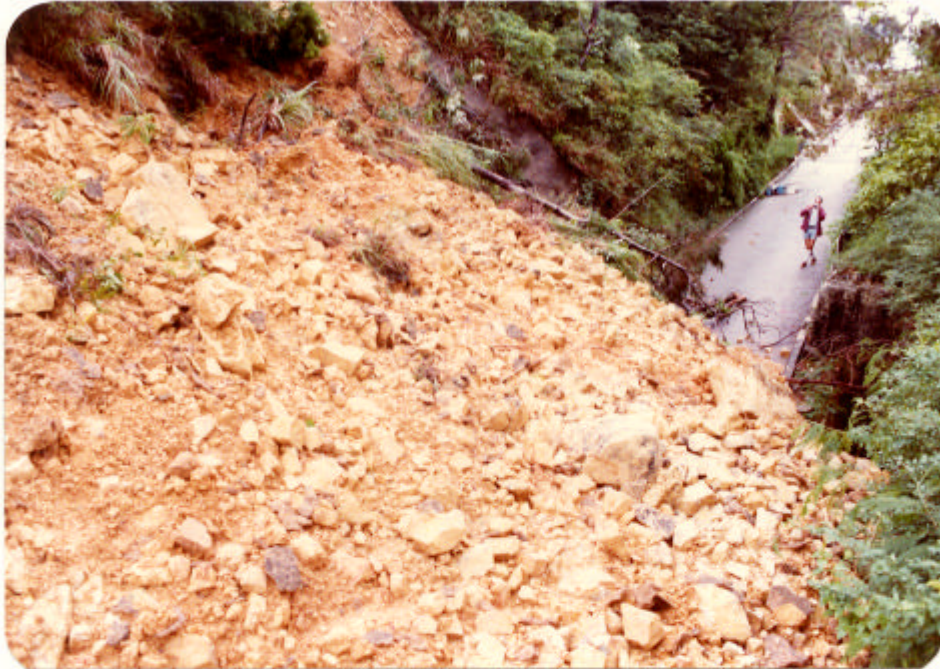
Plate 57 & Plate 58

Natural & soil/rock cut slope failure along  
Nam Long Shan Road, access to Ocean Theatre, H.K.  
(Incident No. GCB2)

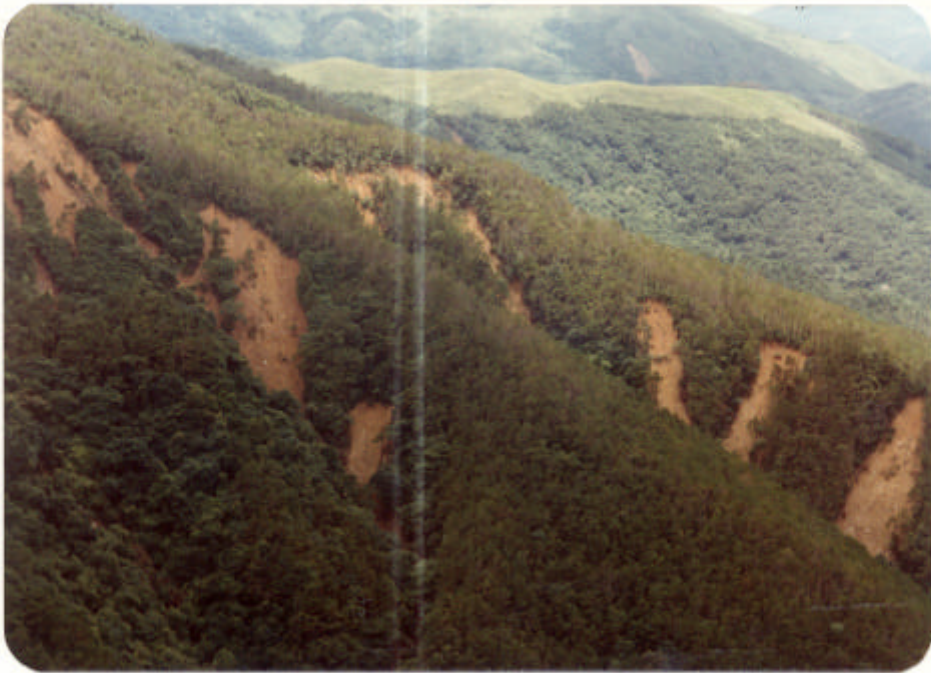
Plate 59

Natural slope failures around Tai Lam Country Park

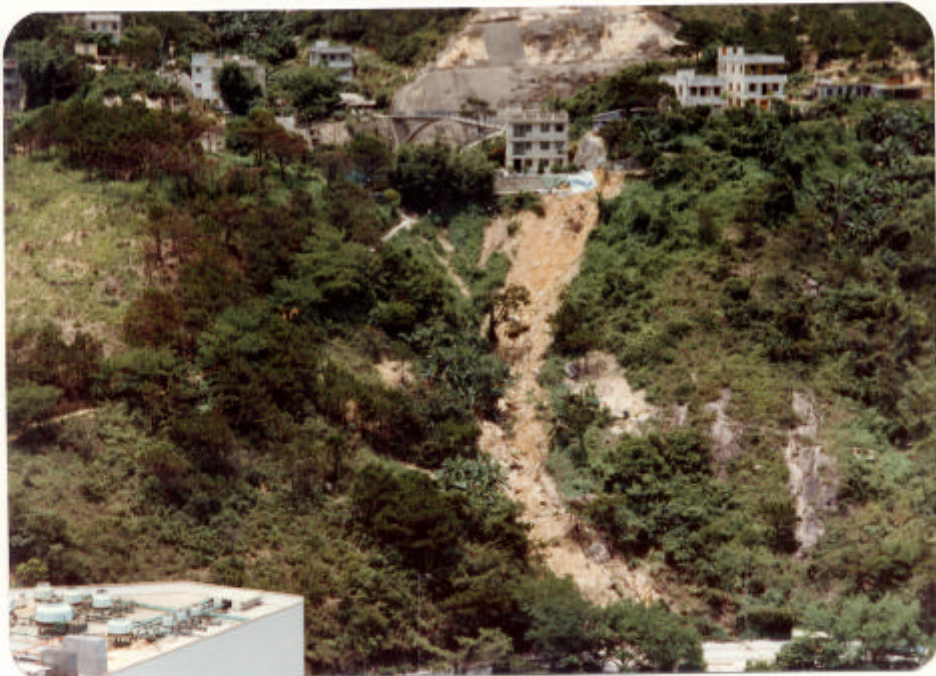
Plate 60

Natural slope failure at DD 390 Lot 207  
Sham Tseng, Tsuen Wan  
(Incident No. 198)
