**SECTION 2 :
DETAILED STUDY OF THE
LANDSLIDE AT TAI PO ROAD
NEAR CHAK ON ESTATE
ON 9 JUNE 1998**

Fugro Scott Wilson Joint Venture

**This report was originally produced in January 2000
as GEO Landslide Study Report No. LSR 18/99**

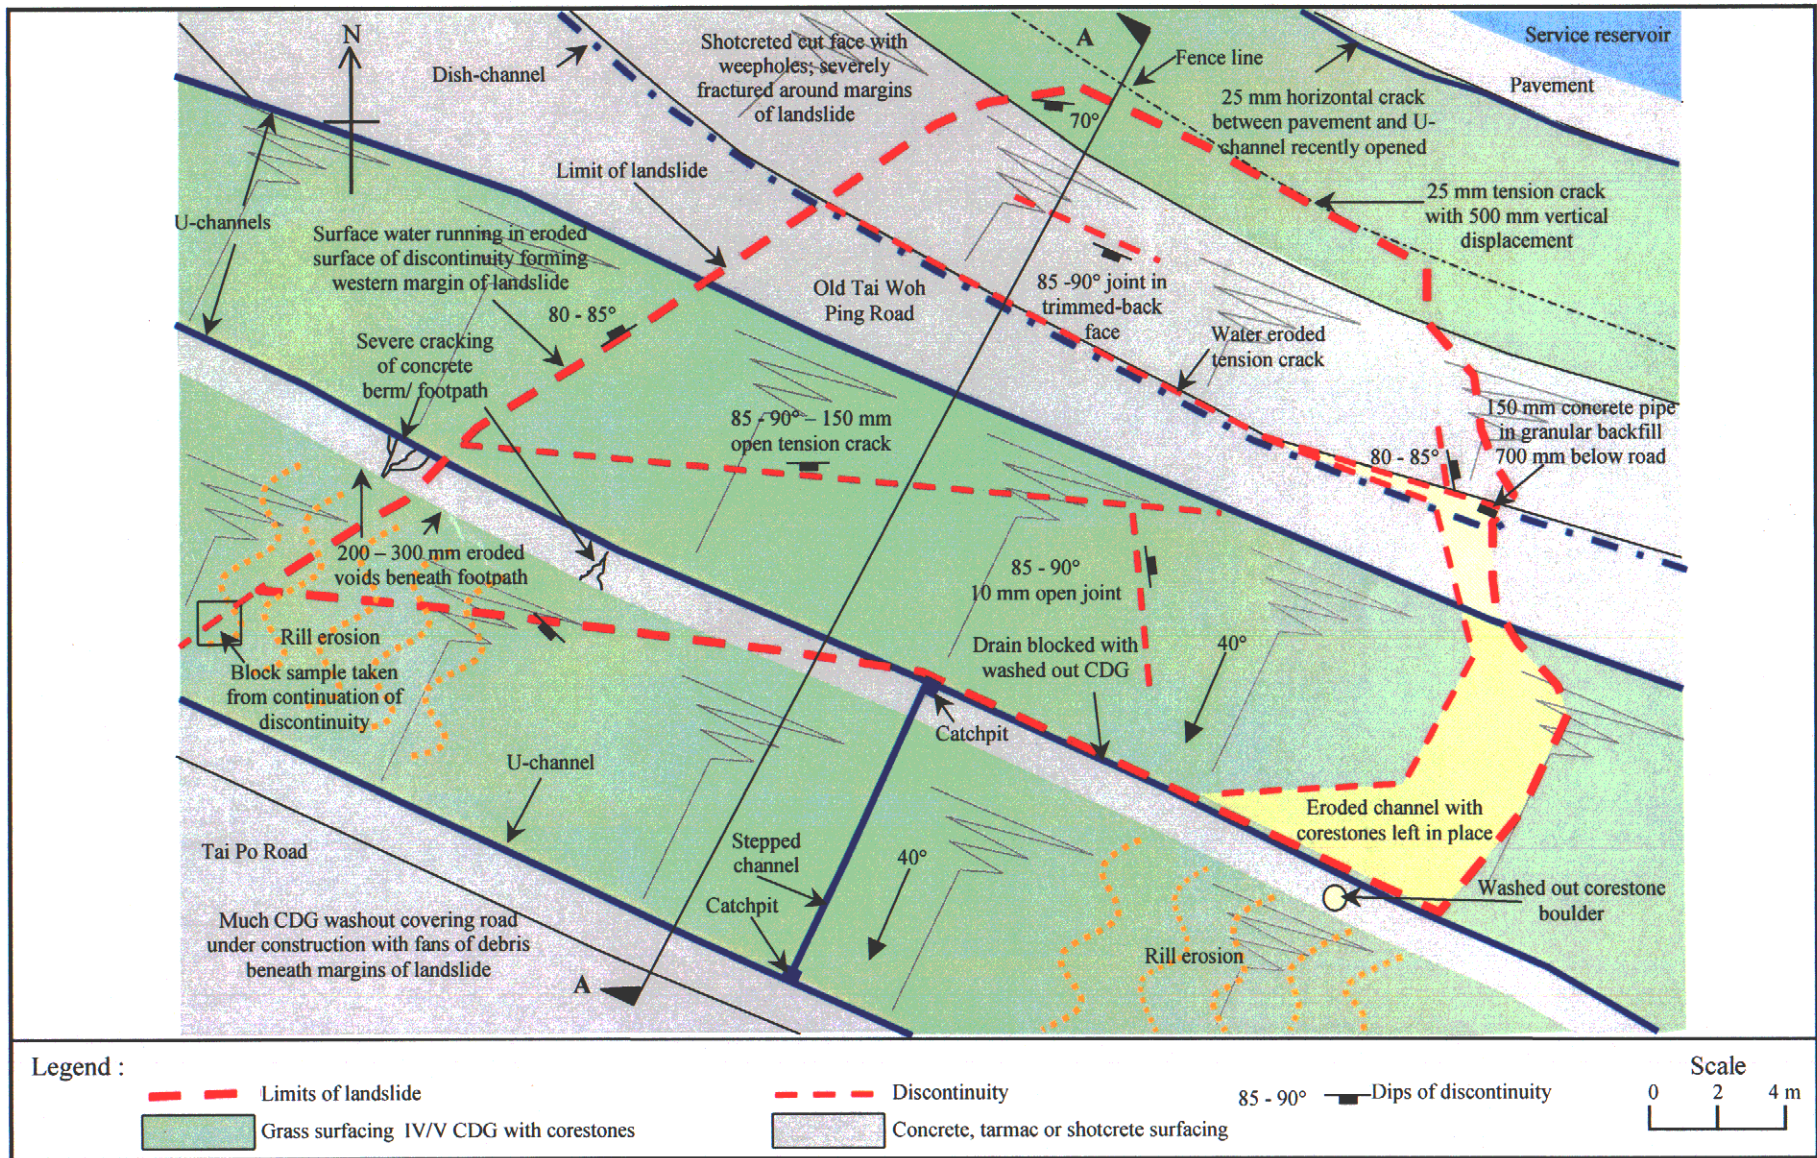
Figure 2 – Plan of the Landslide

The location of the landslide is shown in Figure 1 and photographs of the landslide area, taken on 27 December 1997 and the day before the failure, are shown in Plates 1 and 2 respectively. The failure affected two cut slopes, separated by a strip of the former (now disused) Tai Woh Ping Road. The lower vegetated cut slope has recently been substantially modified by cutting back the former slope No. 11NW-B/C60 in December 1997, to facilitate road widening works at its toe. The newly-formed slope comprises a 14 m-high, 40 degree slope, with a 1.5 m wide berm at about mid-height. A plan and a cross-section of the landslide are shown in Figures 2 and 3 respectively.

The upper shotcreted cutting above the former Tai Woh Ping Road showed significant cracking above the projected margins of the failed cutting below. A major tension crack with a 500 mm (approximately) vertical displacement had developed along the fence line bordering the reservoir compound. A second nominal fracture (25 mm approximately) was noted further back along a previously slightly open (as indicated by grass root development) construction joint between a U-channel and a concrete pavement running around the perimeter of the reservoir (Figures 2 and 3).

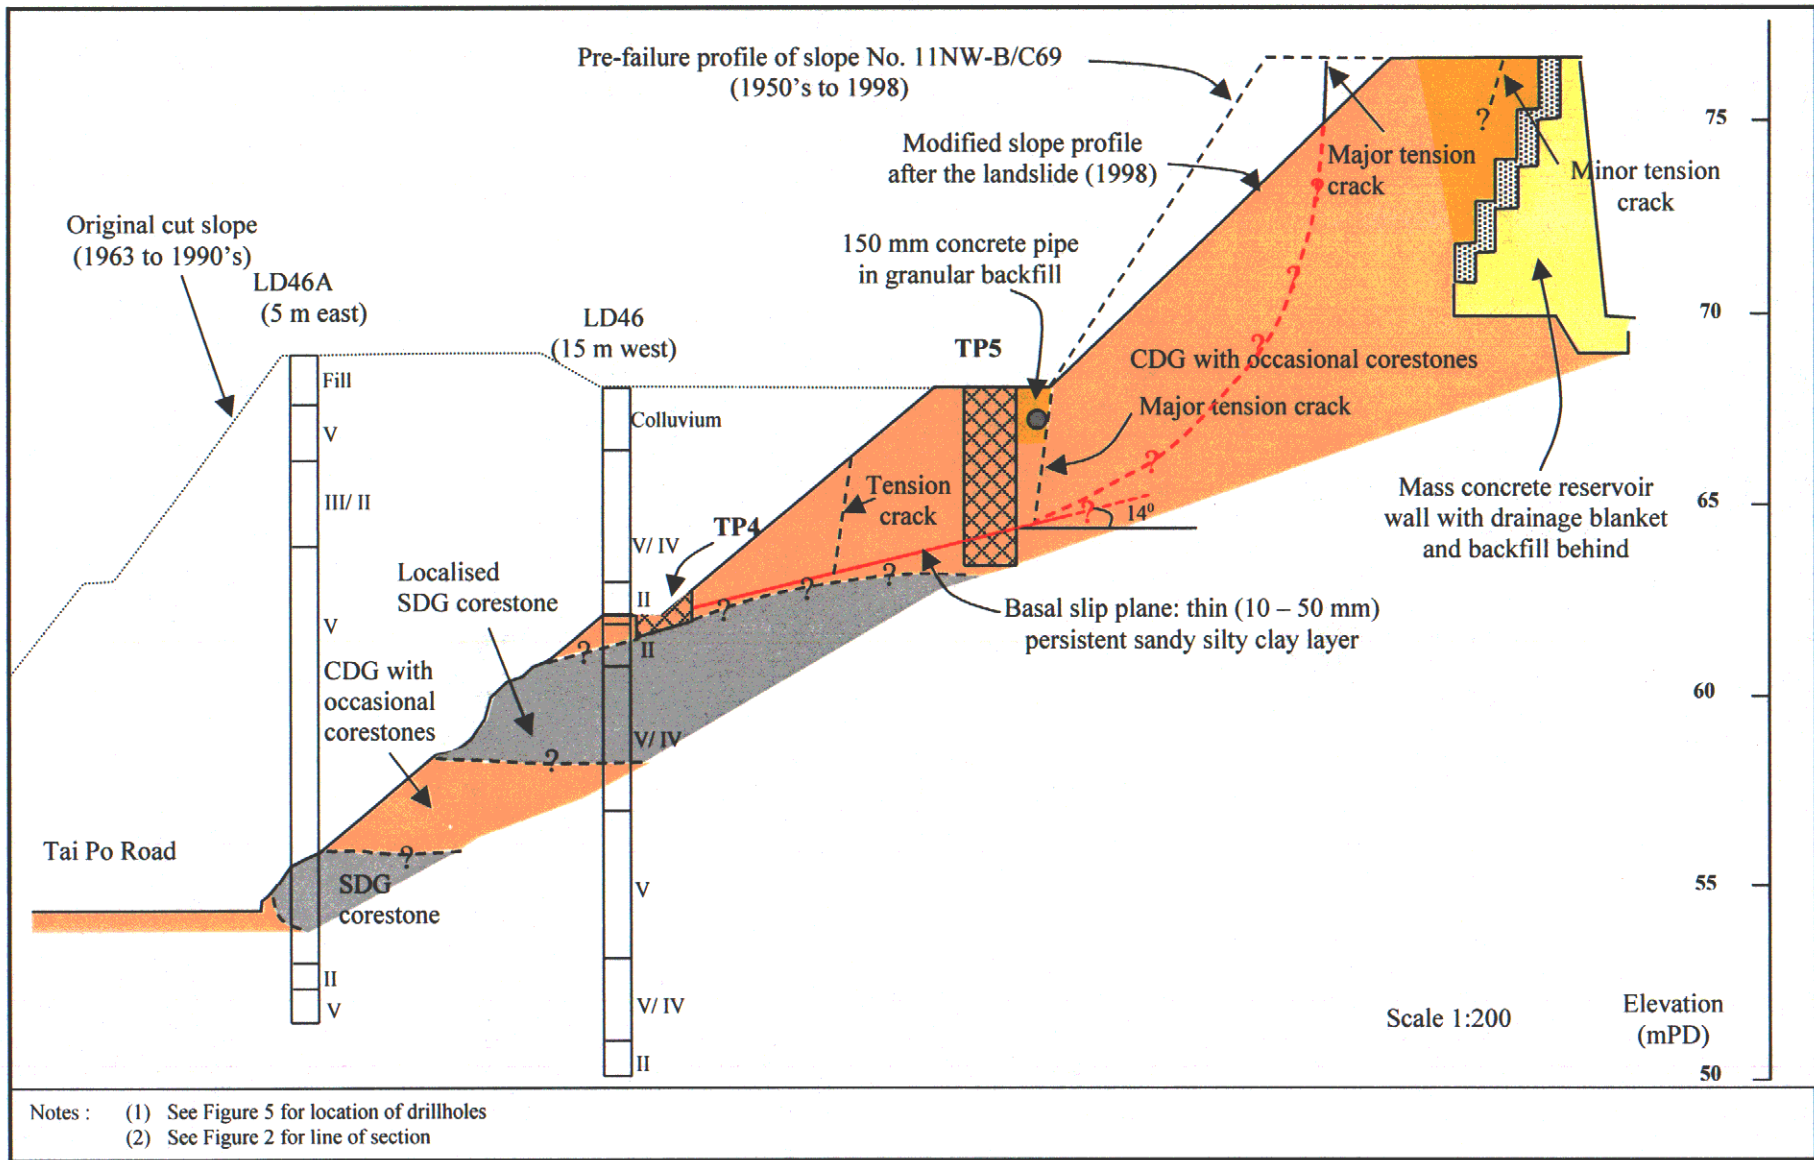
Figure 3 – Section A - A through the Landslide

The landslide appears to consist of essentially two discrete masses, which have been subjected to different amounts of movement, separated by a major tension crack at the back edge of the old Tai Woh Ping Road (Figure 3 and Plate 5). Another major tension crack was located near the crest of the upper cutting above Tai Woh Ping Road (Figure 3). The landslide comprised a main, lower failure within the new cutting (No. 11NW-B/C60), and an upper failure with comparatively less displacement, within slope No. 11NW-B/C69. The main failure mass moved approximately 1 m in a south-westerly direction essentially in a translational mode along a shallow dipping basal failure plane, whilst the upper failure mass moved approximately 0.5 m, along a steeper, and possibly curved, failure surface, essentially in a rotational mode. The basal failure plane was encountered in six of the eight trial pits dug in August to October 1998. A detailed description of the nature of the basal failure plane is given in Section 5.2.

It is noted that this clay layer was not recorded in the logs of the two previous drillholes (Nos. LD46 and LD46A), which are closest to the landslide area (Figure 3). As these drillholes were sunk by water-flush drilling with Mazier sampling at about 2 m intervals, the clay layer may not be readily identified by such routine drilling.

Stability analyses using the rigorous method of Morgenstern & Price (1965) were carried out to assist in the diagnosis of the probable causes and mechanism of the failure. A representative cross-section through the landslide is presented in Figure 3. The pre-failure ground profile was established from topographic survey plans, and the geometry of the failure surface was based on FSW's field observations, including the findings from the trial pitting exercise.

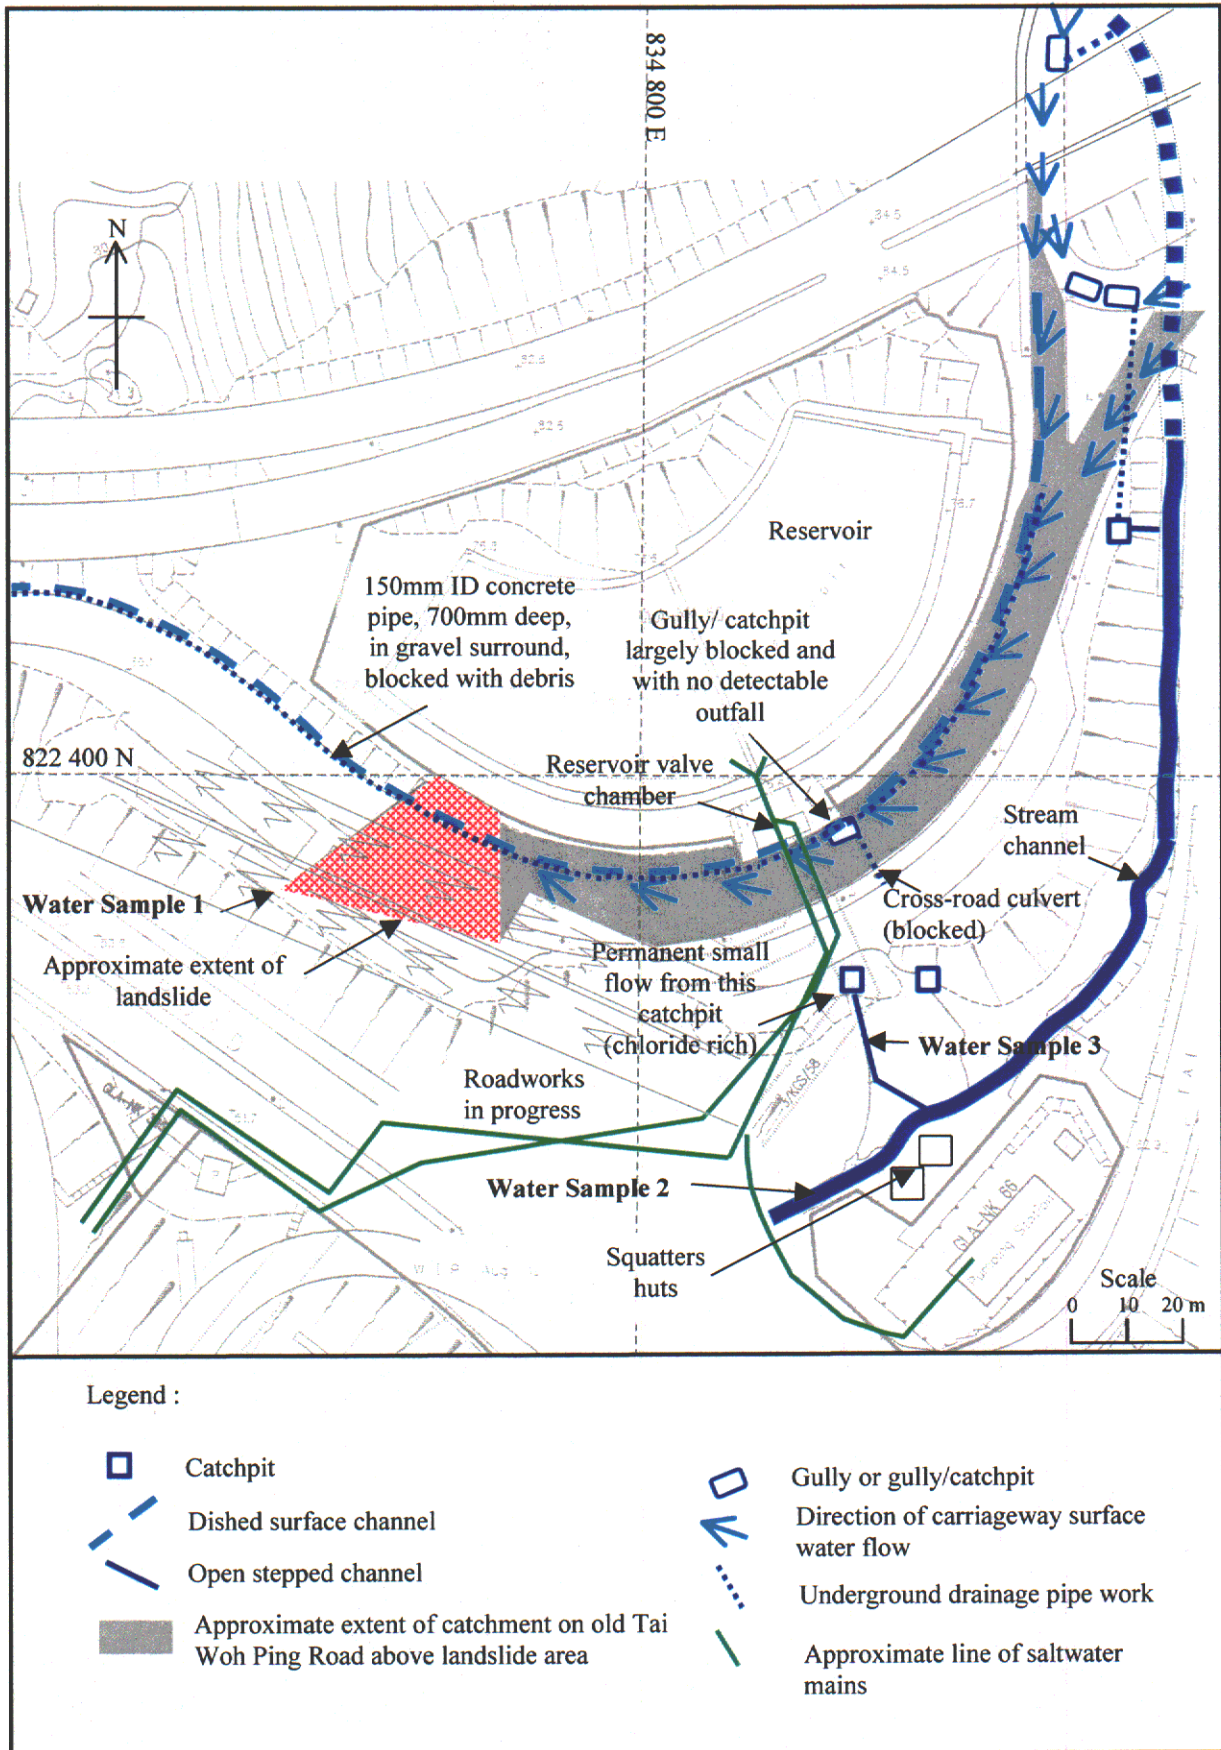
Figure 7 - Sketch Plan Showing Surface and Underground Water-carrying Services

According to HyD' s records, the 150 mm diameter pipe extends for a considerable distance (over 100 m) up-gradient from the site and its alignment is shown in Figure 7. Observations of the pipe run indicate that it was blocked with black-stained debris in the vicinity of the landslide.

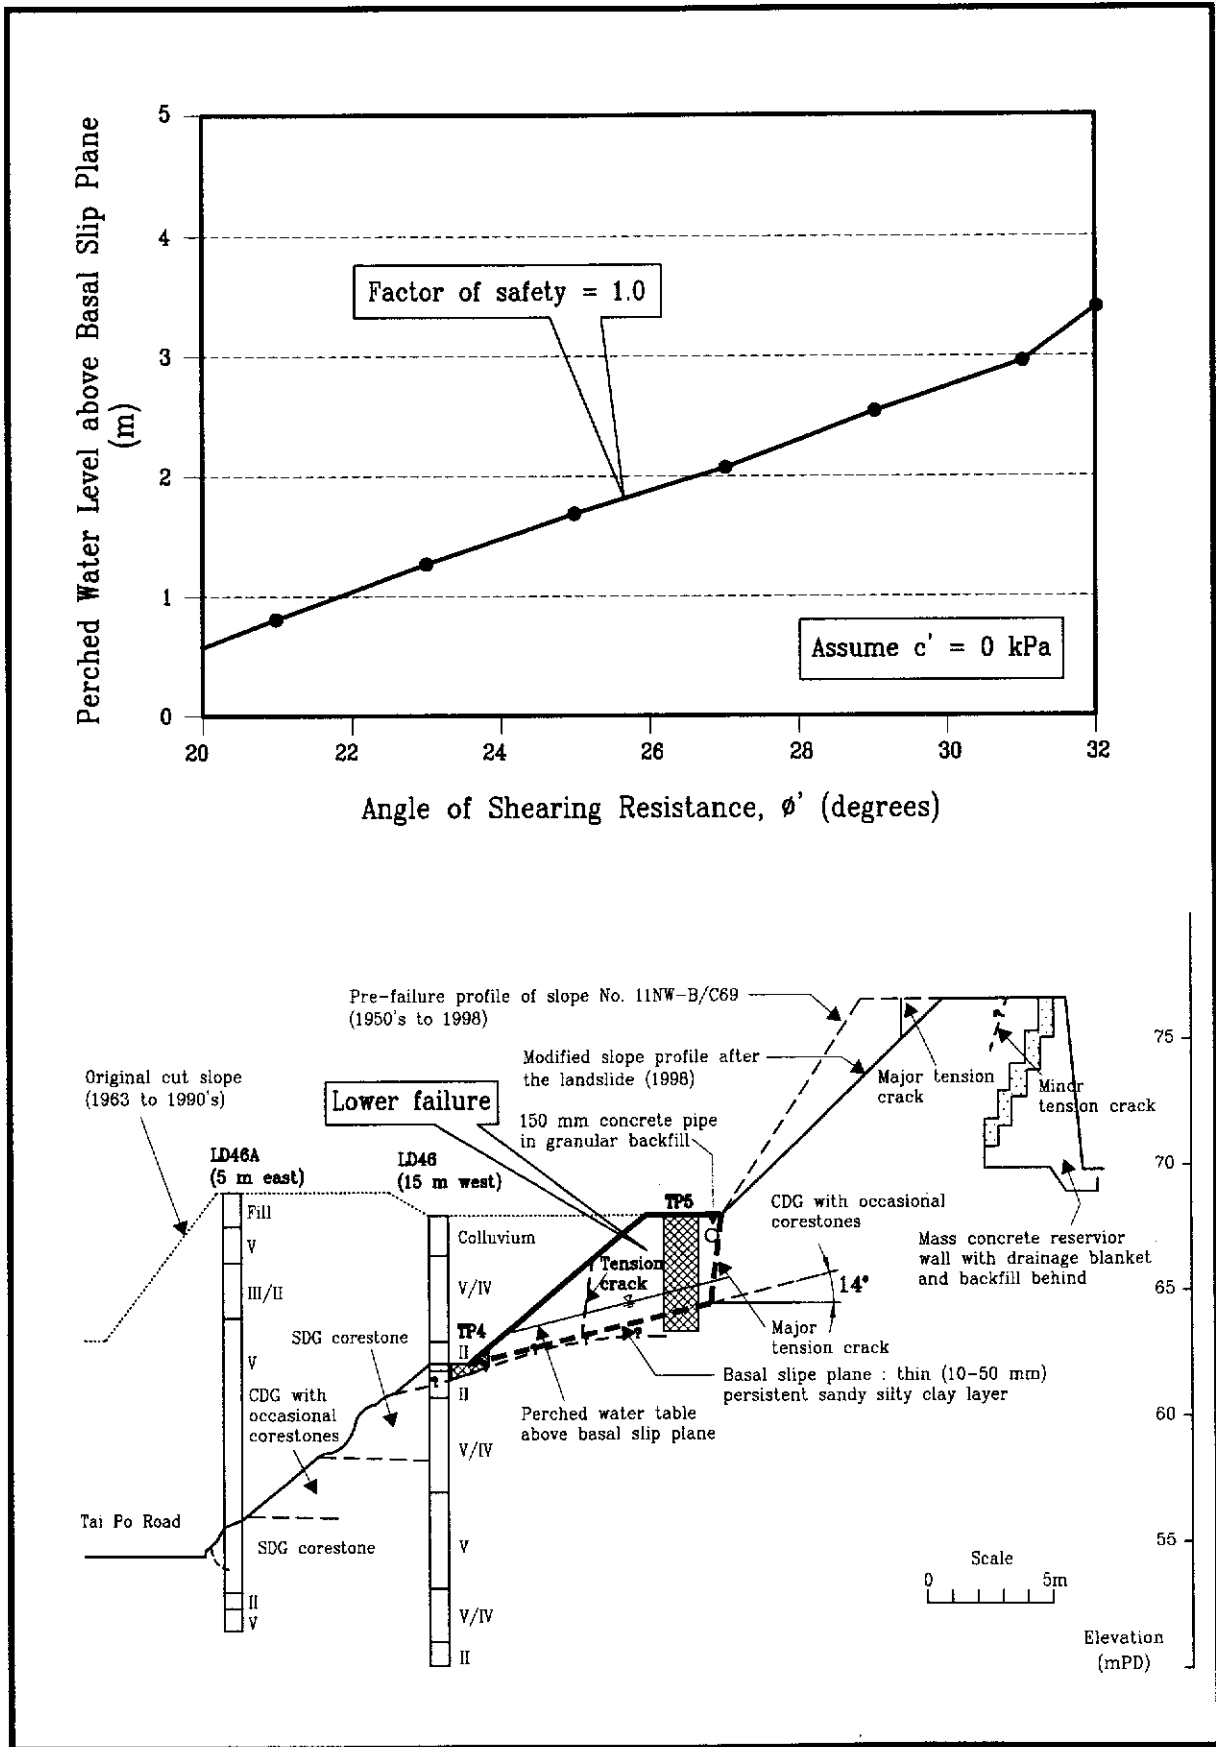
Figure 12 - Sensitivity of Lower Failure to Height of Perched Water Level

The lower cut slope is considered to have failed along a thin, probably persistent sandy silty clay layer dipping at a shallow angle (about 14°) out of the cut face, based on observations in the trial pits. For the purposes of stability analyses, shear strength parameters with c' value of zero and ϕ' values ranging from 20° to 32° were considered, together with various perched water tables above the clay layer.

The results of the stability analyses are shown in Figure 12. These indicate that the main failure was likely to have been the result of the presence of a material with relatively low shear strength and high groundwater conditions. Given the uncertainties in groundwater conditions acting on the slip surface at the time of failure, and that laboratory testing could not adequately establish the representative shear strength parameters for the clay layer, it is not possible to determine the operational mass shear strength and critical groundwater conditions from the analyses.

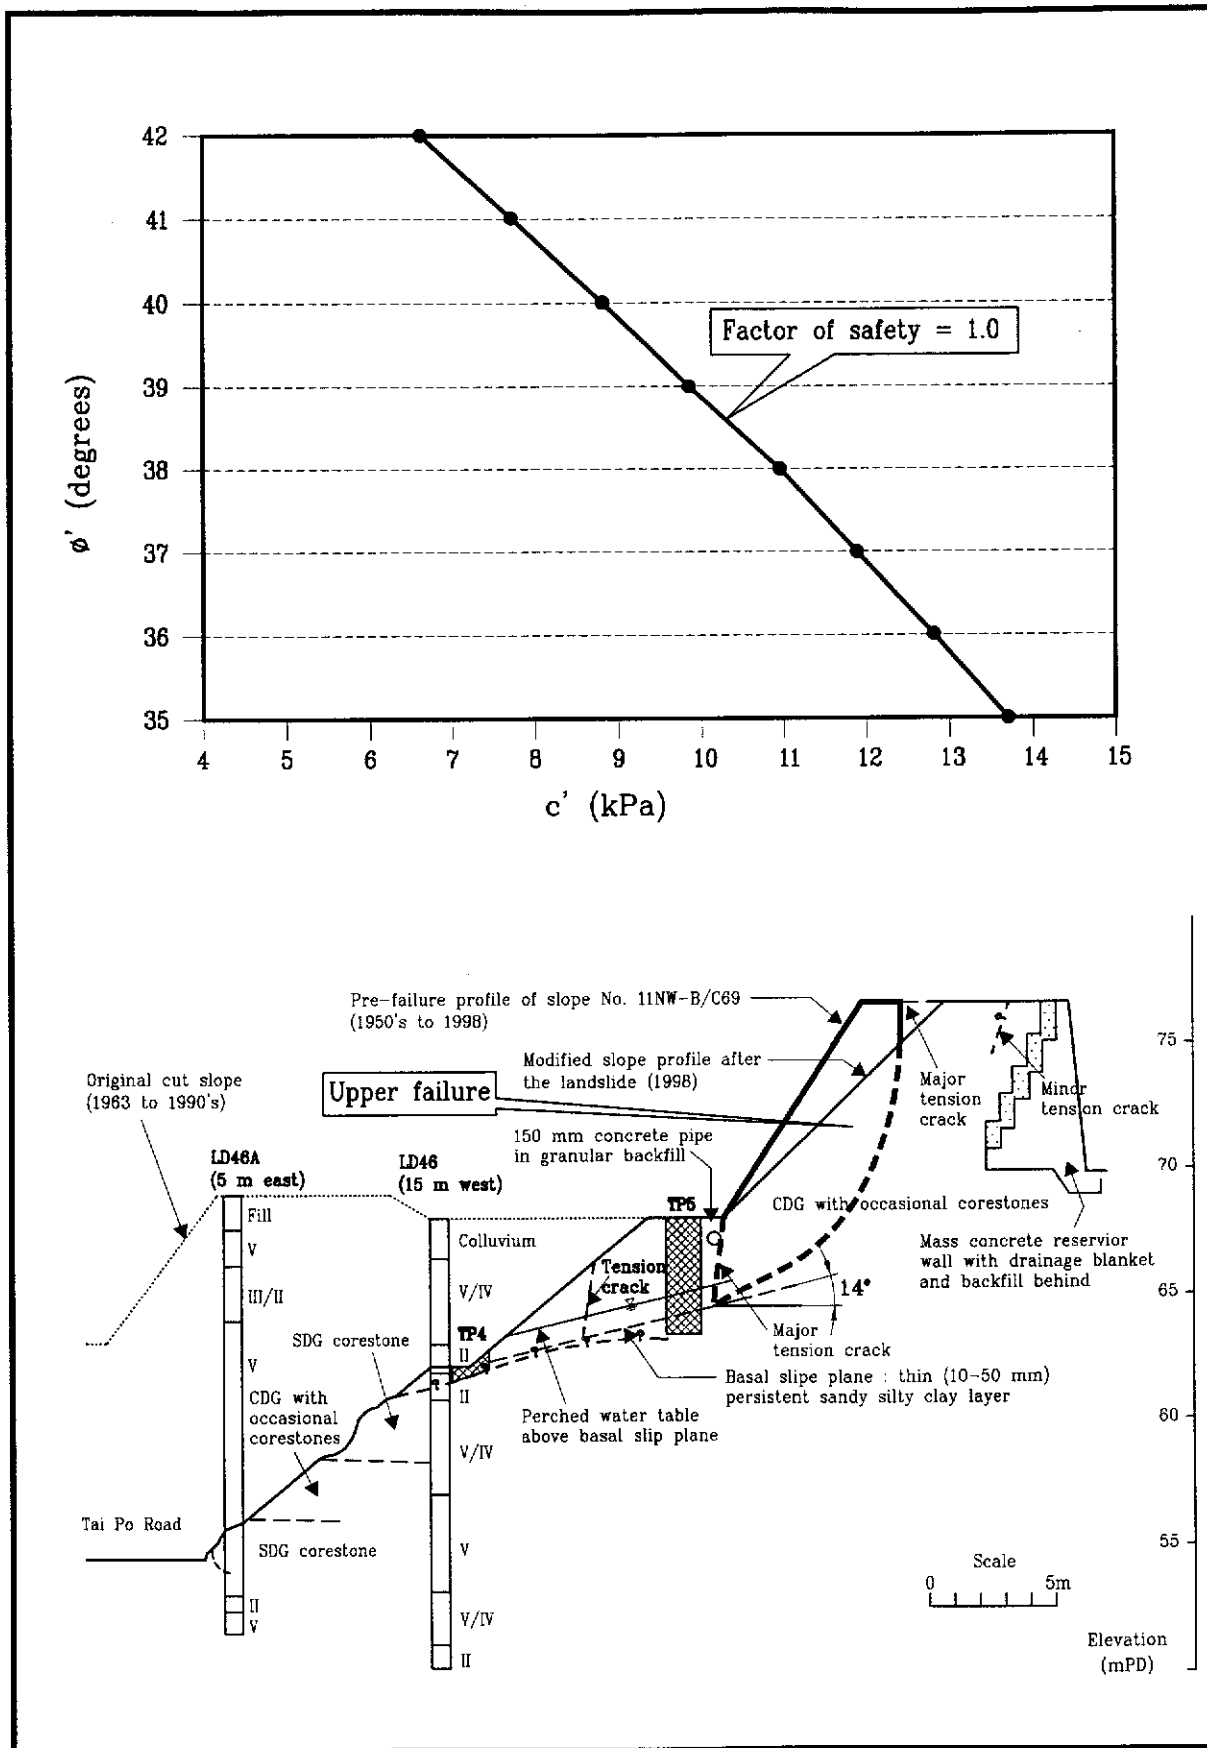
Figure 13 - Sensitivity of Upper Failure to Variation in c' and phi'

The failure surface of the upper landslide generally passed through relatively intact CDG. There was no field evidence that relict joints with weak infill material played a significant role in this failure. For the purposes of analysis, a range of c' values of between 6 and 14 kPa, and ϕ' values of between 35° and 42° have been considered. Dry conditions (i.e. fully saturated but with no positive water pressure) were assumed. The results are given in Figure 13. The findings suggest that the failure can be explained by fairly typical shear strength parameters of the CDG.

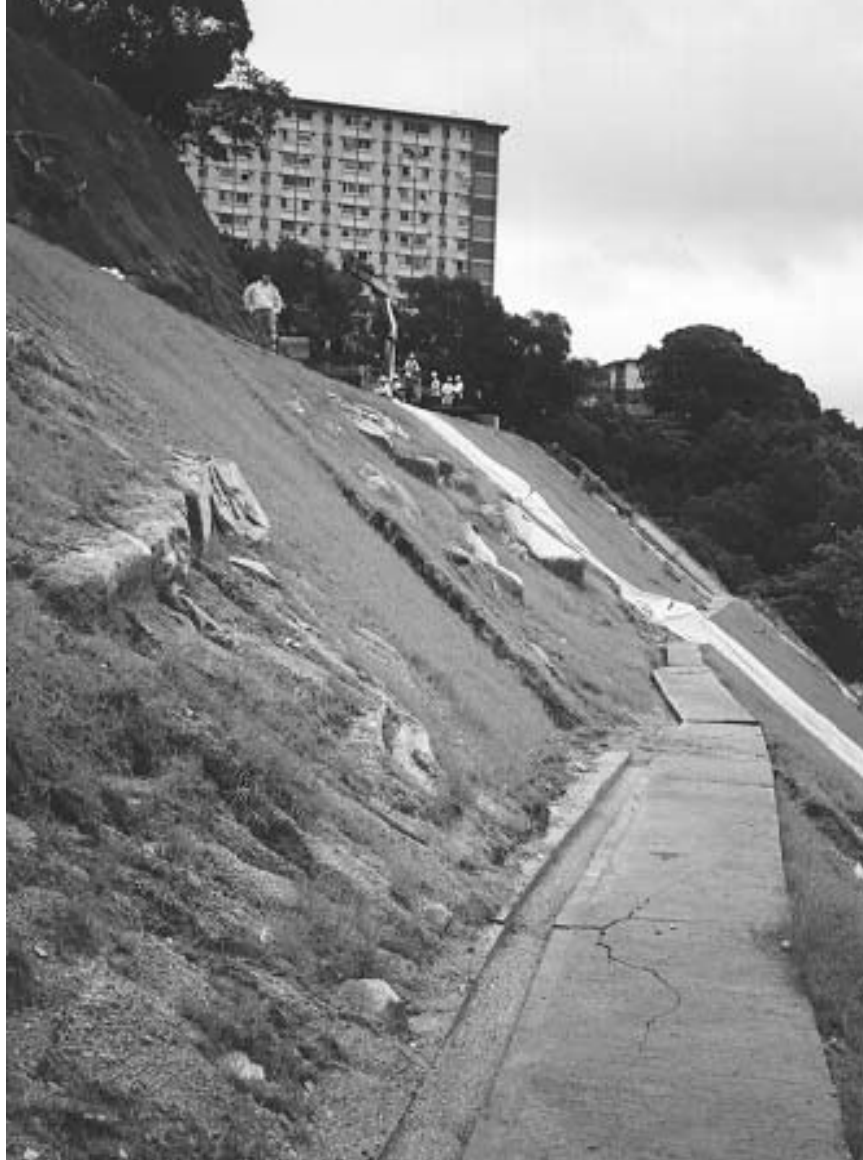
Plate 6 - View from West of Slip
(Photograph Taken on 10 June 1998)

The landslide mass remained relatively intact, apart from the shear/tension cracks dividing it into separate blocks, and did not break up significantly. However, extensive signs of distress, in the form of significant cracking and dislocation of berm slabs, were observed (Plate 6).

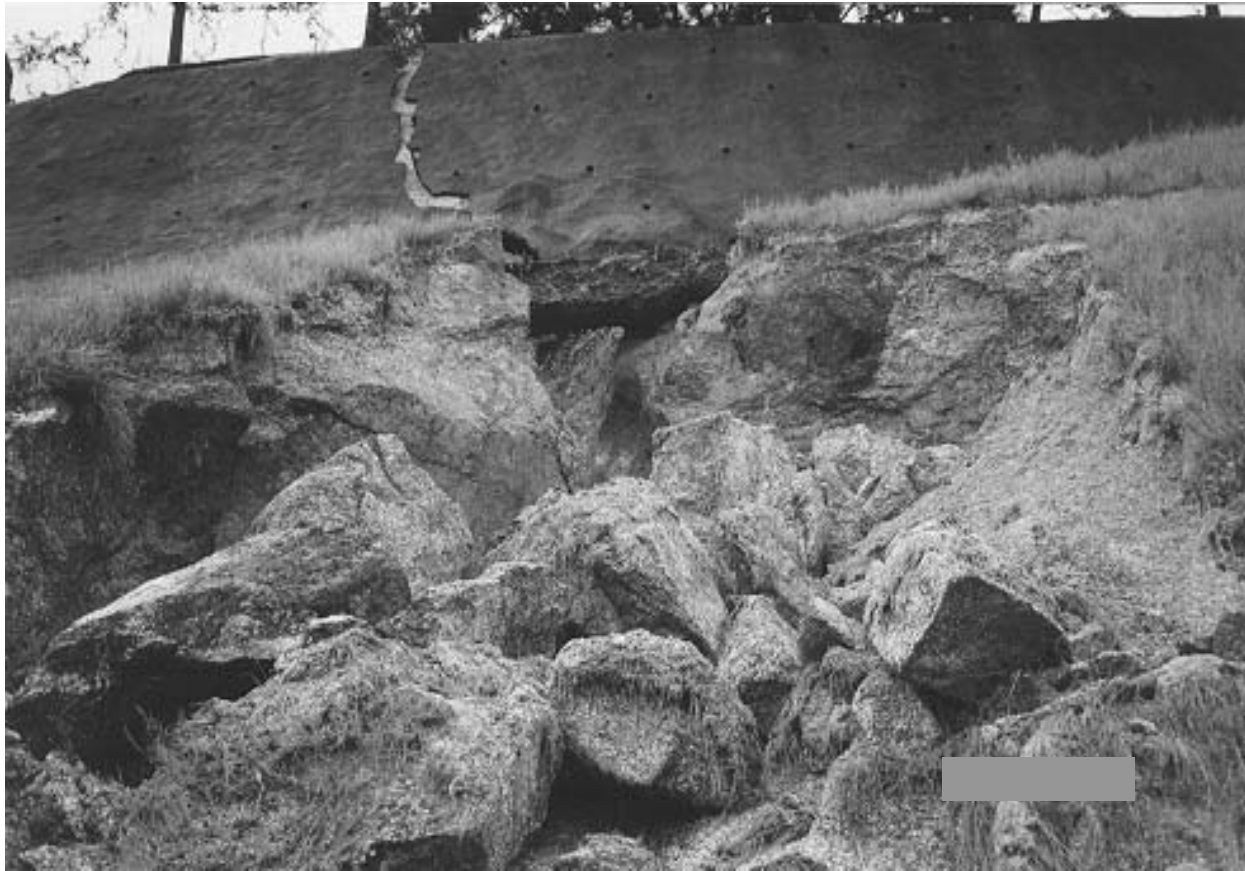
Plate 7 – View up Eastern Margin from Mid-Berm
(Photograph Taken on 10 June 1998)

Although the displaced material remained largely on the slopes, a large amount of sand and fine gravel was washed out following the failure. This was evidenced by two deep fan concentrations of deposits at the base of the slope, immediately beneath the margins of the landslide. The eastern margin in particular was eroded to a 2 to 3 m wide channel, where weathered granite was washed out from around corestones (Plate 7).

The eastern margin was less well defined as a linear feature, partly as a result of the extensive post-failure erosion (Plate 7), and partly as a result of the presence of two joint sets that acted as release planes. One set was measured as 80°-90°/080° (dip/dip direction) and the other as 80°-90°/180°. This margin was more open than the western relict discontinuity, as a result of the main soil mass sliding obliquely away from these release planes (Plate 10).

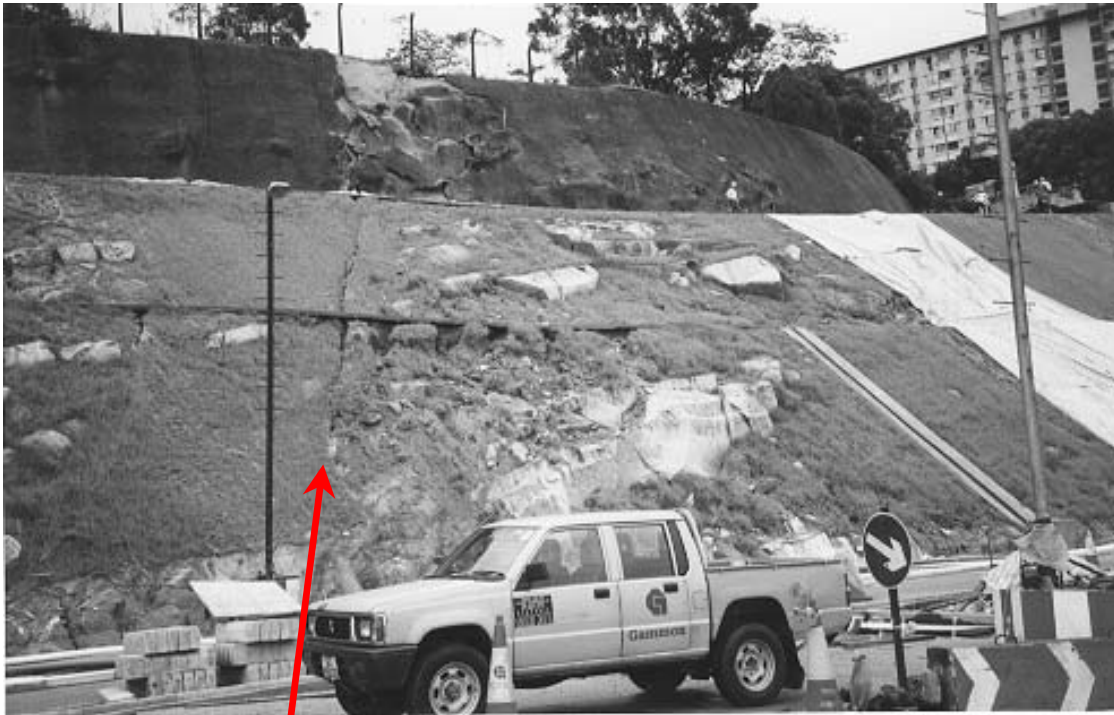
Plate 8 - View of the Landslide Western Margin
(Photograph Taken on 10 June 1998)

the discontinuity is about 40° west of the slope-facing direction. The general orientation of the discontinuity was measured as 85°/330° (dip/dip direction), whereas the slope is typically orientated at 40°/200°, implying a direction of movement oblique to the direction of the slope face. The discontinuity, extending outside the landslide area down to the slope toe, was seen to be heavily iron stained and infilled with manganese oxide. The manganese infilling had been polished to a slightly undulating planar surface where movement had taken place.

Discontinuity forming western
release plane

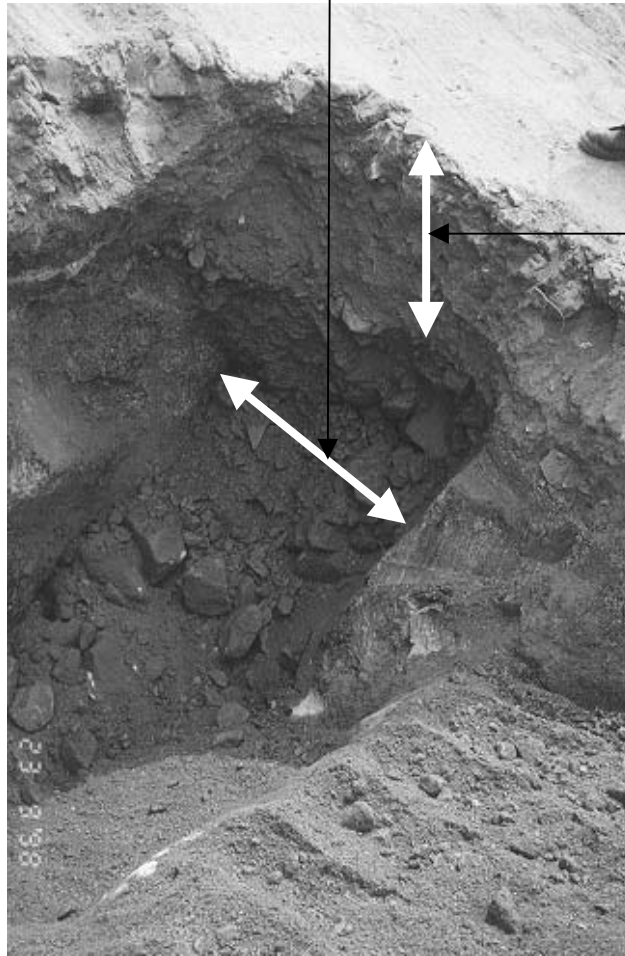
Plate 10 – View of Trial Pit No. TP2 Showing Eastern Release Plane/Tension Crack
View Looking Northwest
(Photograph Taken on 23 September 1998)

Apparent width of eastern release
plane/tension crack

Recently
placed fill

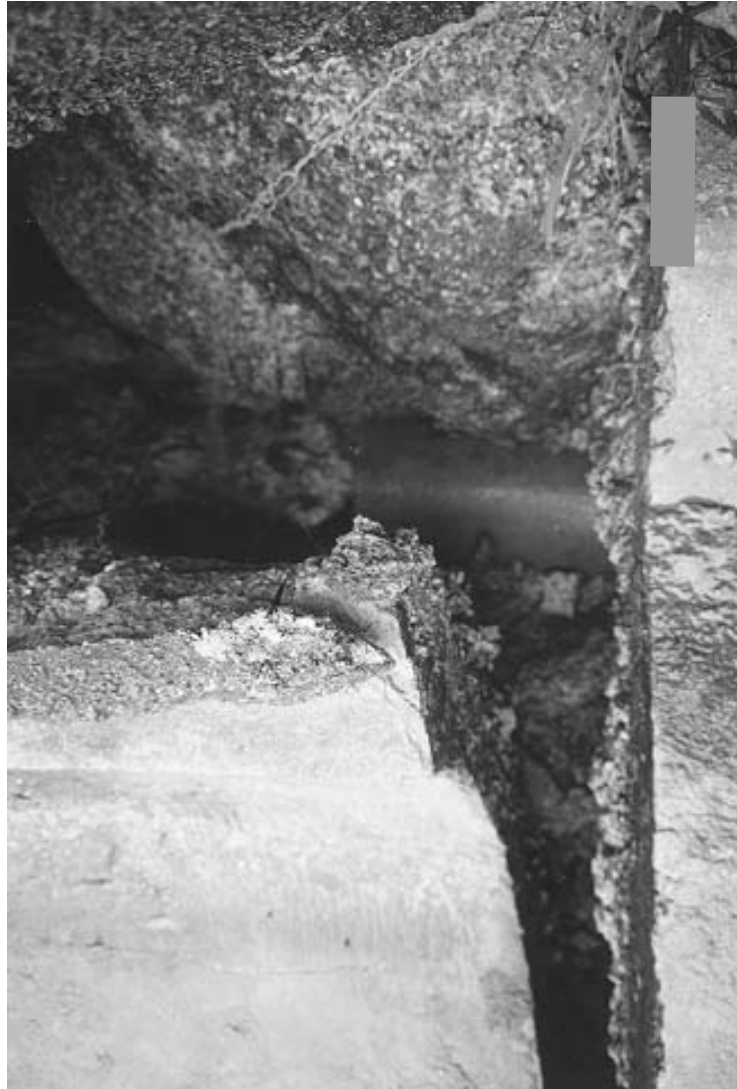
Plate 11 – View of 150 mm Pipe Exposed in Main Tension Crack
(Photograph Taken on 10 June 1998)

A 150 mm diameter concrete pipe was observed approximately 700 mm beneath the northern verge of the old road, within a gravel-filled trench. The pipe, which had been dislocated by the landslide, was exposed in the tension crack and lateral margin of the mass movement. This is described in more detail in Sections 4.3 and 8.

The only underground water-carrying services of relevance to the landslide was the 150 mm concrete butt-jointed pipe, in gravel surround, immediately beneath the northern verge of the former Tai Woh Ping Road at the toe of the upper cutting (Figure 3). A photograph of this pipe is shown in Plate 11. It can be seen that the exposed end of the dislocated pipe is at the junction of the main tension crack and the eastern margin of the landslide. Although rain was continuing at the time of the inspection by FSW on 10 June 1998, some 20 hours after the landslide, only a small amount of seepage was observed coming out of the exposed end of the debris-filled pipe.

Another possible contributory factor to the failure is the influence of the 150 mm diameter pipe and its gravel surround below the road above the crest of the lower cut slope. This may have contributed to feeding water into the landslide area, although the fact that the pipe was largely blocked and that the pipe apparently acted only as a subsoil drain, with no surface water connection, would have limited this effect. However, the gravel filled trench could have conducted a fairly large amount of water and may have acted as a release plane at the back of the main failure. It is also noted that poor maintenance of the cross-road culvert probably resulted in surface water flow along the carriageway from a relatively large catchment area to the area above the landslide site. The possibility of concentrated water ingress through cracks in the road and/or water overtopping the road during rainstorms cannot be excluded.

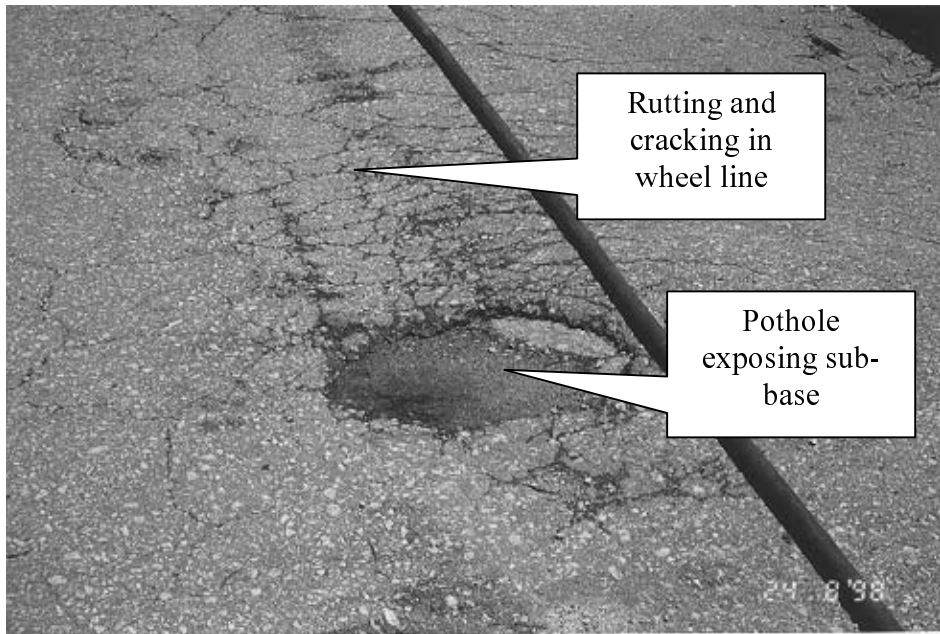
Plate 12 – View of Condition of the Old Tai Woh Ping Road Pavement
(Photograph Taken on 24 August 1998)

The former tarmac road surface forming the crest of the new cutting was severely cracked and pot-holes were noted in places, particularly along wheel ruts (Plate 12). The nature of the damage suggests that these may be a result of excessive trafficking. At the time of FSW's inspection on the morning of 10 June 1998, workers were seen to be laying a concrete screed over part of the former carriageway surface, immediately upslope of the landslide, which might have been in a particularly poor condition.

- (c) the existence of cracks in the damaged road pavement of the old Tai Woh Ping Road which promoted concentrated water ingress into the lower cut slope.

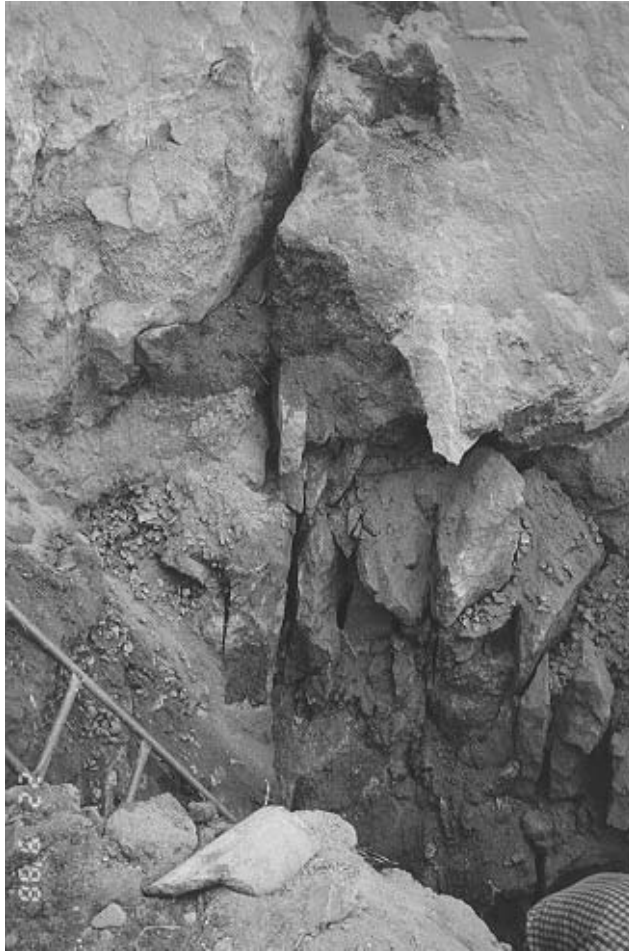
Plate 13 – View of Trial Pit No. TP1 Showing Western Release Plane
View Looking North
(Photograph Taken on 22 September 1998)

The trial pits in the upper western part of the landslide (particularly TP1) showed closely fractured, Grade II and III rock, as well as the lateral release plane (Plate 13). These fractures were up to 50 mm in width. Hand probing using reinforcement bars proved a minimum depth of fracturing to 5 m below original ground (road) level at TP1.

Opened joint forming release
plane dipping $85^{\circ}/330^{\circ}$

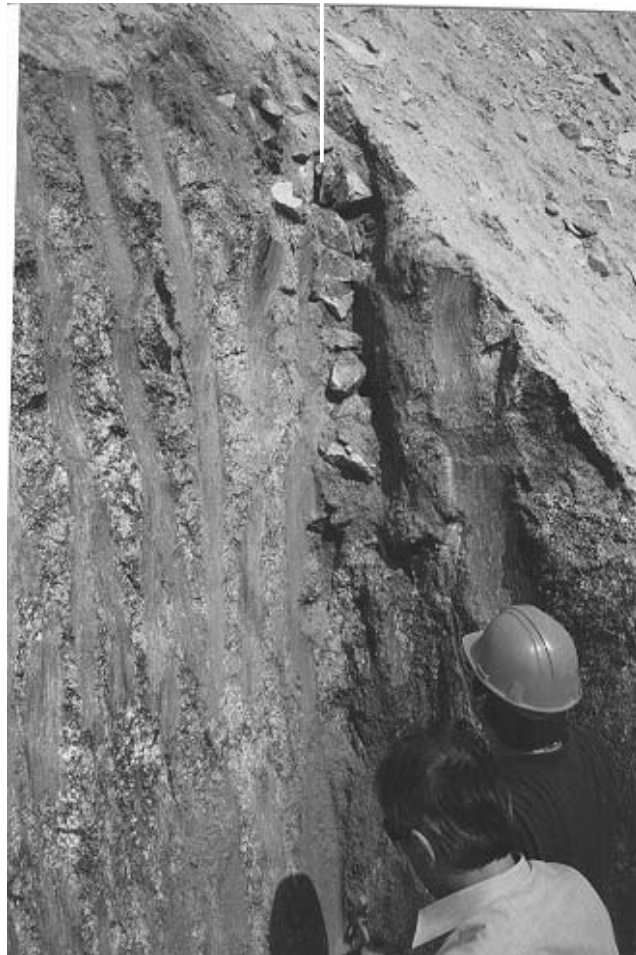
Plate 14 – View of Trial Pit No. TP3 Showing Filled Minor Tension Crack
View Looking East
(Photograph Taken on 25 September 1998)

Trial Pit No. TP3 encountered part of the lateral tension crack within the main failed mass (Plate 14). The 150 mm (approximately) crack had become infilled with rockfill that was used to surcharge the slope as part of the emergency stabilisation works.

Tension crack (dipping $86^{\circ}/175^{\circ}$)
infilled with rockfill

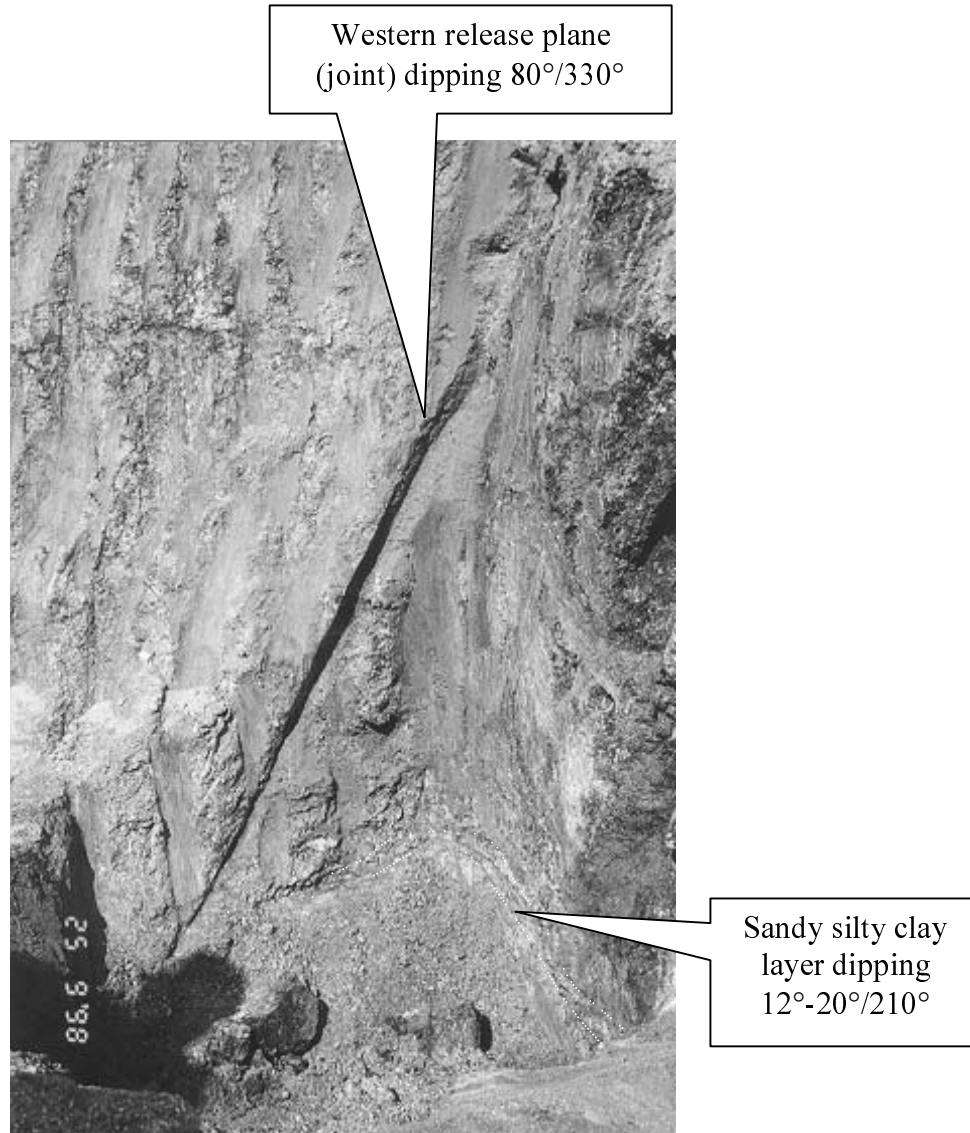
Plate 15 – View of Trial Pit No. TP3 Showing Release Plane and Sandy Silty Clay Layer
View Looking North
(Photograph Taken on 25 September 1998)

The basal slip plane to the main lower failure was encountered in six of the trial pits (Nos. TP3, TP4, TP5, TP6, TP7 and TP8). This consisted of a thin (10 to 50 mm), apparently persistent, slightly undulating layer of soft to firm sandy silty clay, which exhibited signs of movement and dipped at angles of between 10° and 20° in a south-westerly direction. At the location of the major tension crack at the toe of the upper cutting, the clay layer was located at approximately 4 m below ground (road) level. Based on its elevation at the various locations encountered, the clay layer appears to have an average dip of about 14° in a direction sub-parallel to the strike of the western release plane, and oblique to the slope face. Typical views of this clay layer are shown in Plates 15 to 17.

It is considered that the apparently persistent clay layer possibly represents an infilled sheeting joint. The infilling may be a deposit left in the joint by leaching or infiltration, above a weathering zone of lower permeability. Alternatively, the clay layer may be the product of a long period of near-surface weathering of the insitu material.

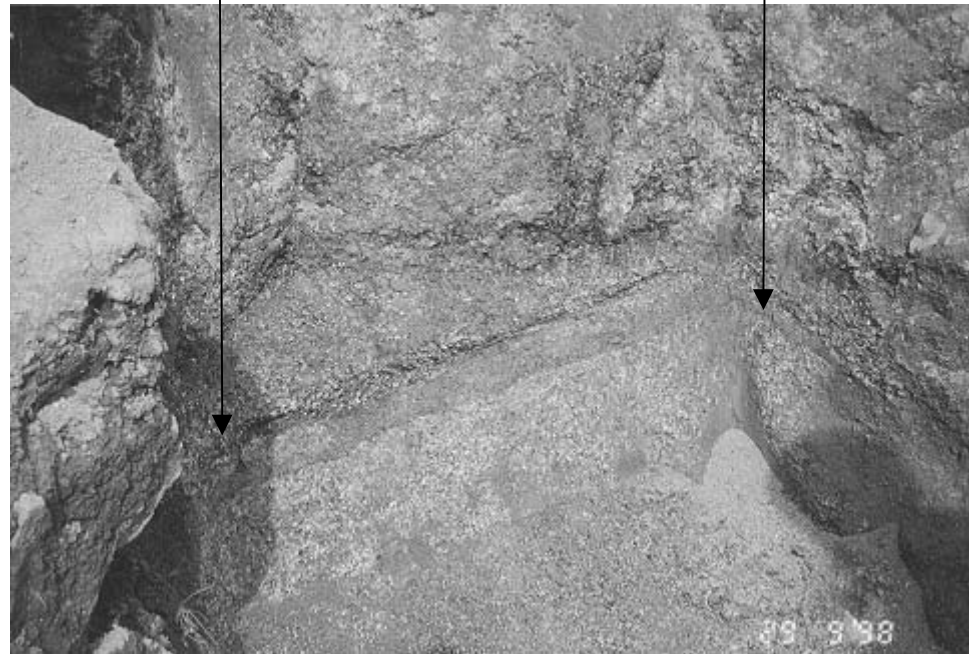
Plate 16 – View of Trial Pit No. TP4 Showing Sandy Silty Clay Layer Representing Probable Basal Slip Plane
View Looking North
(Photograph Taken on 29 September 1998)

Sandy silty clay layer, 10 – 50 mm thick.

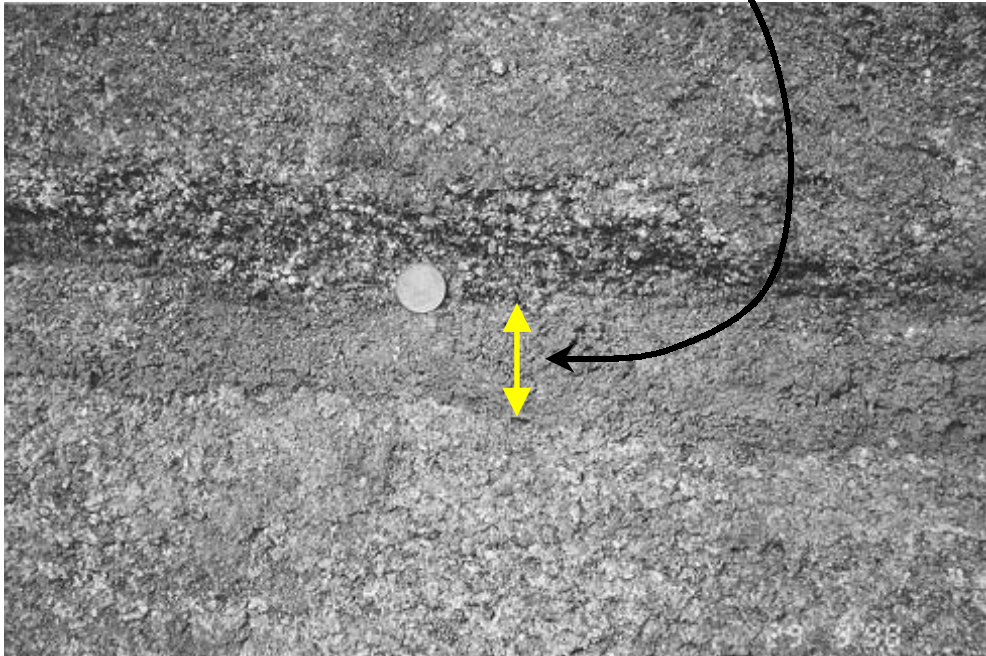
Plate 17 – Close-up of Sandy Silty Clay Layer, Trial Pit No. TP4
(Photograph Taken on 29 September 1998)

Sandy silty clay layer
