**SECTION 2 :
DETAILED STUDY OF THE
LANDSLIDE AT TAI PO ROAD
NEAR CHAK ON ESTATE
ON 9 JUNE 1998**

Fugro Scott Wilson Joint Venture

**This report was originally produced in January 2000
as GEO Landslide Study Report No. LSR 18/99**

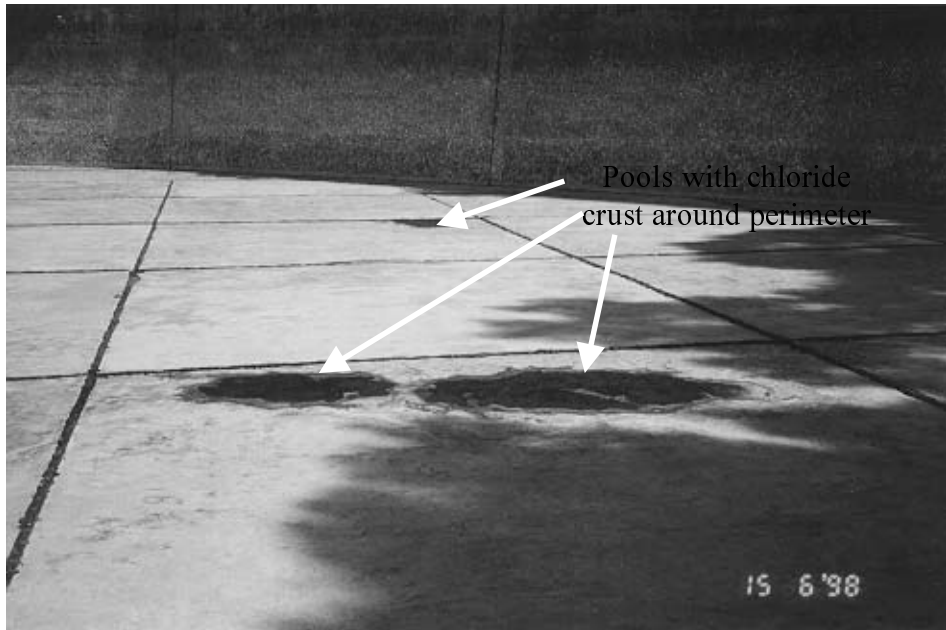
Plate 18 – View of Reservoir Floor After Emptying
(Photograph Taken on 15 June 1998)

When the site was inspected by FSW some 16 hours after the failure, seepages were noted to be issuing along the persistent discontinuity marking the western boundary of the slip. The base and sides of the emptied service reservoir above the landslide were inspected by FSW on 15 June 1998, and no significant structural defects which might affect its watertightness were observed. There were however isolated damp patches on the reservoir floor slab, with a surrounding chloride crust (Plate 18), which was probably the result of evaporation of salt water following emptying of the reservoir.
