**REVIEW OF INCIDENTS
INVOLVING SLOPES AFFECTED
BY LEAKAGE OF
WATER-CARRYING SERVICES**

GEO REPORT No. 203

**This report was originally produced in May 2005
as GEO Landslide Study Report No. LSR 7/2005**

This report presents the findings of an overall review of selected notable incidents involving slopes affected by leakage of water-carrying services. Areas that warrant attention are identified and follow-up actions are recommended.

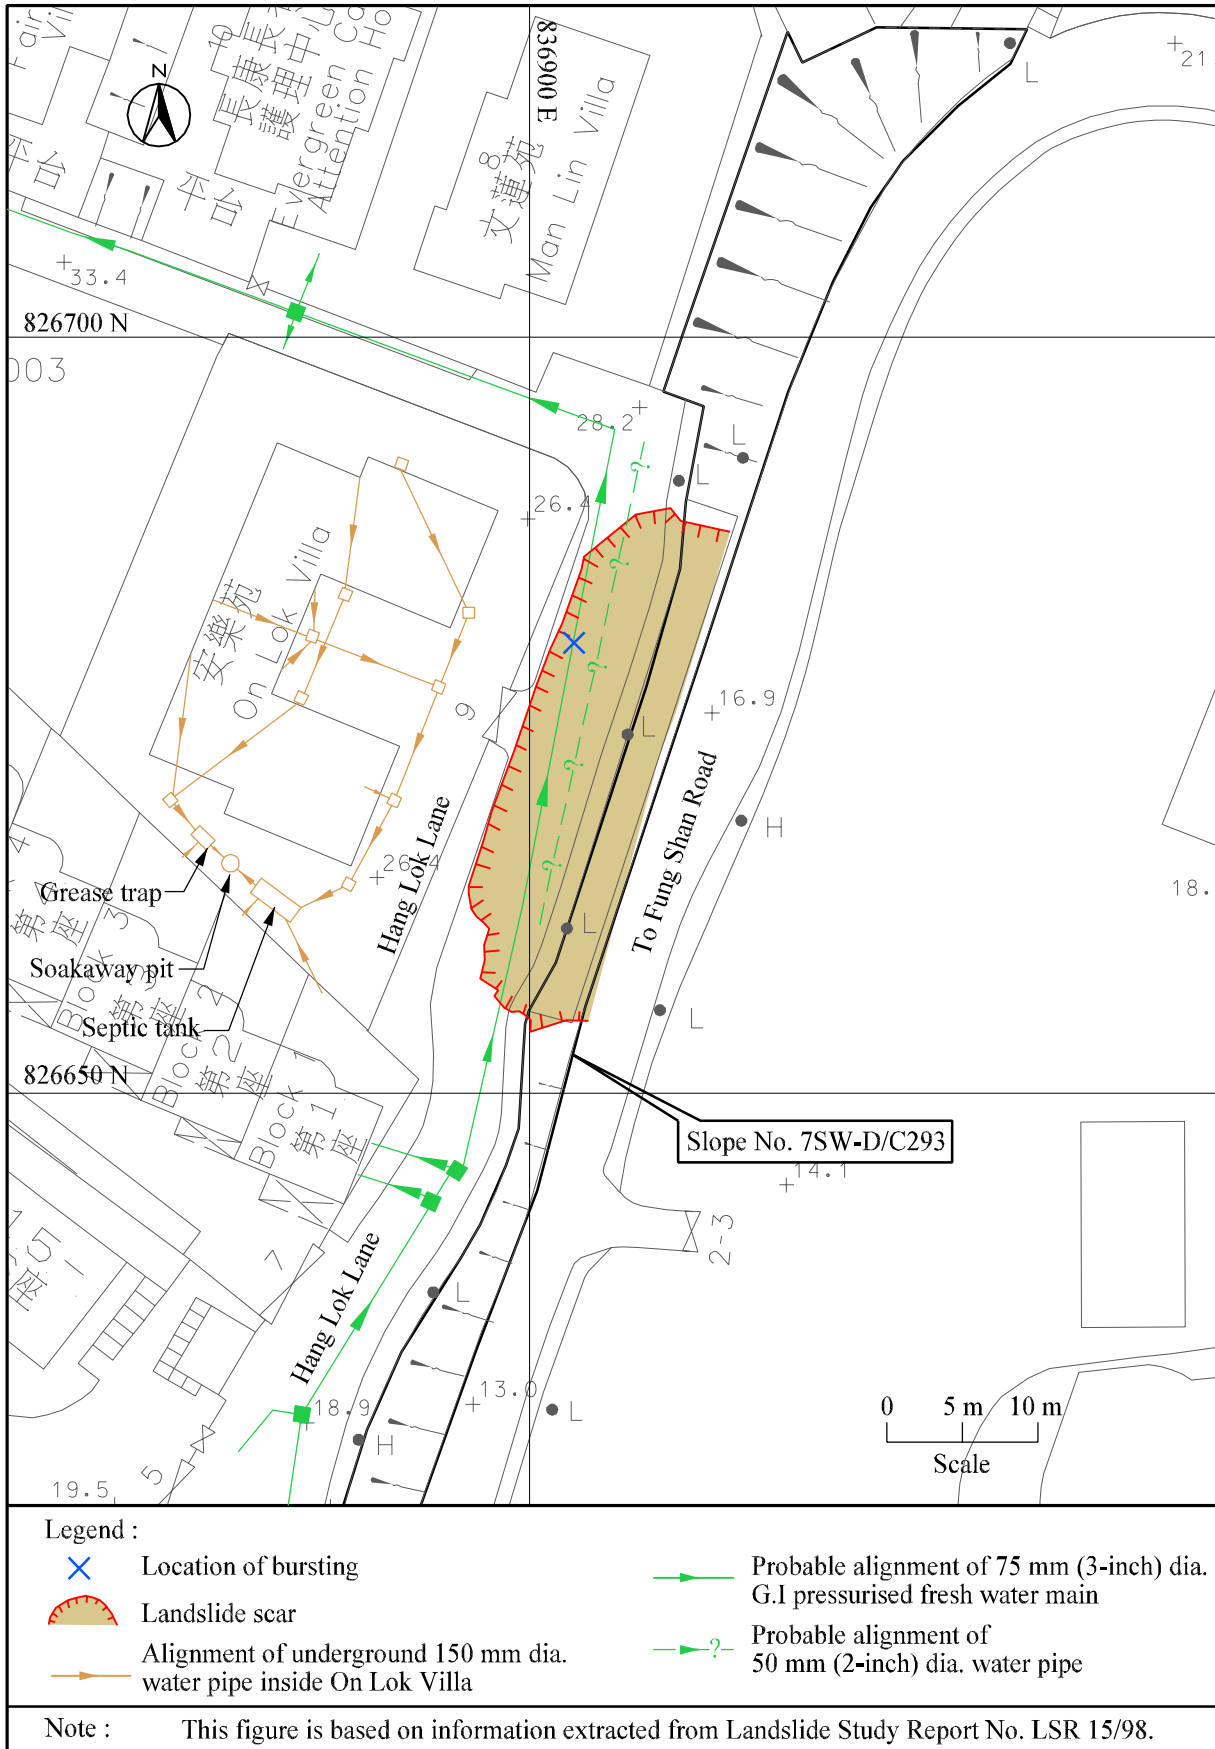
Figure 3 - The 8 February 1998 Landslide at Hang Lok Lane

On 8 February 1998 (i.e. during the dry season), a large-scale landslide (about 1,100 m³ in volume) occurred on a non-engineered soil cut slope. The landslide was probably caused by leakage from a 20-year old, 3-inch diameter pressurised fresh water main (Figure 3 and Plate 1) and a 36-m long section of the slope, together with a section of Hang Lok Lane above the slope, collapsed as a result of the landslide. A total of 143 residents of the buildings above the landslide had to be evacuated temporarily.

The landslide investigation (FSWJV, 1998) concluded that the failure was probably triggered by the ingress of a significant amount of water leaking from the old buried water main. It was diagnosed that the leakage might have been caused by deterioration of the water main over time and possible damage to the shallow water main due to loading by heavy vehicles and subsidence of fill under the road.

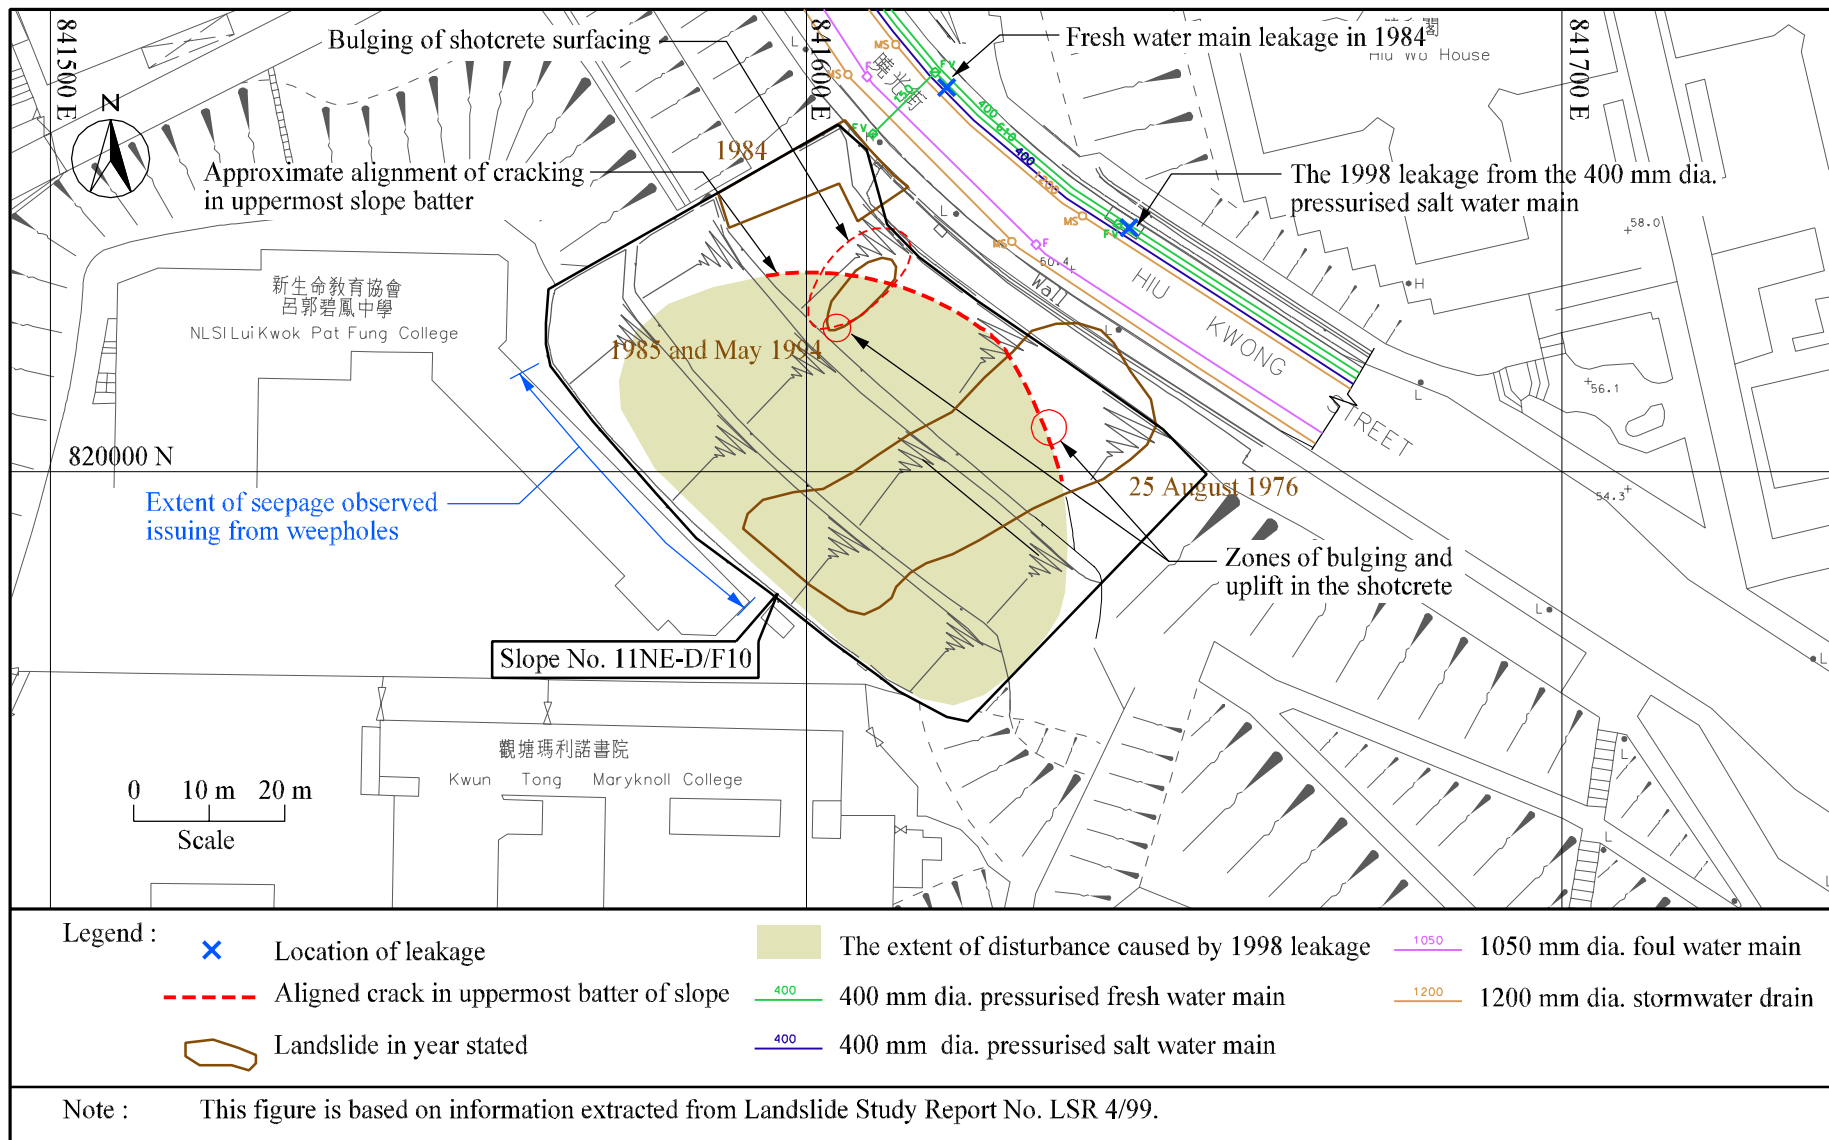
Figure 4 - The 9 April 1998 Distress at Slope No. 11NE-D/F10 below Hiu Kwong Street

The slope was originally formed by end-tipping fill to a depth of more than 10 m into a valley in the mid-1960's. Following a failure in 1976, the slope was upgraded in 1977 by placing a compacted fill cap with a thickness of 3 m to 6 m thick over the pre-existing old fill.

The slope has a history of leakage from buried services. A major failure occurred in 1984 due to leakage from a water main. Since 1984, the slope has been subjected to progressive deterioration with the development of distress and intermittent movement.

Since early February 1998, continuous seepage was observed from the weepholes at the slope toe, which was subsequently found to be associated with leakage from a 400 mm diameter pressurised saltwater main above the slope crest (see Plate 4). On 9 April 1998, significant distress in the form of local cracking, displacement and bulging of the shotcrete cover was observed in the upper portion of the fill slope (Figure 4, Plates 5 and 6). The saltwater main was one of several major water-carrying services (two pressurised fresh water mains, two stormwater drains and one foulwater sewer) located on a large depth of old fill below Hiu Kwong Street, and the slope posed a hazard to a school building located directly below the toe.

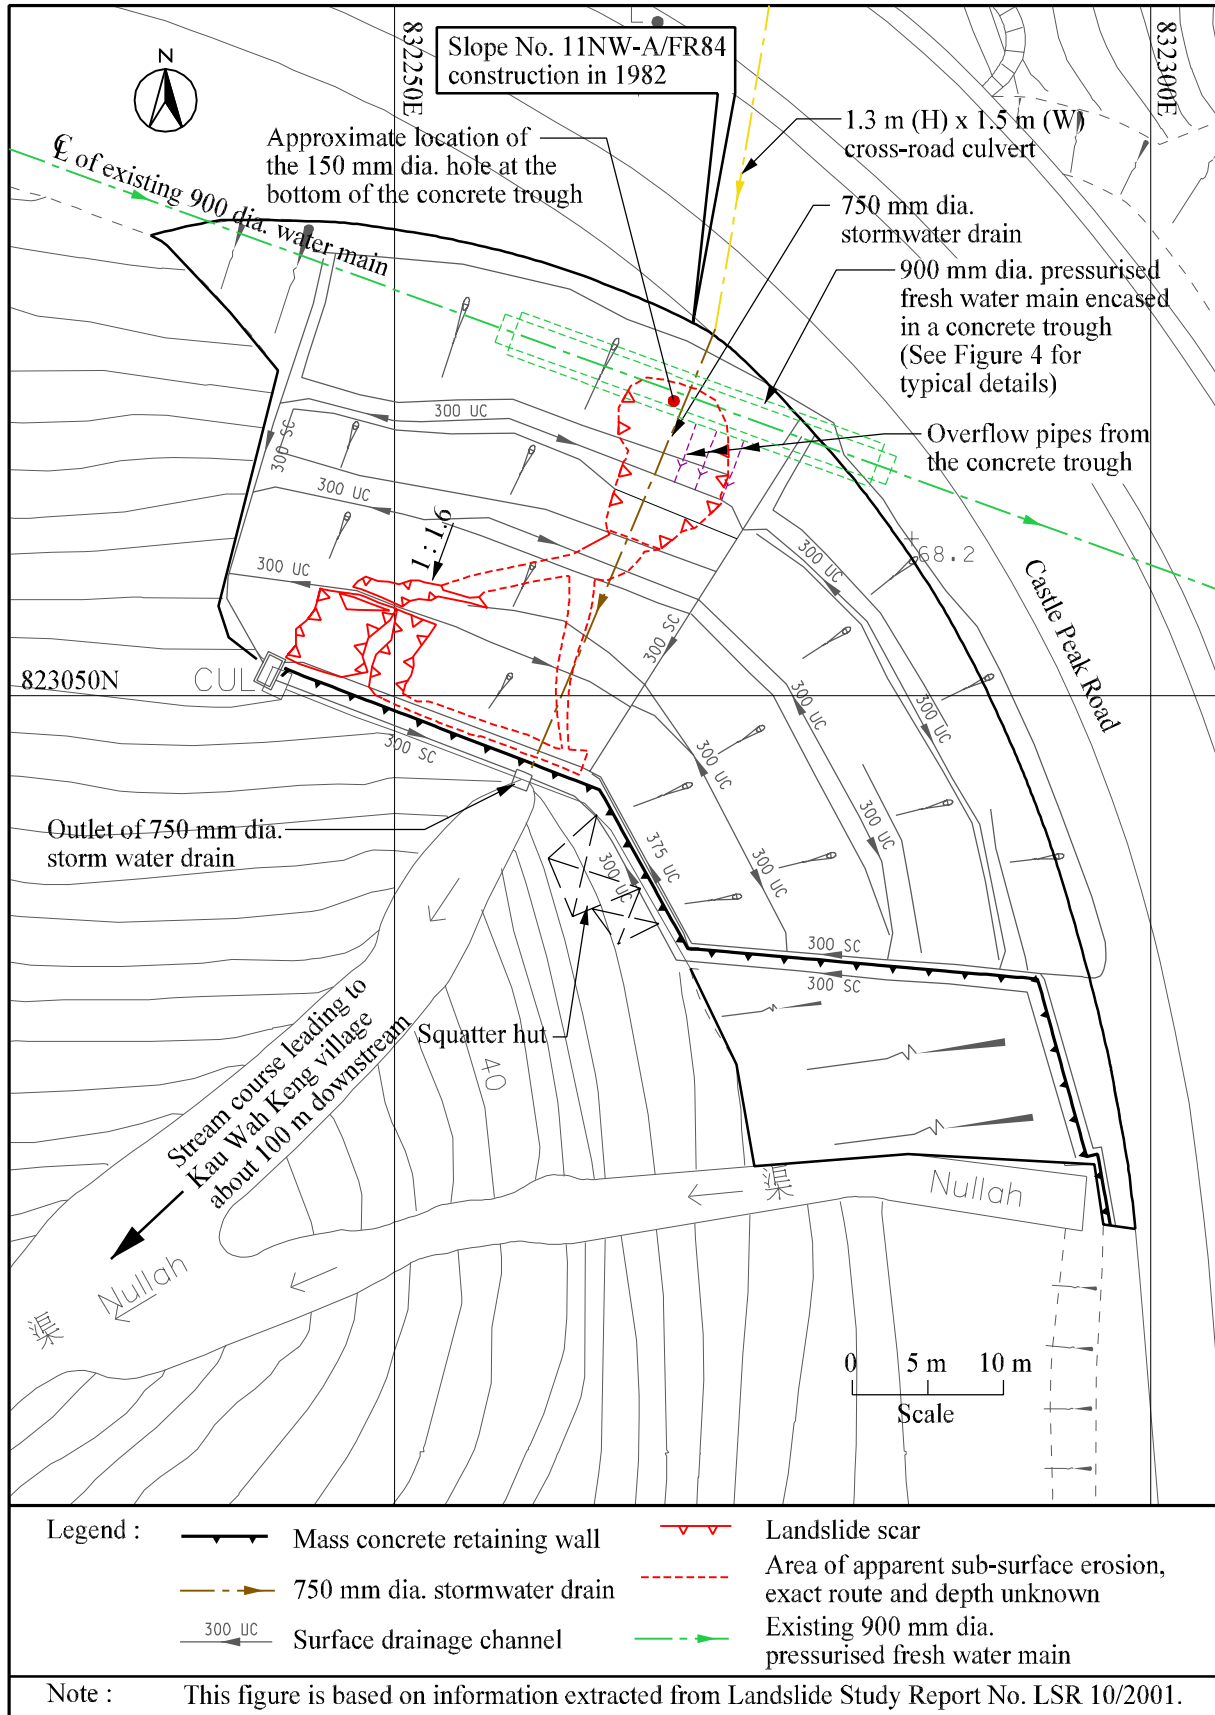
Figure 5 - The 14 January 2002 Landslide at Slope No. 11NW-A/FR84 below Castle Peak Road near Kau Wah Keng Village

On 14 January 2000, major internal erosion and severe distress (involving about 700 m³ of material) were observed on the fill slope, which was previously upgraded in 1982. The cause was probably associated with leakage from a 900 mm diameter pressurised water main (Figure 5 and Plate 7) that had apparently been encased in a concrete trough as part of the leakage collection/detection system constructed during the slope upgrading works (Figure 6).

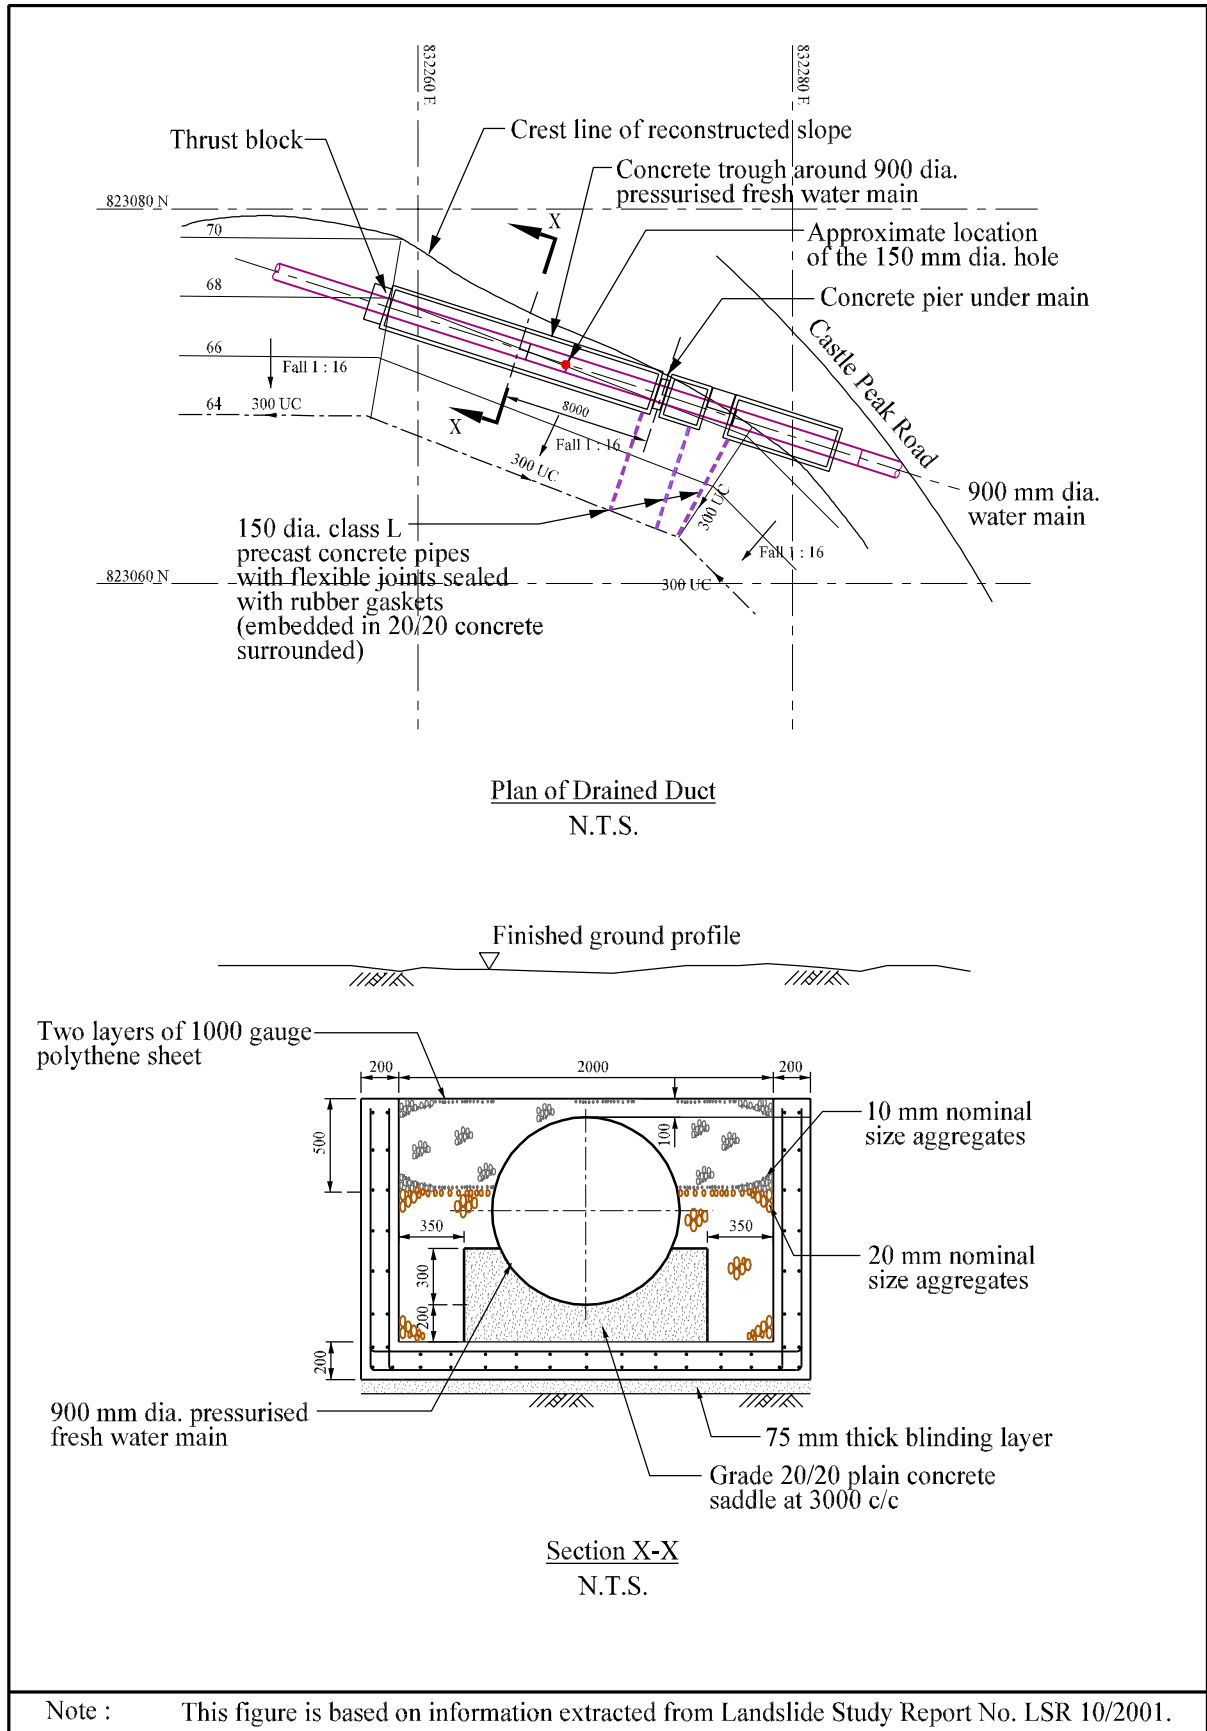
Figure 6 - Details of Leakage Collection/Detection System near Kau Wah Keng Village

The leakage from the pressurised water main resulted in concentrated water ingress into the fill slope through a 150 mm diameter hole at the invert of the concrete trough (Plate 8). Inadequate connection (i.e. poor sealing) between the drain pipe and the trough also played a contributory role by allowing additional water ingress into the slope following dislocation of connection, which was probably caused by the development of local movement as the slope wetted up.

This incident emphasises the need for proper design and detailing of the ducting system for water-carrying services and the importance of proper documentary records and recommended inspection procedures in the slope maintenance manual.

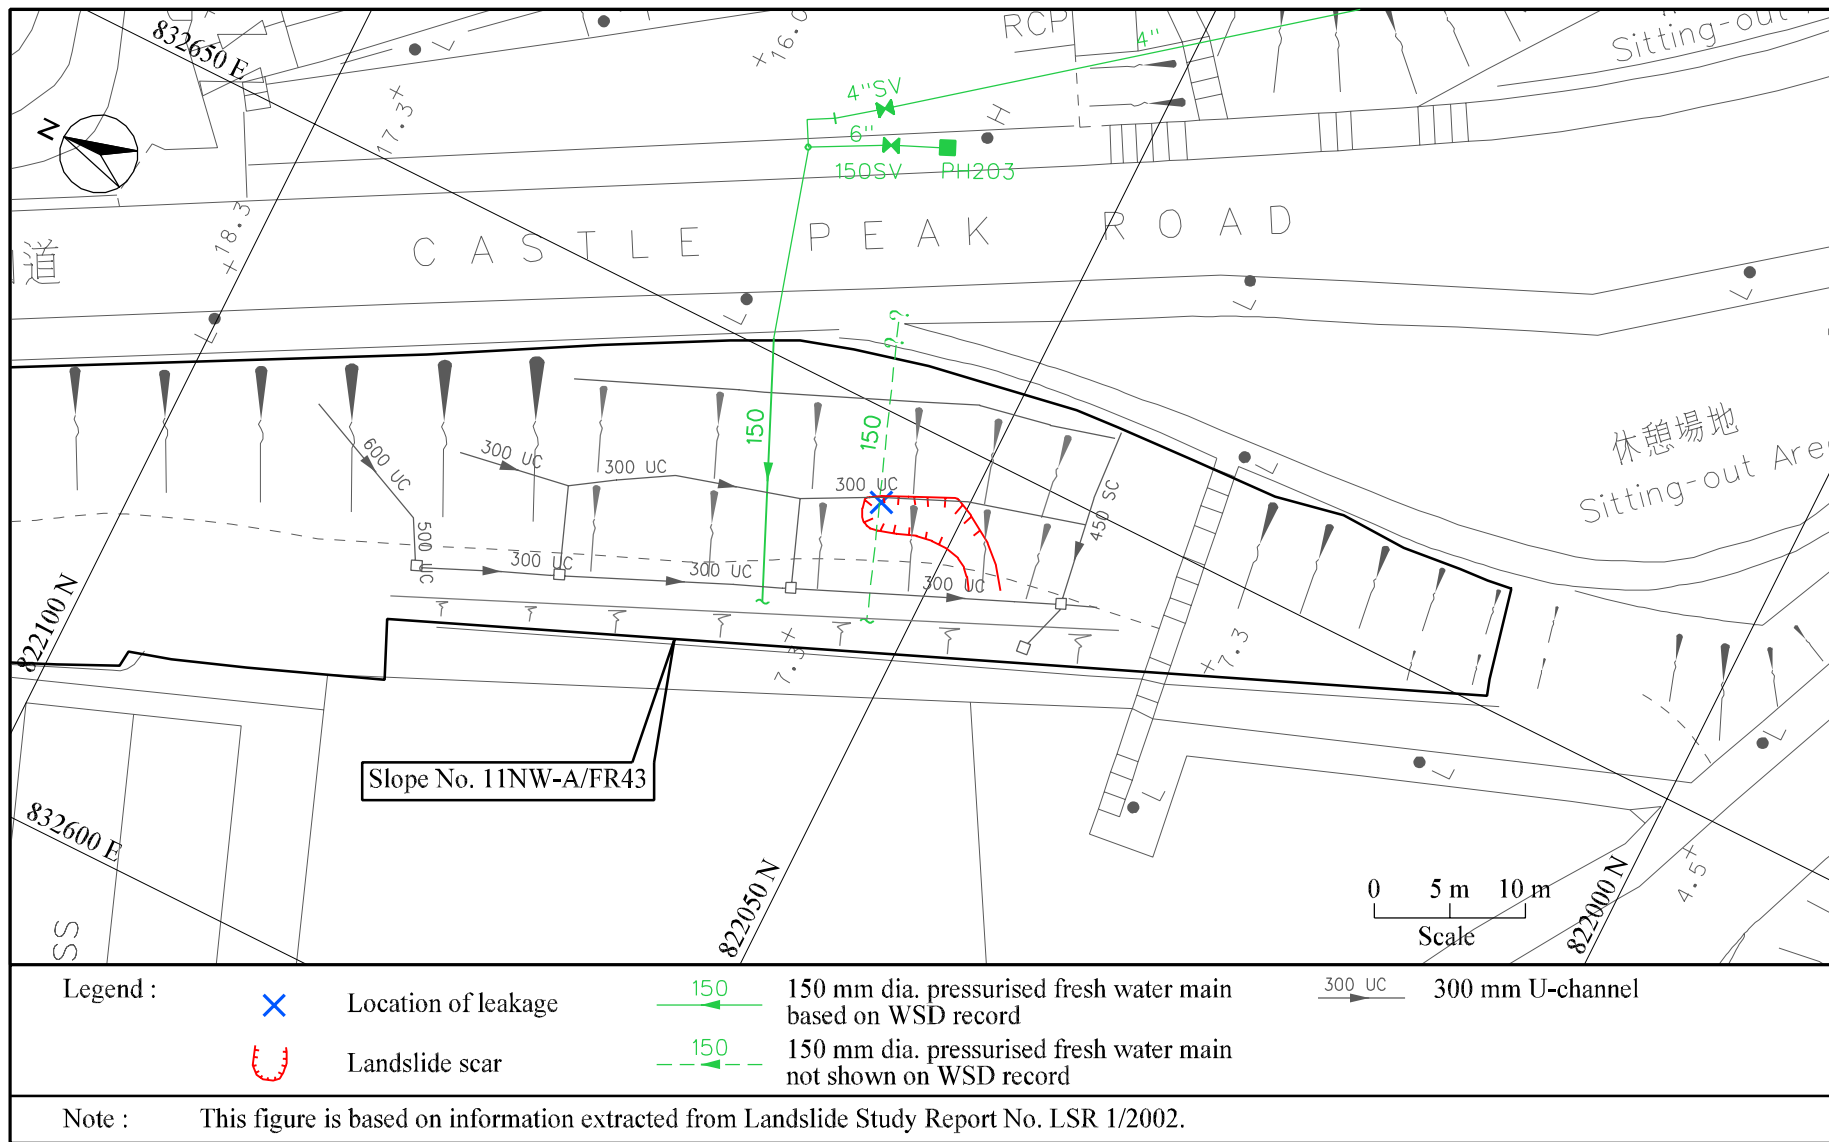
Figure 7 - The 27 August 2000 Landslide below Castle Peak Road near Lai Chi Kok Hospital

The washout incident (about 10 m³ in volume, discounting the associated disturbance and loosening of the recompacted fill cap) occurred on a recently upgraded fill slope (Figure 7 and Plate 9), which was caused by the bursting of an old (>50 years), pressurised cast iron fresh water main (Plate 10) that traversed the slope within the loose fill and below the recompacted fill cap. The slope upgrading works, comprising surface re-compaction of the existing loose fill and provision of a drainage filter blanket, were completed about six months before the incident.

The main burst incident was probably the result of progressive deterioration of an old installation, which had become significantly dilapidated and severely corroded. The water main was subsequently diverted by WSD after the incident.

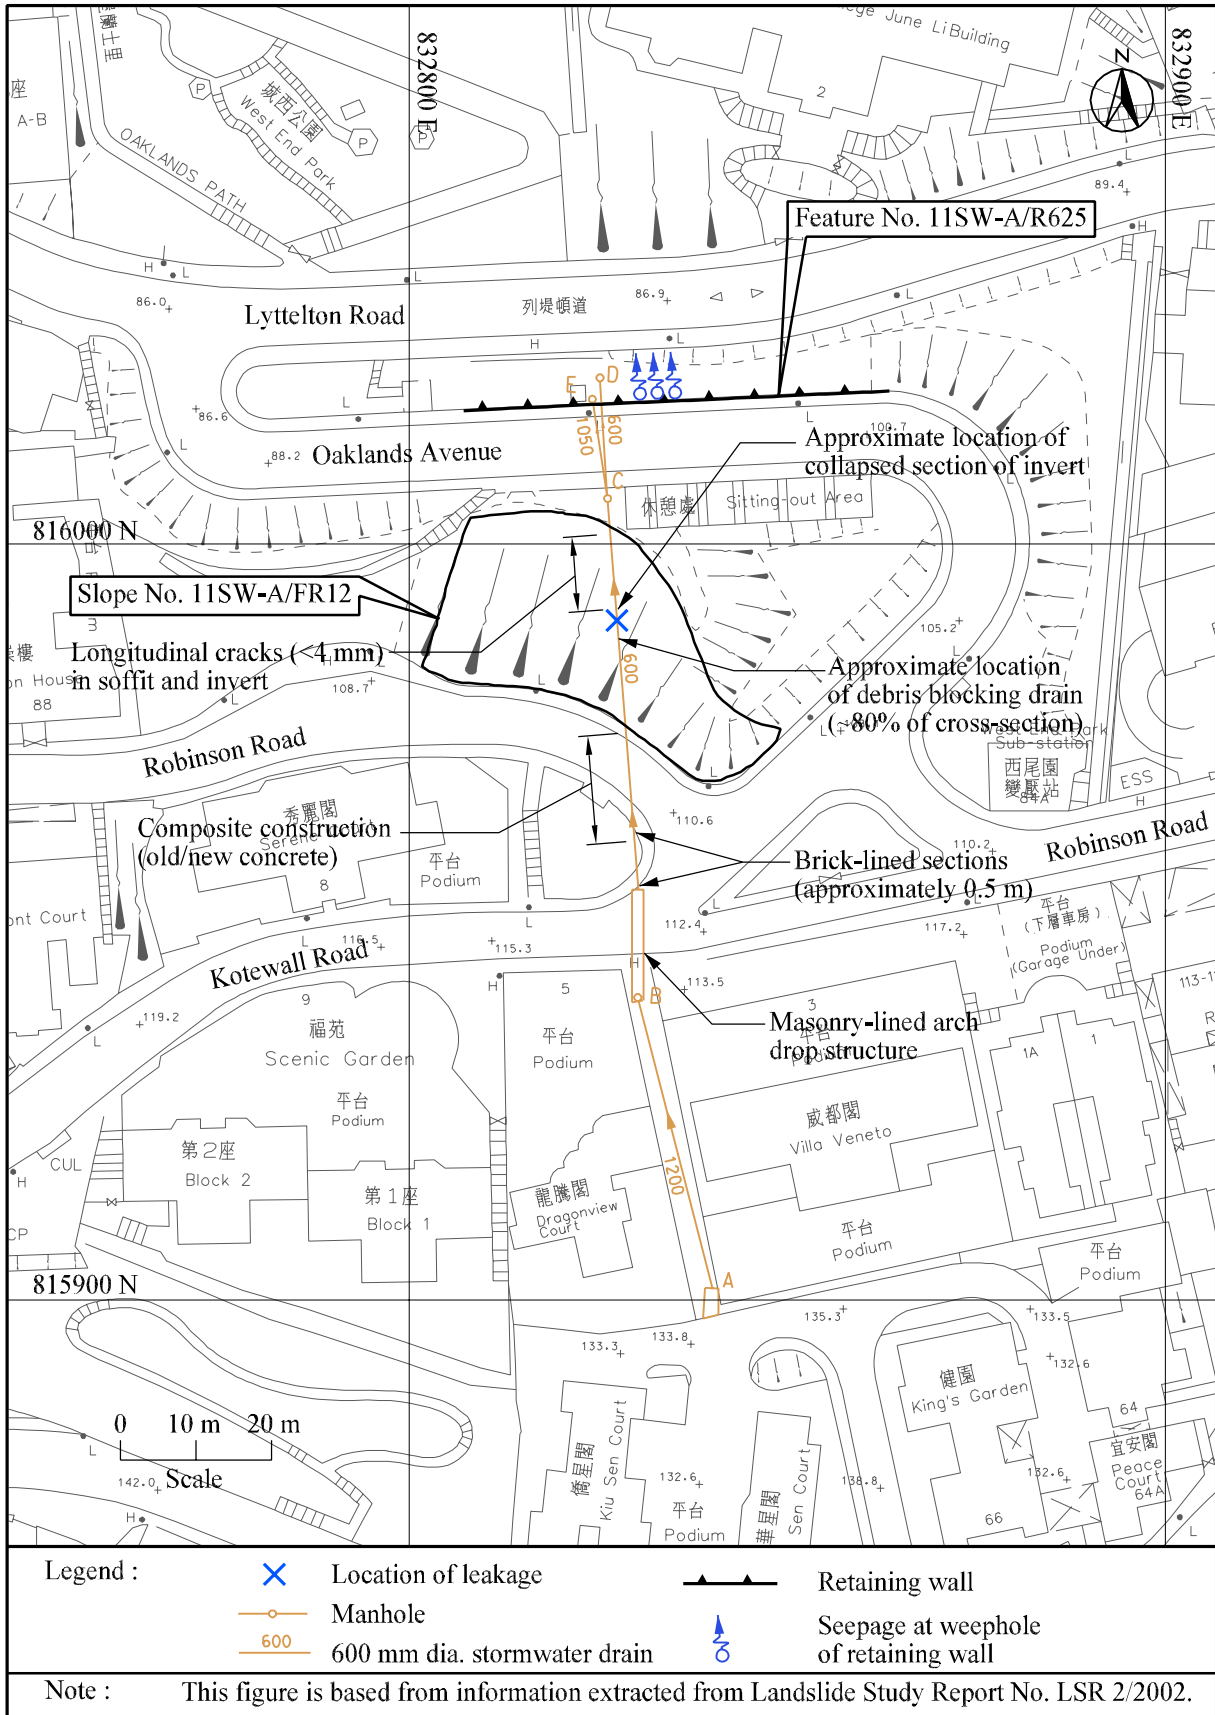
Figure 8 - The 18 June 2000 Seepage Incident at Slope No. 11SW-A/R625 and Ground Subsidence behind Slope No. 11SW-A/FR12 near Oaklands Avenue

This incident involved significant leakage from an old concrete stormwater drain that had been constructed in the mid-1960's (Figure 8 and Plate 11) and ranged from 600 mm to 1200 mm in diameter. The drain collected surface water flow from the Po Shan Stream. The incident resulted in major subsurface erosion and local ground subsidence above the slope crest.

CCTV surveys carried out following the 2000 incident revealed defects (i.e. collapsed invert and a break at a pipe joint) in the section of the drain underneath fill slope No. 11SW-A/FR12 and at the connection to a manhole on Oaklands Avenue (Plate 12). Seepage from the broken drain was probably directed to the back of retaining wall No. 11SW-A/R625 along a network of soil erosion pipes within the colluvium, thus resulting in a strong outflow of muddy water from the weepholes in the wall. The defects in the drain were probably the result of progressive deterioration over the long period of time that it has been in service.

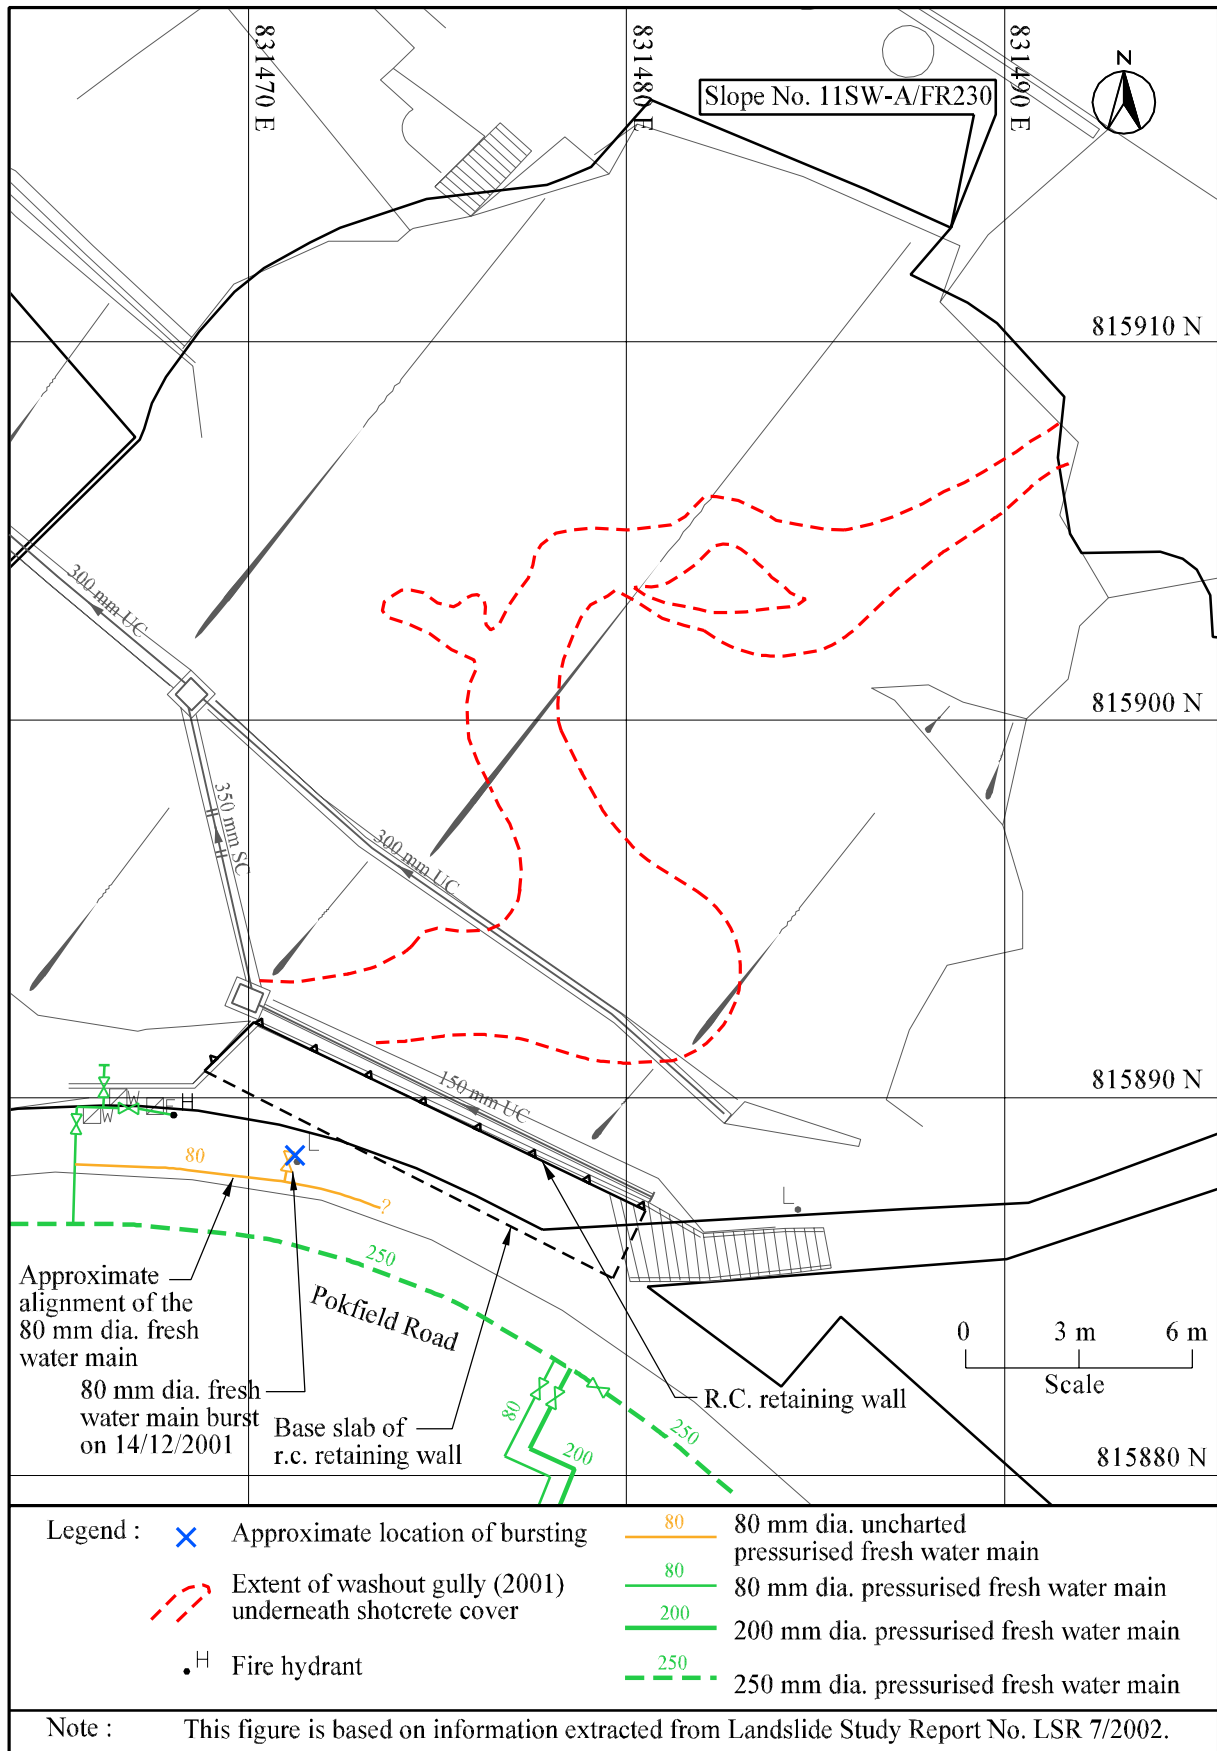
Figure 9 - The 14 December 2001 Landslide at a Fill Slope below Pokfield Road

The uncharted fresh water pipe (Figure 9, Plates 13 and 14) was located at a sharp bend on Pokfield Road above the old fill slope. The water pipe was likely to branch off the 250 mm diameter fresh water main supplying the area (Plate 15) and probably used to supply water to the now abandoned squatter areas below the fill slope before the 1970's. According to WSD's investigation subsequent to the incident, the burst of the water pipe was caused by external erosion of the galvanized iron pipe body, which was more than 20 years old and was in a dilapidated state.

The water pipe was uncharted in that it was not included in WSD's mains record plans. Based on WSD's advice, leakage from the corroded and uncharted water pipe probably occurred for some time prior to the burst. Water ingress arising from the leakage would have wetted up the ground mass and probably resulted in the local build-up of groundwater pressures.

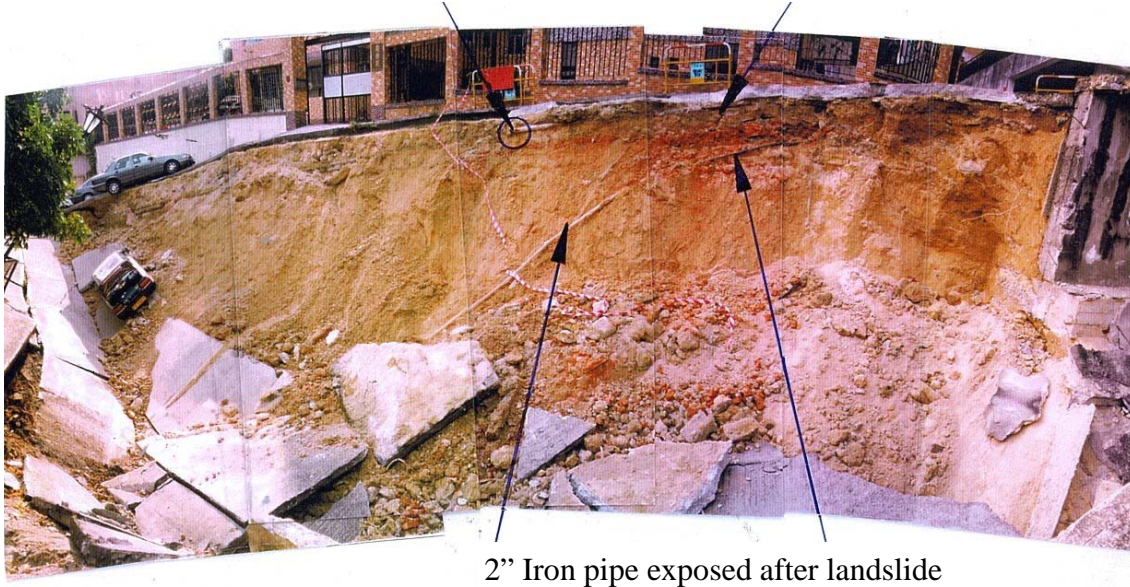
3" G.I. fresh watermain exposed after landslide

2" Iron pipe exposed after landslide

Plate 1 - The Landslide Scar and the Exposed Water-carrying Services - Hang Lok Lane
(Photograph taken on 8 February 1998)

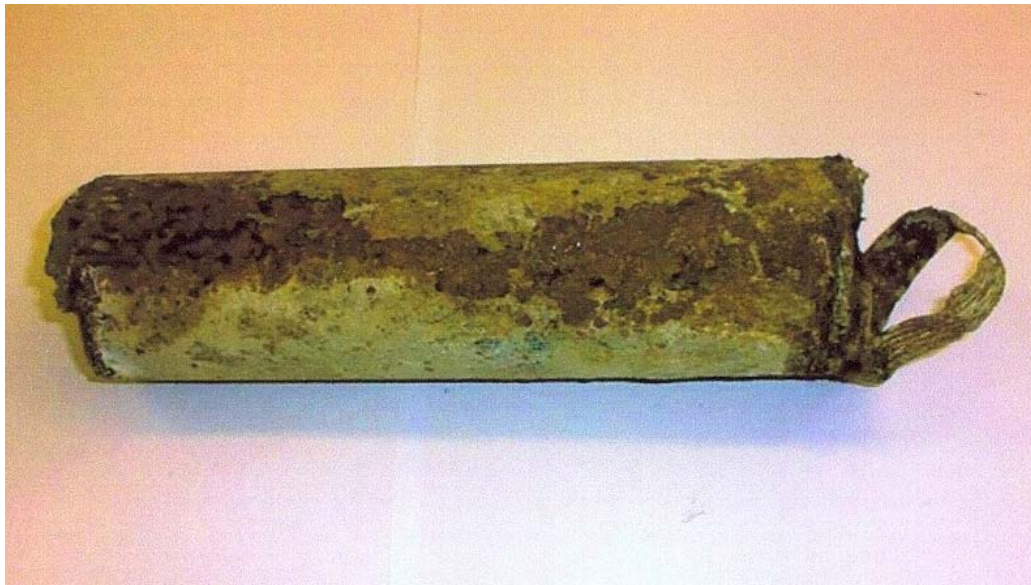
Close examination of the exposed 3-inch galvanized iron fresh water pipe indicated rusting and pitting around a screw joint (Plates 2 and 3). The water pipe was buried at a minimum depth of about 340 mm below the ground surface.

Plate 2 - Close-up View Showing Rusting Stains on the Underside of Pipe Surface - Hang Lok Lane
(Photograph taken on 27 March 1998)

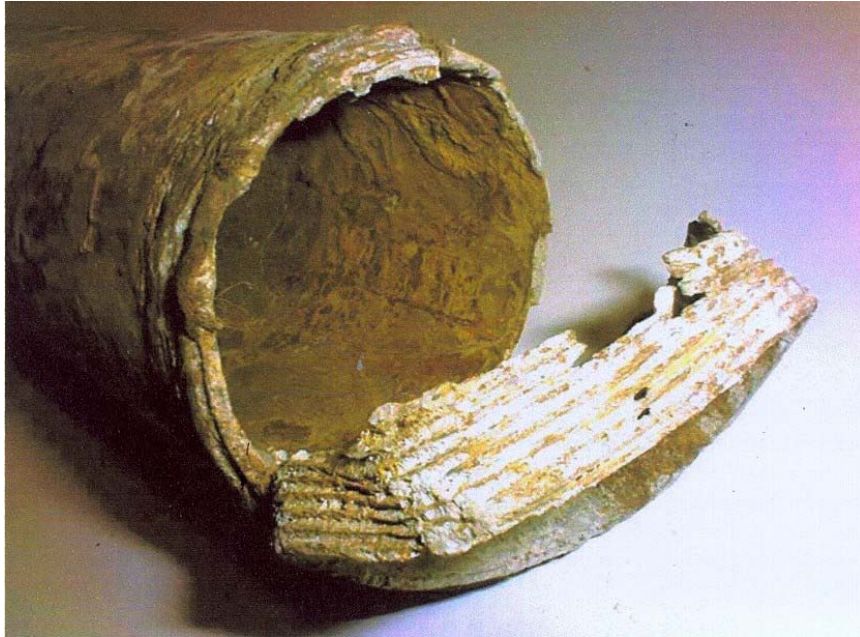
Plate 3 - Close-up View Showing Severe Rusting and Pin-Holes at the Screw Joint - Hang Lok Lane
(Photograph taken on 27 March 1998)

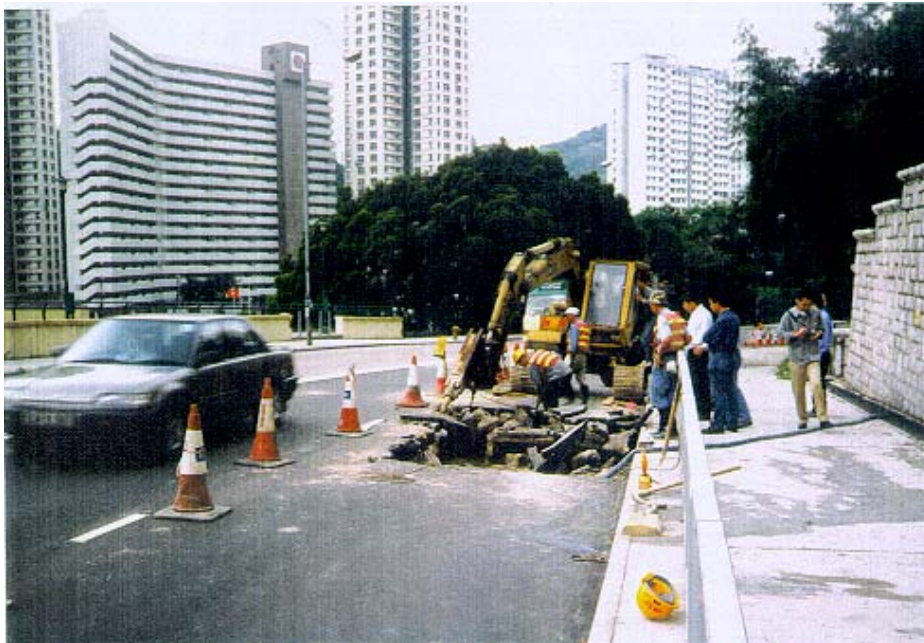
Plate 4 - View of Exploratory Pit Opened at the Location of Leak in Water Main along Northern Side of Hiu Kwong Street
(Note blue hose for de-watering. Photograph taken on 14 April 1998)

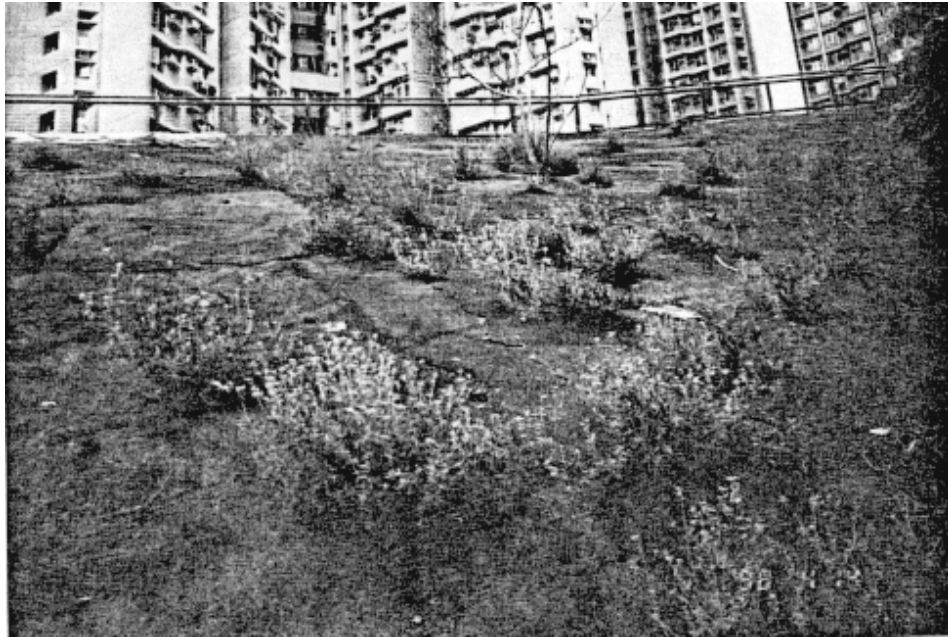
Plate 5 - View of the Zone of Cracking and Bulging
in Shotcrete - Hiu Kwong Street
(Photograph taken on 14 April 1998)

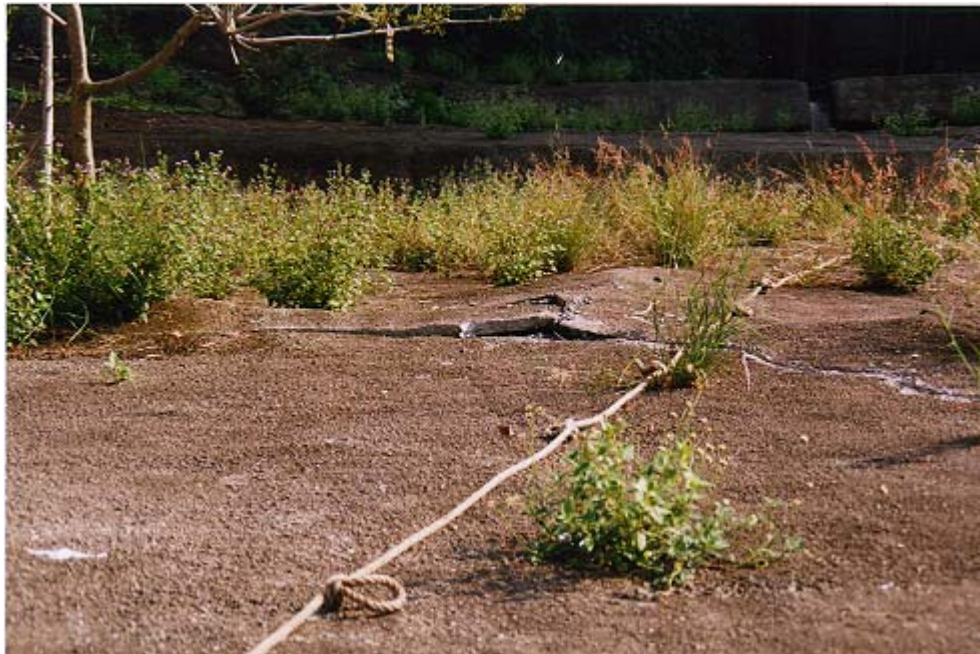
Plate 6 - Downslope View of the Zone of Bulging
at Upper Batter - Hiu Kwong Street
(Photograph taken on 5 May 1998)

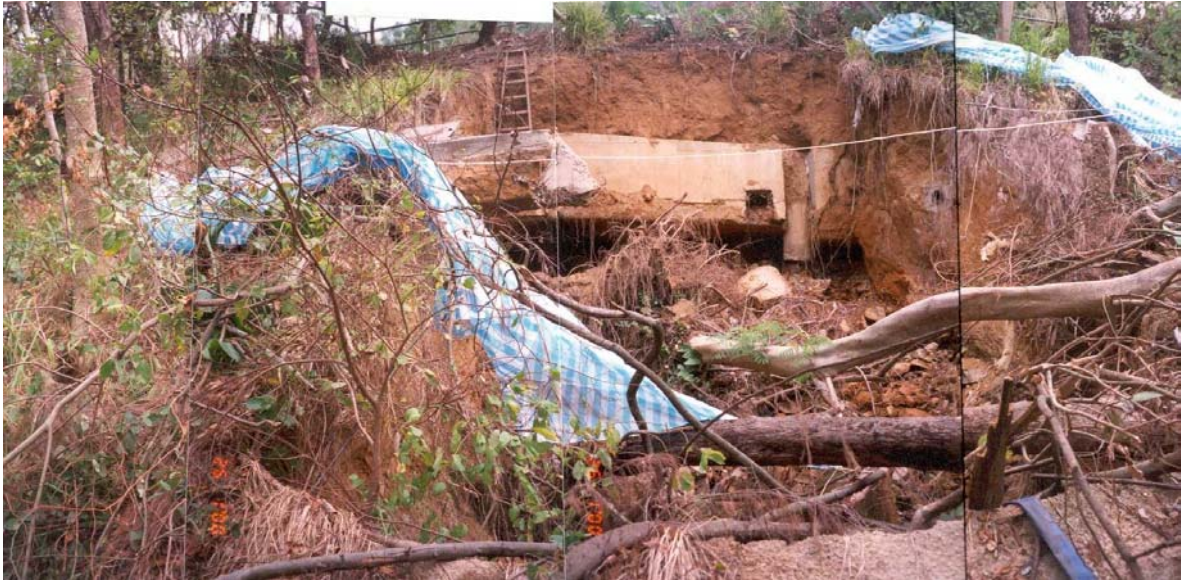
Plate 7 - View of Main Scar and the Leakage Collection Trough - Kau Wah Keng Village
(Photograph taken on 26 January 2000)

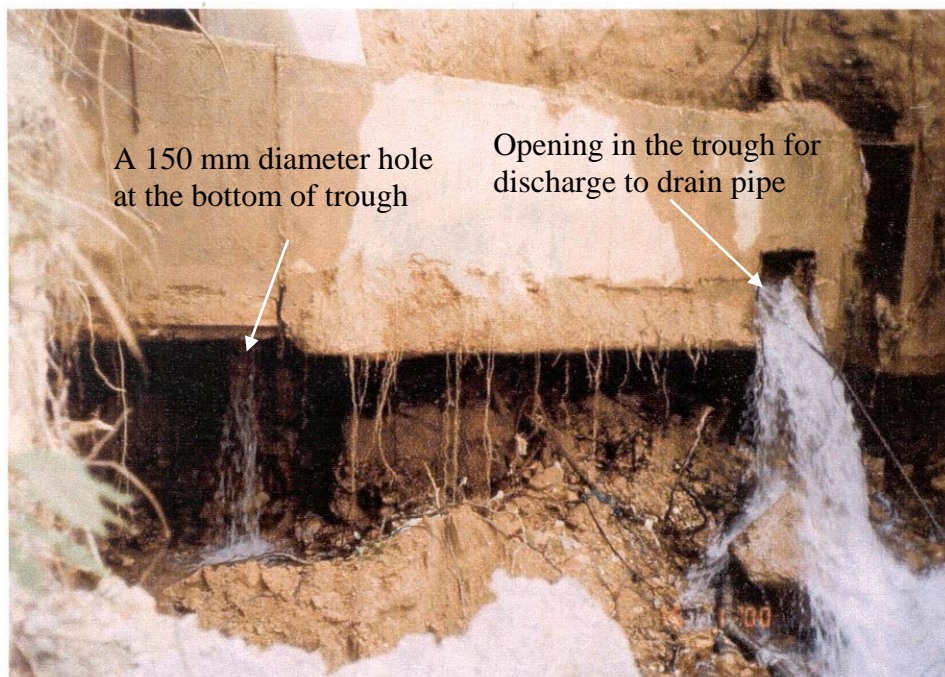
Plate 8 - View of Water Discharging from Leakage Collection Trough - Kau Wah Keng Village
(Photograph taken on 14 January 2000)

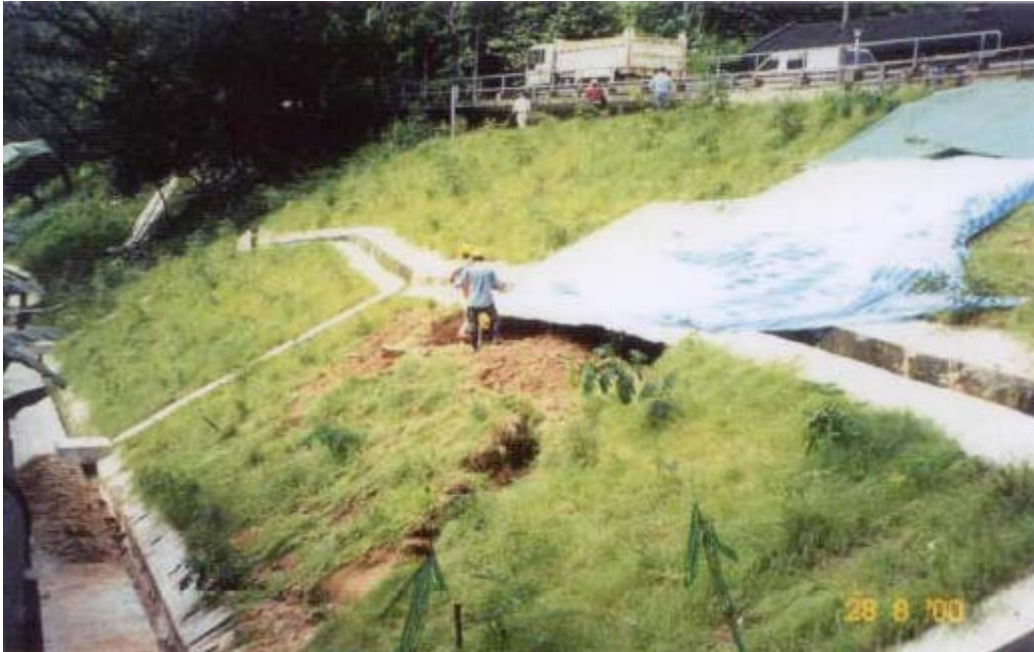
Plate 9 - General View of the Landslide Scar - Lai Chi Kok Hospital
(Photograph taken on 28 August 2000)
