**REVIEW OF INCIDENTS
INVOLVING SLOPES AFFECTED
BY LEAKAGE OF
WATER-CARRYING SERVICES**

GEO REPORT No. 203

**This report was originally produced in May 2005
as GEO Landslide Study Report No. LSR 7/2005**

This report presents the findings of an overall review of selected notable incidents involving slopes affected by leakage of water-carrying services. Areas that warrant attention are identified and follow-up actions are recommended.

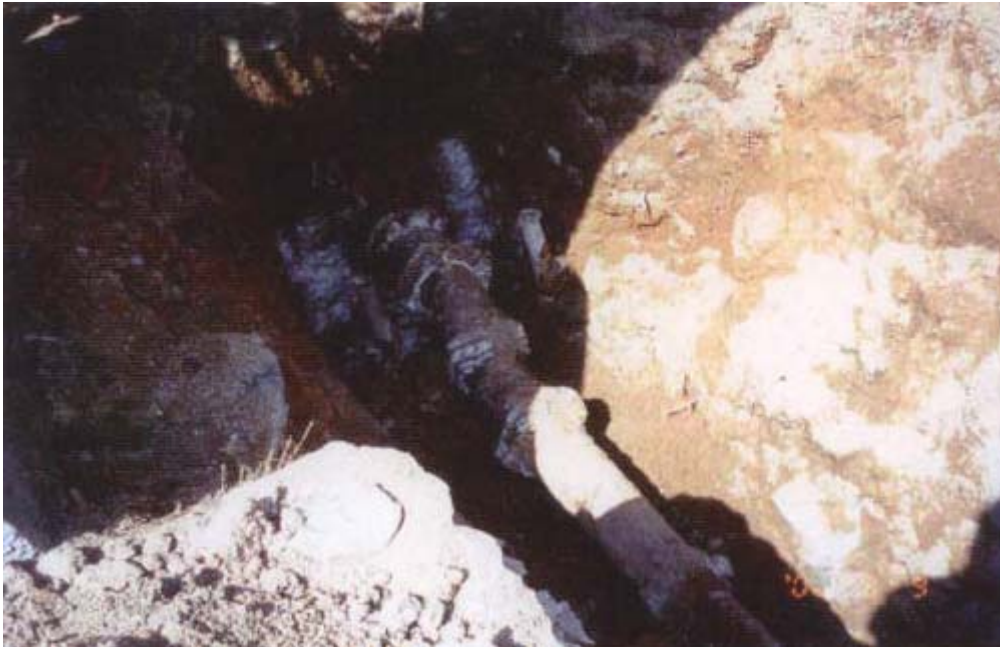
The main burst incident was probably the result of progressive deterioration of an old installation, which had become significantly dilapidated and severely corroded. The water main was subsequently diverted by WSD after the incident.

Plate 10 - The 150 mm Heavily Corroded Water Pipe near
the Footpath at Slope Toe - Lai Chi Kok Hospital
(Photograph taken on 9 September 2000)

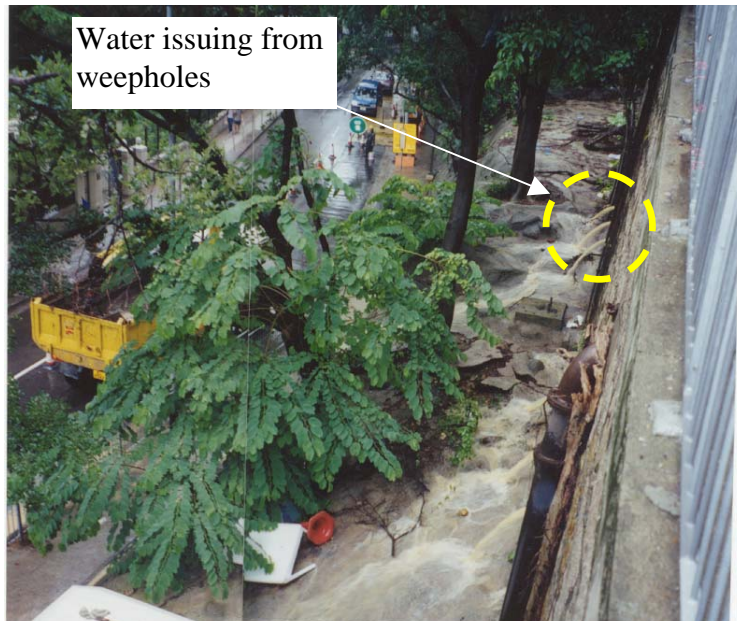
Plate 11 - View of Water Issuing from Weepholes in Retaining Wall No. 11SW-A/R625 - Oaklands Avenue (Photograph taken on 18 June 2000)

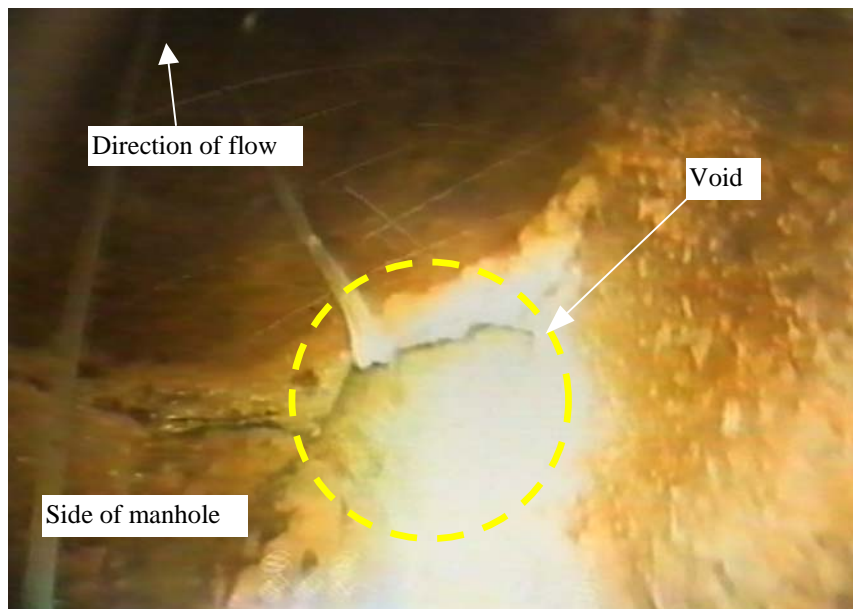
CCTV surveys carried out following the 2000 incident revealed defects (i.e. collapsed invert and a break at a pipe joint) in the section of the drain underneath fill slope No. 11SW-A/FR12 and at the connection to a manhole on Oaklands Avenue (Plate 12). Seepage from the broken drain was probably directed to the back of retaining wall No. 11SW-A/R625 along a network of soil erosion pipes within the colluvium, thus resulting in a strong outflow of muddy water from the weepholes in the wall. The defects in the drain were probably the result of progressive deterioration over the long period of time that it has been in service.

Plate 12 - View of Leakage Through Void at Connection Between Manhole and Stormwater Drain - Oaklands Avenue (Captured from CCTV Video taken on 19 June 2000)

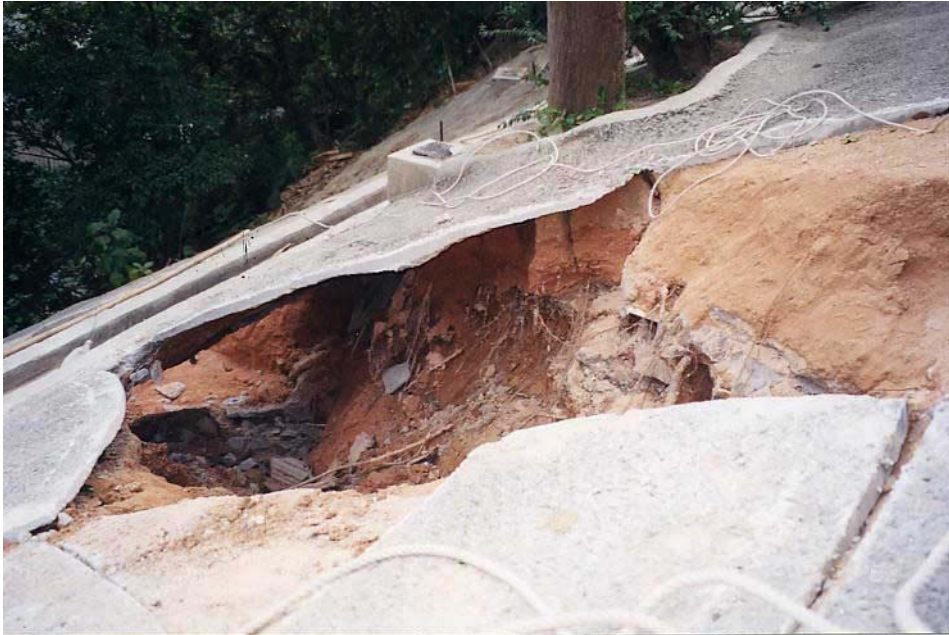
Plate 13 - Washout of Soil from underneath the Shotcrete Cover - Pokfield Road
(Photograph taken on 4 February 2002)

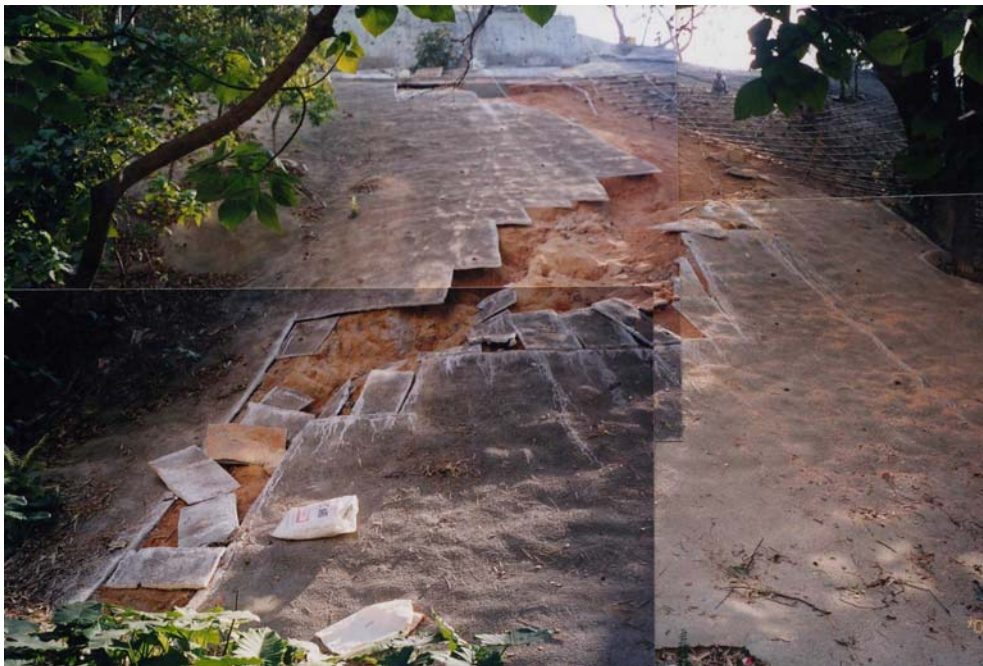
Plate 14 - View of the Erosion Gully After Removing the Shotcrete Cover - Pokfield Road
(Photograph taken on 25 February 2002)

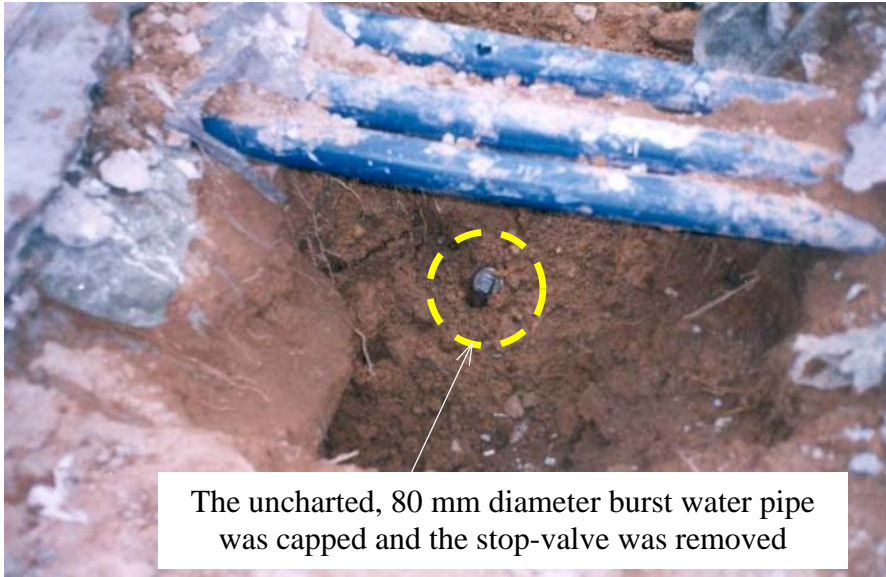
The uncharted fresh water pipe (Figure 9, Plates 13 and 14) was located at a sharp bend on Pokfield Road above the old fill slope. The water pipe was likely to branch off the 250 mm diameter fresh water main supplying the area (Plate 15) and probably used to supply water to the now abandoned squatter areas below the fill slope before the 1970's. According to WSD's investigation subsequent to the incident, the burst of the water pipe was caused by external erosion of the galvanized iron pipe body, which was more than 20 years old and was in a dilapidated state.

The water pipe was uncharted in that it was not included in WSD's mains record plans. Based on WSD's advice, leakage from the corroded and uncharted water pipe probably occurred for some time prior to the burst. Water ingress arising from the leakage would have wetted up the ground mass and probably resulted in the local build-up of groundwater pressures.

Plate 15 - The Uncharted Water Pipe - Pokfield Road
(Photograph taken on 14 December 2001)

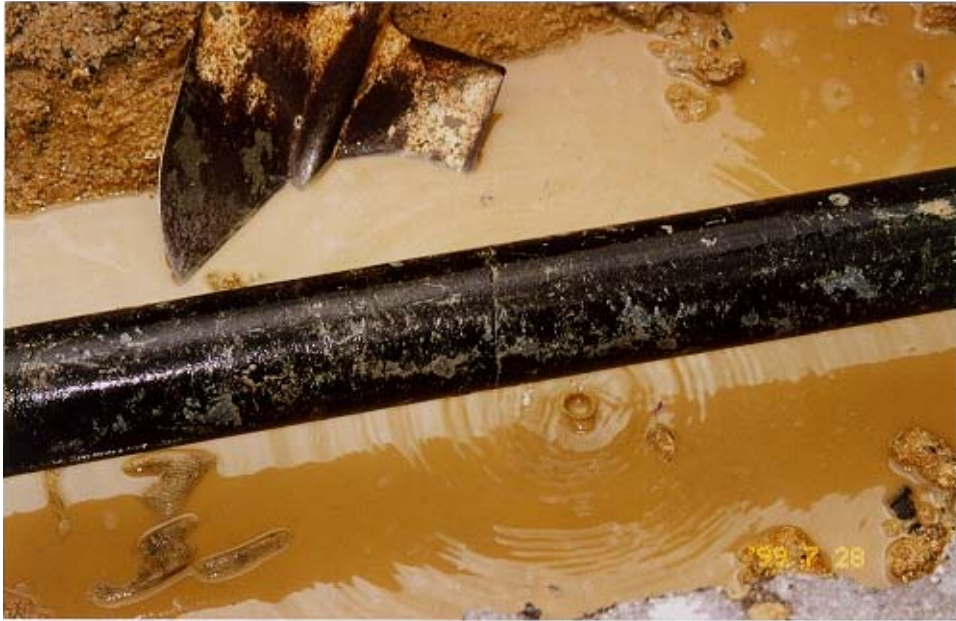
Plate 17 - Leakage Identified from a 75 mm Diameter Galvanized Iron Fire Services Pipe at the Crest of the Slope - Chinese University
(Photograph taken on 6 July 1999)

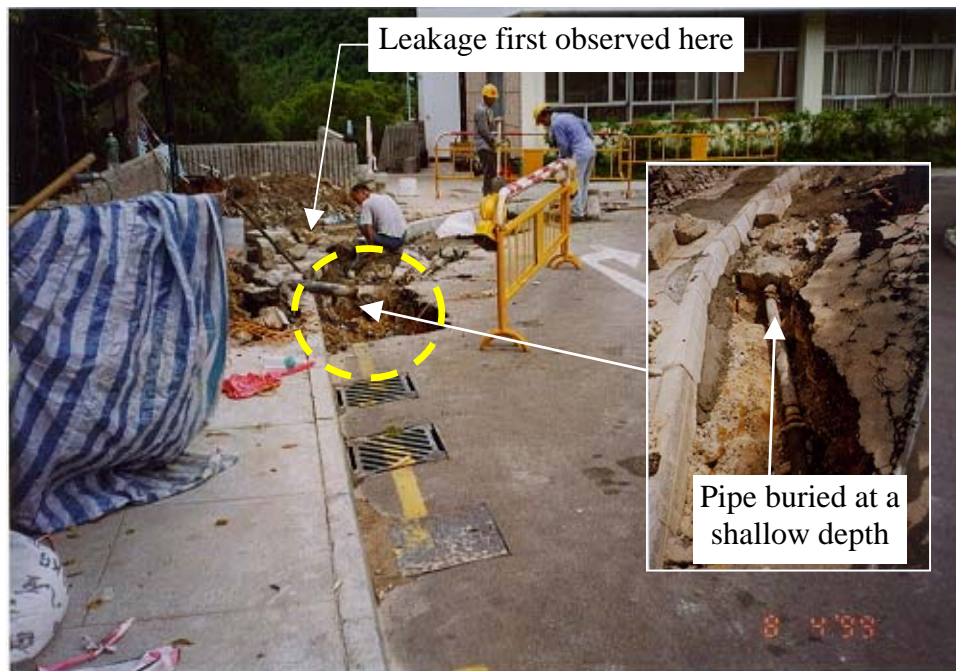
Plate 18 - Additional Leakage in the 75 mm Diameter Fire Services Pipe Identified During Pavement Repair Works - Chinese University
(Photograph taken on 29 July 1999)

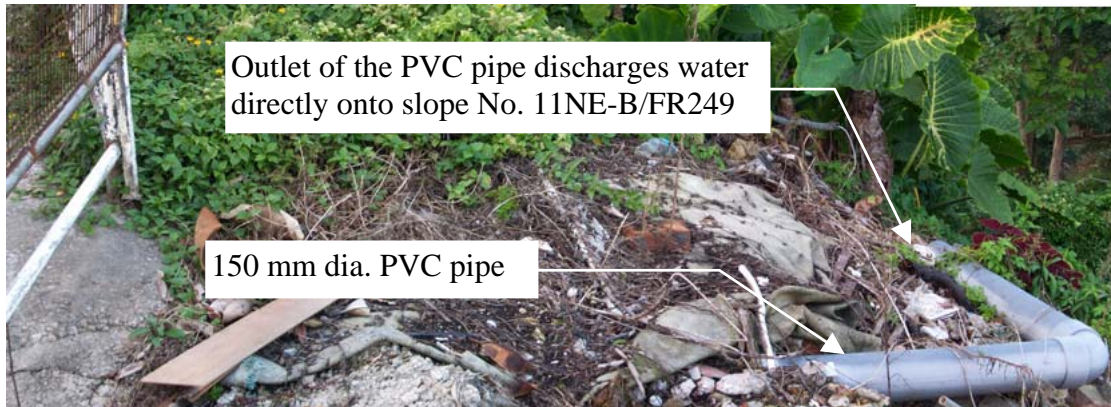
Plate 23 - View of the 150 mm Diameter PVC Pipe on Slope No. 11NE-B/FR249 - Denon Terrace (Photograph taken on 21 December 2001)

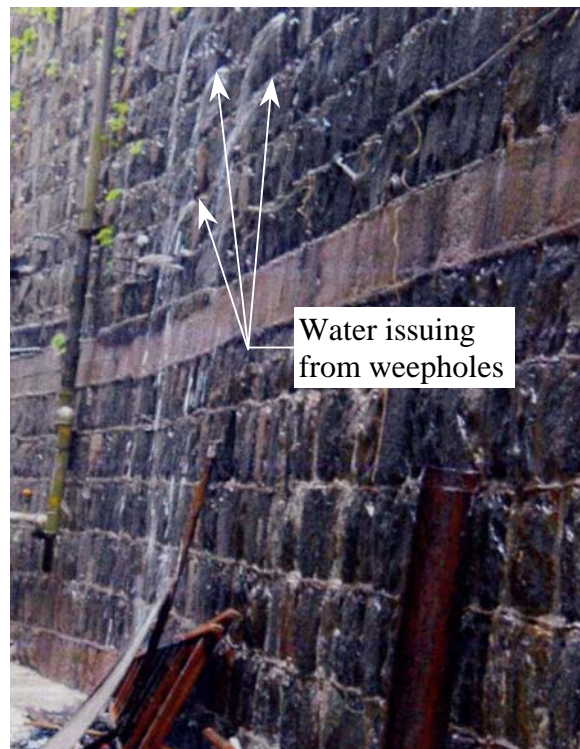
Plate 26 - Close-up View of Water Issuing from the Weepholes of the Masonry Wall - Wyndham Street (Photograph taken on 18 February 2003)

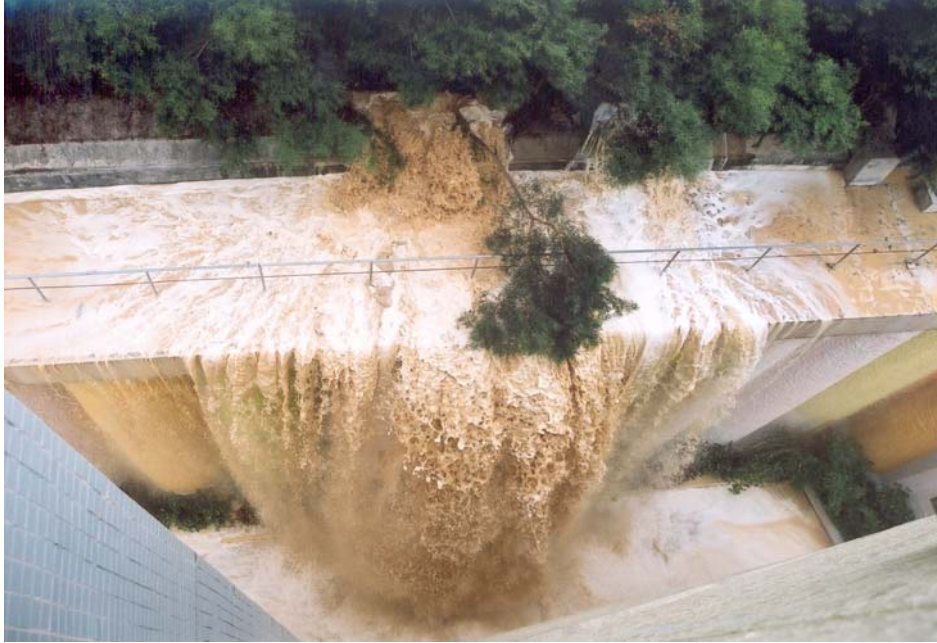
Plate 27 - General View of Muddy Water Discharging
from Slope No. 11NE-D/CR15 - Sau Mau Ping
(Photograph taken on 23 November 2004)

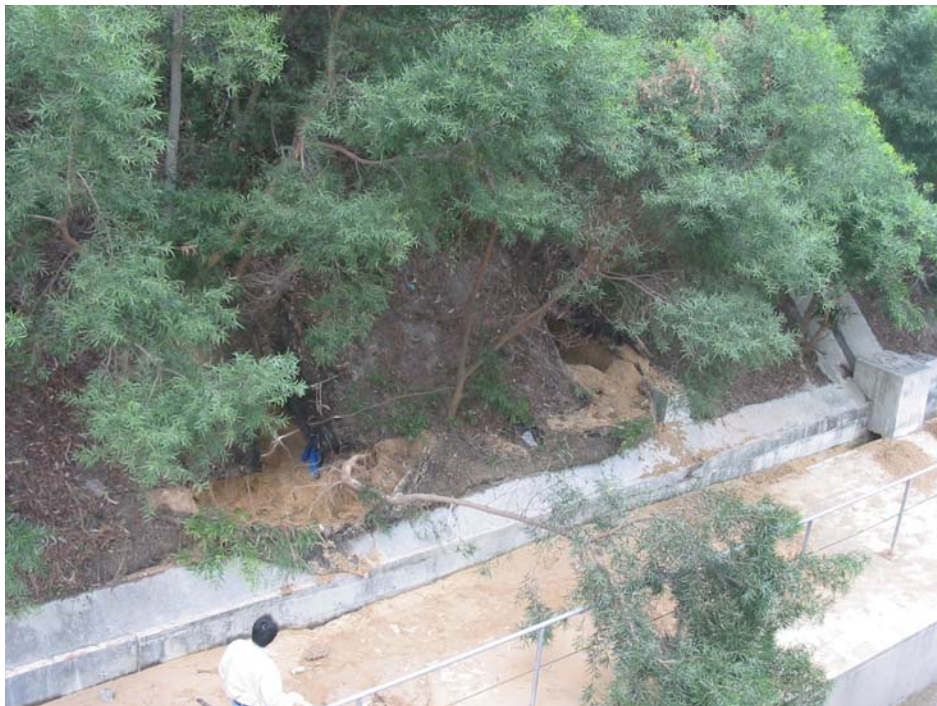
Plate 28 - General View of the Washout Scars at
Slope No. 11NE-D/CR15 - Sau Mau Ping
(Photograph taken on 24 November 2004)

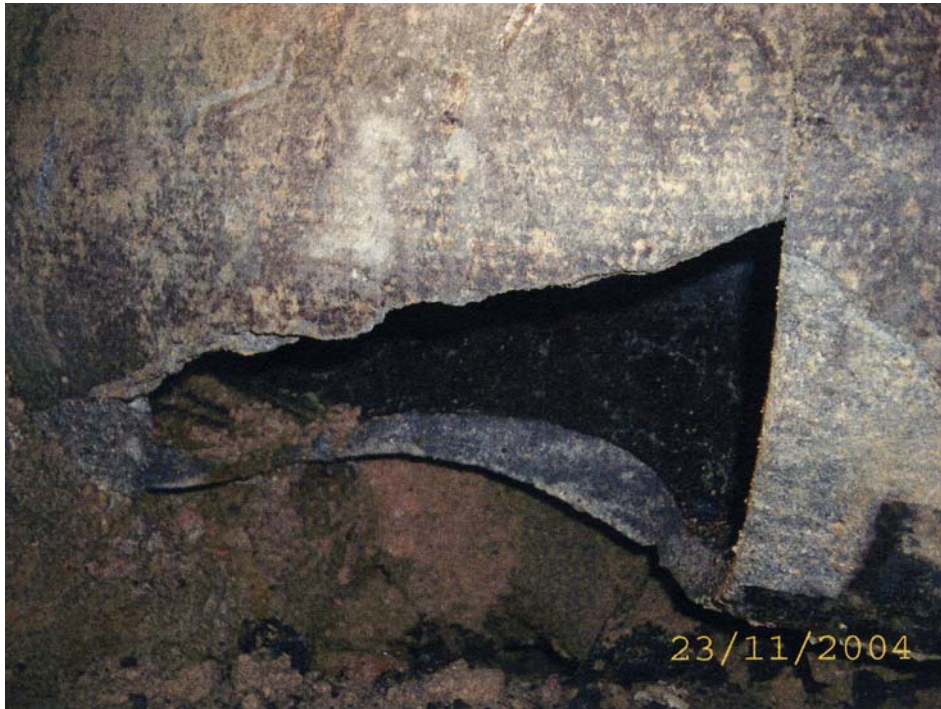
Plate 29 - Close-up View of Broken Saltwater Main - Sau Mau Ping
(Photograph taken on 23 November 2004)

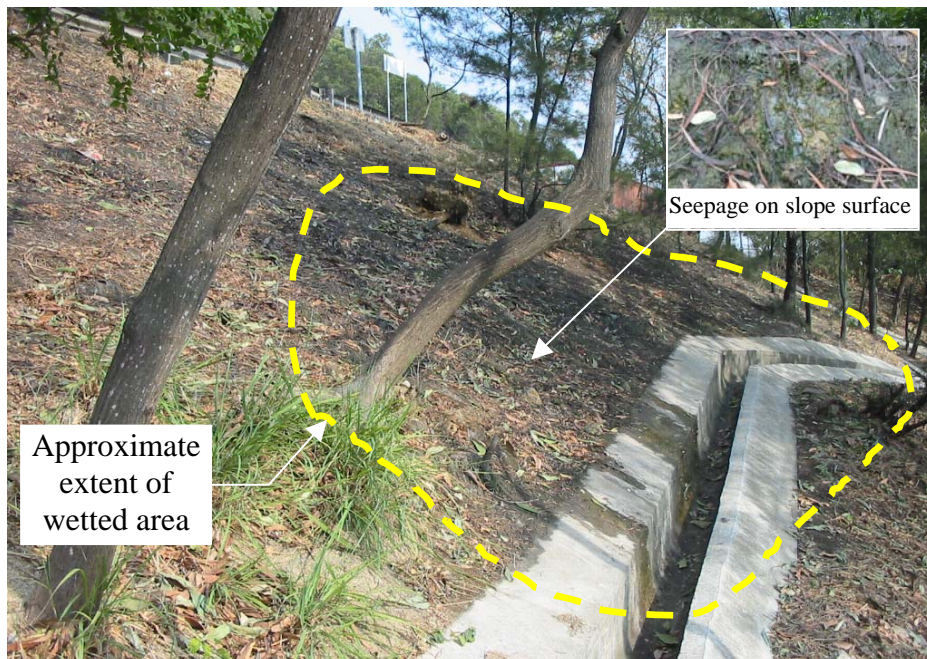
Plate 30 - General View of the Wetted Slope Face of
Slope No. 11NW-A/FR1 - Tai Po Road
(Photograph taken on 6 January 2005)

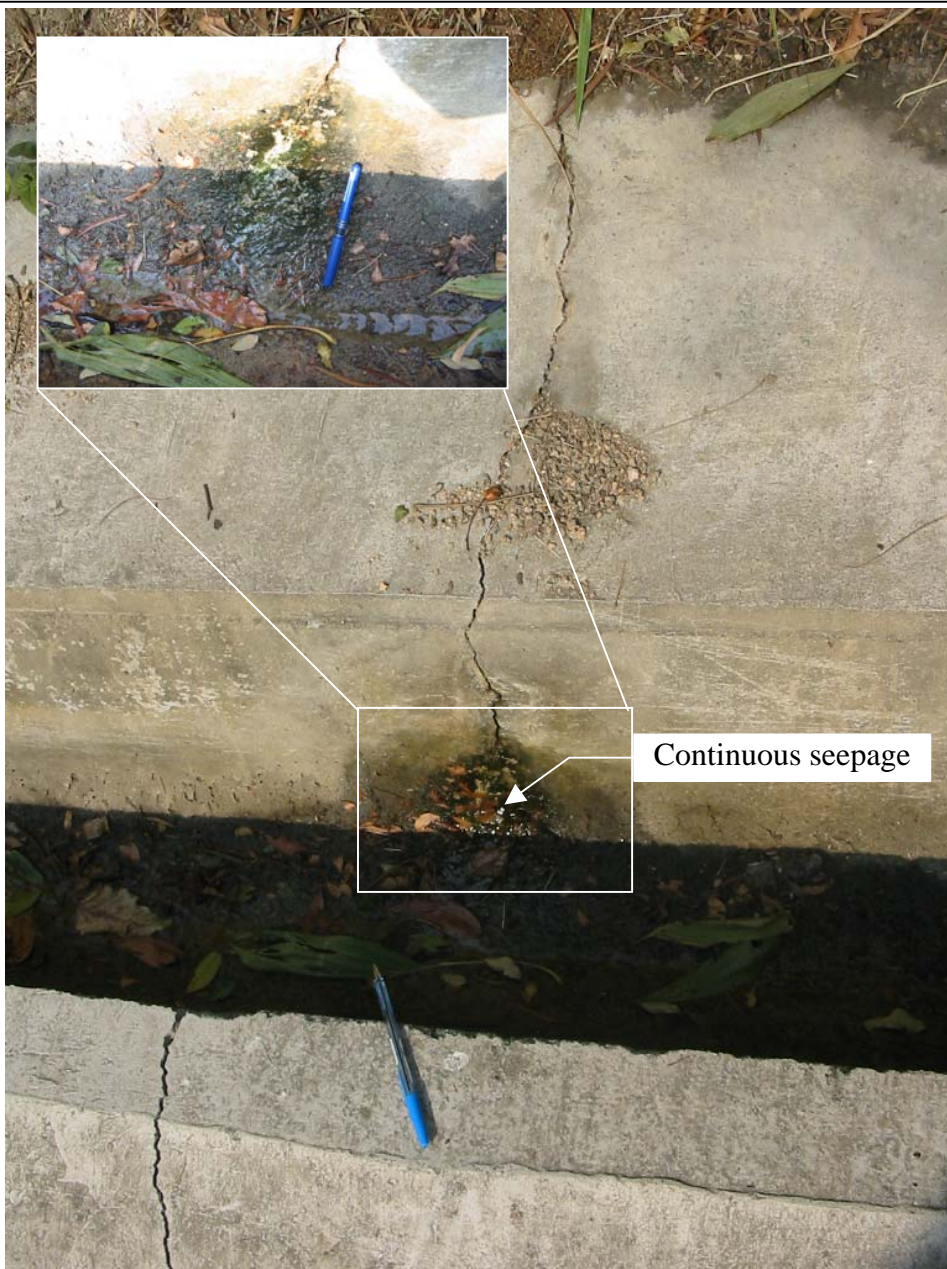
Plate 31 - Continuous Seepage at Cracked Surface Channel - Tai Po Road
(Photograph taken on 6 January 2005)

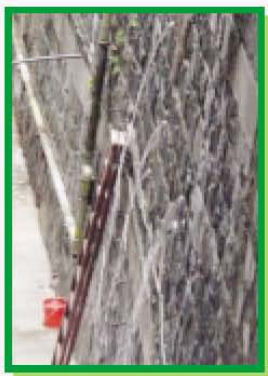
中環雲咸街後巷
護土牆嚴重滲水
