Project Tsing Shan Debris Flow Study

Drawing title Longitudinal Section and Representative Cross Sections of the Debris Flow Scar

**Tsing Shan Debris Flow Study**

**Cross Section of the Debris Deposit (Trenches 1 and 2)**

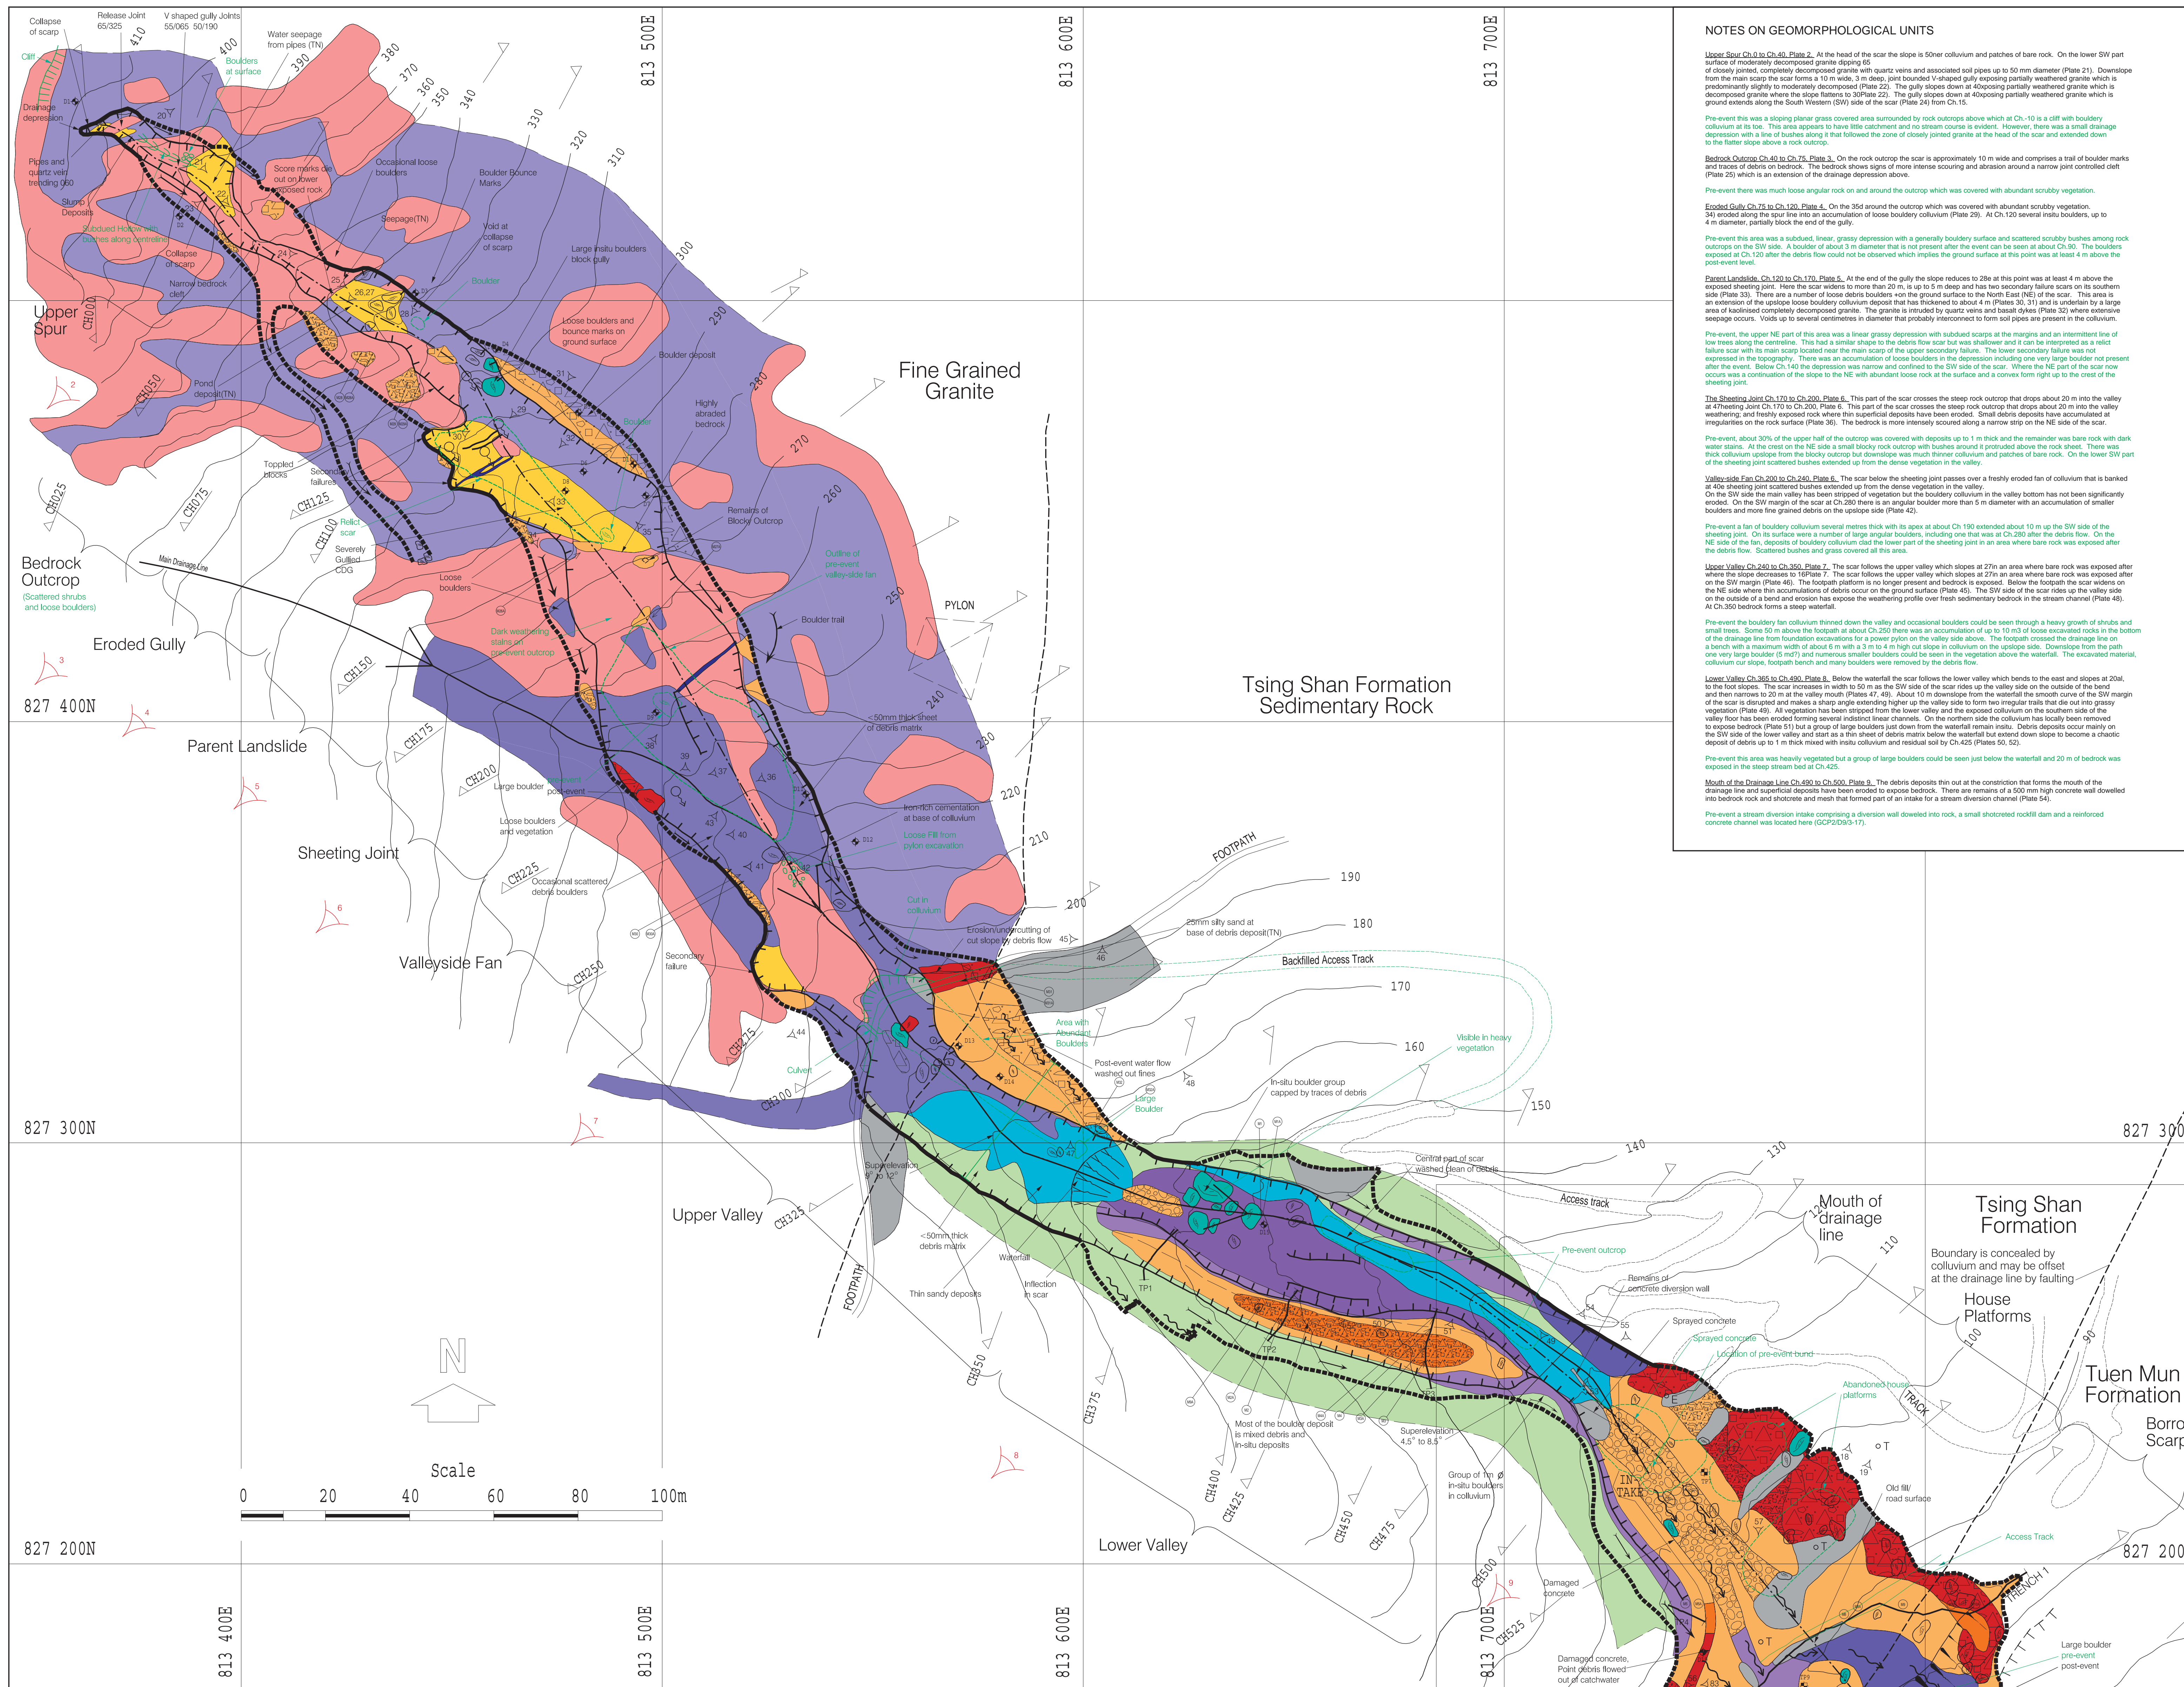
**Upper Spur Ch. 40 to Ch. 40, Plate 2.** At the head of the scar the slope is 50m colluvium and patches of bare rock. On the lower SW part surface of moderately decomposed granite dipping 65° of coarse grained, completely decomposed granite with quartz veins and associated soil pits up to 10m diameter (Plate 21). Downslope from the main scarp the scar forms a 10 m wide, 3 m deep, joint bounded V-shaped gully exposing partially weathered granite which is predominantly slightly to moderately decomposed (Plate 22). The gully slopes down at 40° exposing partially weathered granite which is decomposed granite where the slope features to 30° (Plate 22). The gully slopes down at 40° exposing partially weathered granite which is ground extends along the South Western (SW) side of the scar (Plate 24) from Ch. 15.

**Pre-event** this was a sloping planar grass covered area surrounded by rock outcrops above which at Ch. 10 is a cliff with bouldery colluvium at its top. This area appears to have little dissection and no stream courses is evident. However, there was a small drainage depression with a line of boulders along it that followed the zone of closely jointed granite at the head of the scar and extended down to the faster slope above a rock outcrop.

**Backlog Outcrop Ch. 40 to Ch. 75, Plate 3.** On the rock outcrop the scar is approximately 10 m wide and comprises a trail of boulder marks and traces of debris on bedrock. The bedrock shows signs of more intense scouring and abrasion around a narrow joint controlled cleft (Plate 25) which is an extension of the drainage depression above.

**Pre-event** there was much loose angular rock on and around the outcrop which was covered with abundant scrubby vegetation.

**Enclaved Gully Ch. 75 to Ch. 120, Plate 4.** On the 35d around the outcrop which was covered with abundant scrubby vegetation. 34 eroded along the spur line an accumulation of loose bouldery colluvium (Plate 26). At Ch. 120 several rock boulders, up to 4 m diameter, partially block the end of the gully.

**Parent Landslide Ch. 120 to Ch. 170, Plate 5.** At the end of the gully the slope reduces to 35e at this point was at least 4 m above the exposed sheeting joint. Here the scar widens to more than 20 m, is up to 5 m deep and has two secondary failure scars on its southern side (Plate 30). There are a number of loose debris boulders on the ground surface to the North East (NE) of the scar. This area is an extension of the upper loose bouldery colluvium deposit that has thickened to about 1 m (Plate 26, 31) and underlain by a large area of kaolinitised completely decomposed granite. The granite is intruded by quartz veins and basalt dykes (Plate 32) where extensive seepage occurs. Voids up to several centimetres in diameter that probably interconnected to form soil pipes are present in the colluvium.

**Pre-event**, the upper NE part of this area was a linear grassy depression with subsided scarps at the margins and an intermittent line of low trees along the centreline. This had a similar shape to the debris flow scar but was shallower and it can be interpreted as a relic failure scar with its main scarp to the upper scarp side. The upper scarp side of the depression is a linear depression, expressed in the topography. There was an accumulation of loose boulders in the depression including one very large boulder not present after the event. Below the main scarp the slope is more irregular and the debris flow scar is a convex form right up to the crest of the sheeting joint.

**The Sheeting Joint Ch. 170 to Ch. 200, Plate 6.** This part of the scar crosses the steep rock outcrop that drops about 20 m into the valley at sheeting joint Ch. 170 to Ch. 200, Plate 6. This part of the scar crosses the steep rock outcrop that drops about 20 m into the valley weathering and freshly exposed rock where the superficial deposits have been eroded. Small debris deposits have accumulated at irregularities on the rock surface (Plate 36). The bedrock is more intensely scoured along a narrow strip on the NE side of the scar.

**Pre-event**, about 30% of the upper half of the outcrop was covered with deposits up to 1 m thick and the remainder was bare rock with dark water stains. At the crest on the NE side a small rocky rock outcrop with bushes around it protruded above the rock sheet. There was thick colluvium spilling from the rocky outcrop but down slope was much thinner colluvium and patches of bare rock. On the lower SW part of the sheeting joint scattered bushes extended up from the dense vegetation in the valley.

**Valleyside Fan Ch. 200 to Ch. 240, Plate 6.** The scar below the sheeting joint passes over a freshly eroded fan of colluvium that is banked at the sheeting joint scattered bushes extended up from the dense vegetation in the valley.

**Pre-event**, the main valley has been stripped of vegetation but the bouldery colluvium in the valley bottom has not been significantly eroded. On the SW margin of the scar at Ch. 260 there is an angular boulder more than 5 m diameter with an accumulation of smaller boulders and rock fine grained debris on the upslope side (Plate 42).

**Pre-event** a fan of bouldery colluvium several metres thick with its apex at about Ch. 190 extended about 10 m up the SW side of the sheeting joint. On its surface were a number of large angular boulders, including one that was at Ch. 280 after the debris flow. On the NE side of the fan, deposits of bouldery colluvium clad the lower part of the sheeting joint in an area where bare rock was exposed after the debris flow. Scattered bushes and grass covered this area.

**Upper Valley Ch. 240 to Ch. 350, Plate 7.** The scar follows the upper valley which slopes at 27° in an area where bare rock was exposed after the debris flow (Plate 43). The scar follows the upper valley which slopes at 27° in an area where bare rock was exposed after the debris flow (Plate 43). The footpath platform is no longer present and bedrock is exposed. Below the footpath the drainage line on the NE side where the accumulations of debris occur on the ground surface (Plate 43). The SW side of the scar rises up the valley side on the outside of a bend and erosion has exposed the weathering profile over fresh sedimentary bedrock in the stream channel (Plate 48). At Ch. 350 bedrock forms a steep waterfall.

**Pre-event** the bouldery fan colluvium thinned down the valley and occasional boulders could be seen through a heavy growth of shrubs and small trees. Some 50 m above the footpath at about Ch. 260 there was an accumulation of up to 10 m of loose excavated rocks in the bottom of the drainage line from foundation excavations for a power pylon on the valley side above. The footpath crossed the drainage line on a bench with a maximum width of about 6 m in a 3 m x 4 m high cut slope in colluvium on the upslope side. Downslope from the path, one very large boulder (5 m x 7 m) and numerous smaller boulders could be seen in the vegetation above the waterfall. The excavated material, colluvium cut slope, footpath bench and many boulders were removed by the debris flow.

**Lower Valley Ch. 350 to Ch. 450, Plate 8.** Below the waterfall the scar follows the lower valley which bends to the east and slopes at 20° to the foot slopes. The scar increases in width to 50 m as the SW side of the scar rises up the valley side on the outside of the bend and then narrows to 20 m at the valley mouth (Plate 47, 48). About 10 m downslope from the waterfall the smooth curve of the SW margin of the scar is disrupted and makes a sharp angle extending higher up the valley side to form two angular trails that die out into grassy vegetation (Plate 49). All vegetation has been stripped from the lower valley and the exposed colluvium on the southern side of the valley floor has been eroded forming several isolated linear channels. On the northern side the colluvium has locally been removed to expose bedrock (Plate 51) but a group of large boulders just down from the waterfall remain in situ. Debris deposits occur mainly on the SW side of the lower valley and start as a thin sheet of debris mats below the waterfall but extend down slope to become a chaotic deposit of debris up to 1 m thick mixed with in situ colluvium and residual soil by Ch. 425 (Plate 50, 52).

**Pre-event** this area was heavily vegetated but a group of large boulders could be seen just below the waterfall and 20 m of bedrock was exposed in the steep stream bed at Ch. 425.

**Mouth of the Drainage Line Ch. 450 to Ch. 500, Plate 9.** The debris deposits thin out at the concretion that forms the mouth of the drainage line and superficial deposits have been eroded to expose bedrock. There are remains of a 500 mm high concrete wall dowelled into bedrock rock and shuttered and mesh that formed part of an intake for a stream diversion channel (Plate 54).

**Pre-event** a stream diversion intake comprising a diversion wall dowelled into rock, a small precast rock dam and a reinforced concrete channel was located here (GP2/2/3/17).

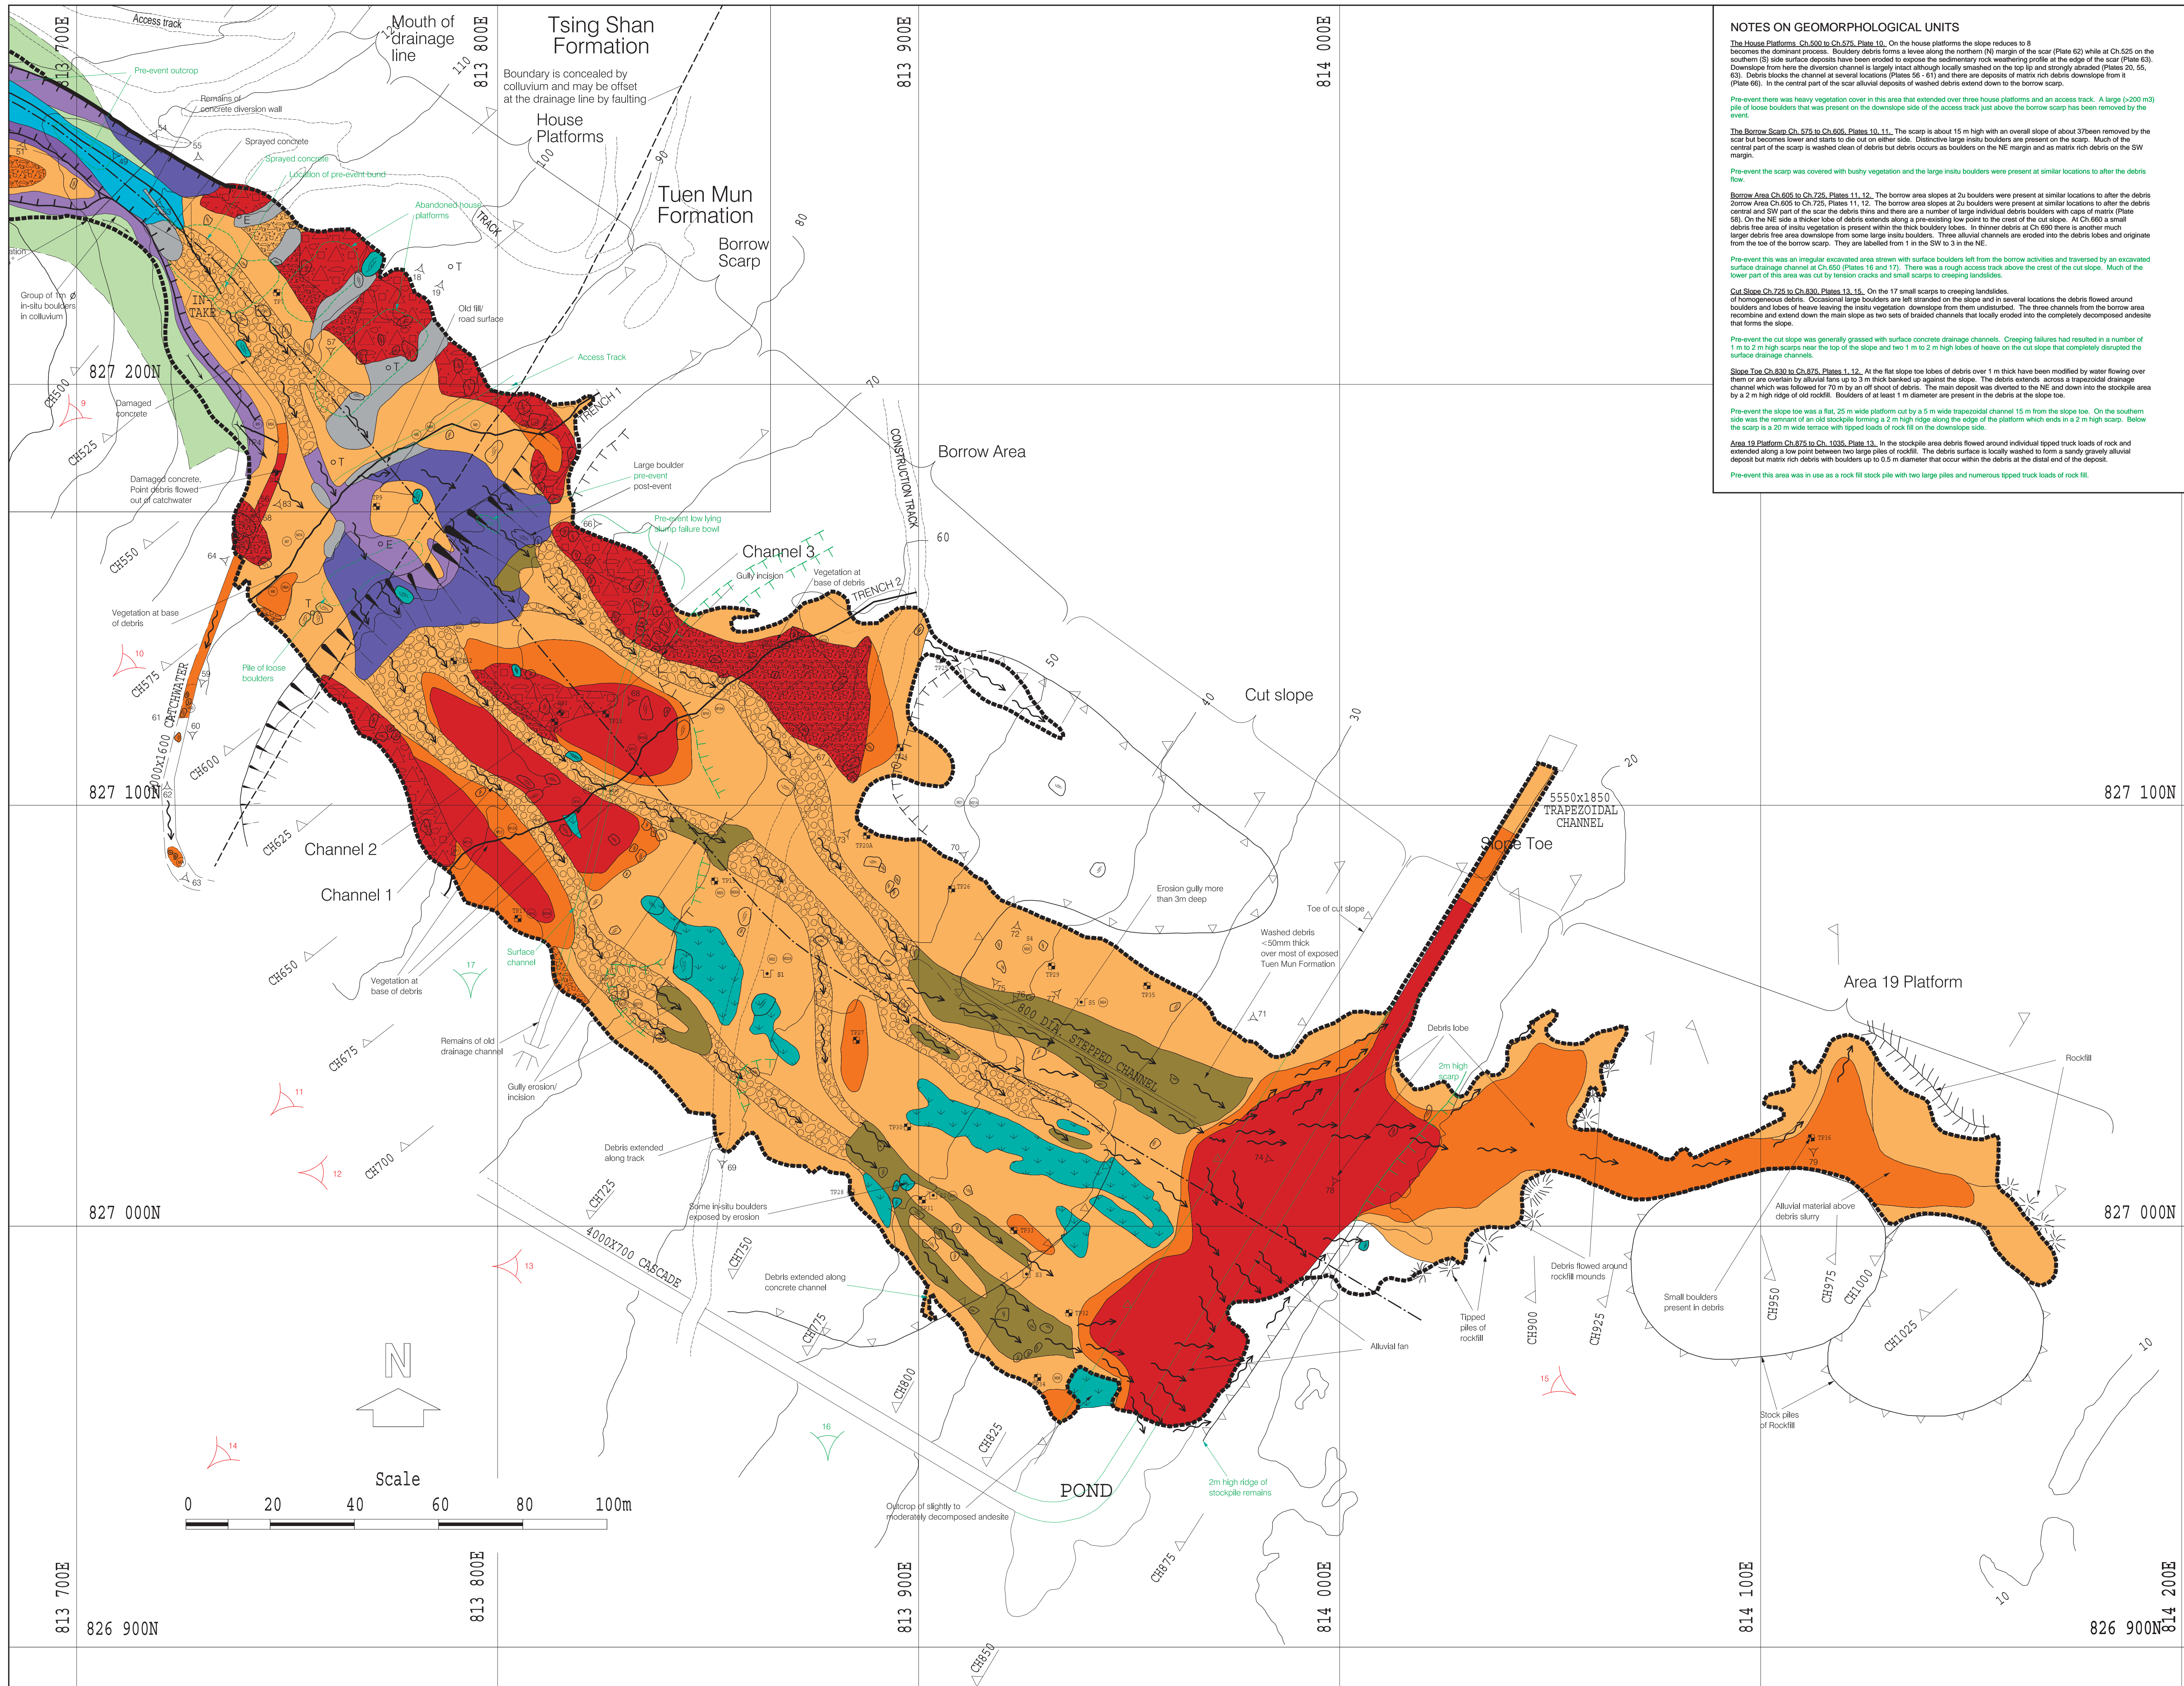
**The House Platforms Ch. 500 to Ch. 575, Plate 10.** On the house platforms the slope reduces to 8 becomes the dominant process. Boundary debris forms a levee along the northern (N) margin of the scar (Plate 62) while at Ch. 525 on the southern (S) side surface deposits have been eroded to expose the sedimentary rock weathering profile at the edge of the scar (Plate 63). Downslope from here the diversion channel is largely intact although locally smoothed on the top to and strongly abraded (Plates 20, 55, 63). Debris blocks the channel at several locations (Plates 56 - 61) and there are deposits of matrix rich debris downslope from it (Plate 66). In the central part of the scar alluvial deposits of washed debris extend down to the borrow scarp.

**Pre-event there was heavy vegetation cover in this area that extended over three house platforms and an access track. A large (>200 m<sup>2</sup>) pile of loose boulders that was present on the downslope side of the access track just above the borrow scarp has been removed by the event.**

**The Borrow Scarp Ch. 675 to Ch. 695, Plates 10, 11.** The scarp is about 15 m high with an overall slope of about 37° been removed by the scar but becomes lower and starts to die out on either side. Distinctive large insitu boulders are present on the scarp. Much of the central part of the scarp is washed clean of debris but debris occurs as boulders on the NE margin and as matrix rich debris on the SW margin.

**Pre-event the scarp was covered with bushy vegetation and the large insitu boulders were present at similar locations to after the debris flow.**

**Borrow Area Ch. 695 to Ch. 725, Plates 11, 12.** The borrow area slopes at 2u boulders were present at similar locations to after the debris flow Area Ch. 695 to Ch. 725, Plates 11, 12. The borrow area slopes at 2u boulders were present at similar locations to after the debris central and SW part of the scar the debris there and there are a number of large individual debris boulders with caps of matrix (Plate 58). On the NE side a thicker lobe of debris extends along a pre-existing low point to the crest of the out slope. At Ch. 660 a small debris free area of insitu vegetation is present within the thick boundary lobes. In thinner debris at Ch. 690 there is another much larger debris free area downslope from some large insitu boulders. These alluvial channels are eroded into the debris lobes and originate from the toe of the borrow scarp. They are labelled from 1 in the SW to 3 in the NE.

**Pre-event this was an irregular excavated area strewn with surface boulders left from the borrow activities and traversed by an excavated surface drainage channel at Ch. 650 (Plates 16 and 17). There was a rough access track above the crest of the cut slope. Much of the lower part of this area was cut by tension cracks and small scarps to creeping landslides.**

**Cut Slope Ch. 725 to Ch. 830, Plates 13, 15.** On the 17 small scarps to creeping landslides of homogeneous debris. Occasional large boulders are left stranded on the slope and in several locations the debris flowed around boulders and lobes of heavy leaving the insitu vegetation downslope from them undisturbed. The three channels from the borrow area recuttable and extend down the main slope as two sets of braided channels that locally eroded into the completely decomposed andesite that forms the slope.

**Pre-event the cut slope was generally grassed with surfaced concrete drainage channels. Creeping failures had resulted in a number of 1 m to 2 m high scarps near the toe of the slope and two 1 m to 2 m high lobes of heavy on the cut slope that completely denuded the surface drainage channels.**

**Slope Toe Ch. 830 to Ch. 875, Plates 13, 12.** At the flat slope toe lobes of debris over 1 m thick have been modified by water flowing over them or are overlain by alluvial fans up to 3 m thick banked up against the slope. The debris extends across a trapezoidal drainage channel which was followed for 70 m by an off-shoot of debris. The main deposit was directed to the NE and down into the stockpile area by a 2 m high ridge of old rockfill. Boulders of at least 1 m diameter are present in the debris at the slope toe.

**Pre-event the slope toe was a flat, 25 m wide platform cut by a 5 m wide trapezoidal channel 15 m from the slope toe. On the southern side was the remnant of an old stockpile forming a 2 m high ridge along the edge of the platform which ends in a 2 m high scarp. Below the scarp is a 20 m wide terrace with spaced loads of rock fill on the downslope side.**

**Area 19 Platform Ch. 875 to Ch. 1035, Plate 13.** In the stockpile area debris flowed around individual tipped truck loads of rock and extended along a low point between two large piles of rockfill. The debris surface is locally washed to form a sandy gravelly alluvial deposit but matrix rich debris with boulders up to 0.5 m diameter that occur within the debris at the distal end of the deposit.

**Pre-event this area was in use as a rock fill stock pile with two large piles and numerous tipped truck loads of rock fill.**

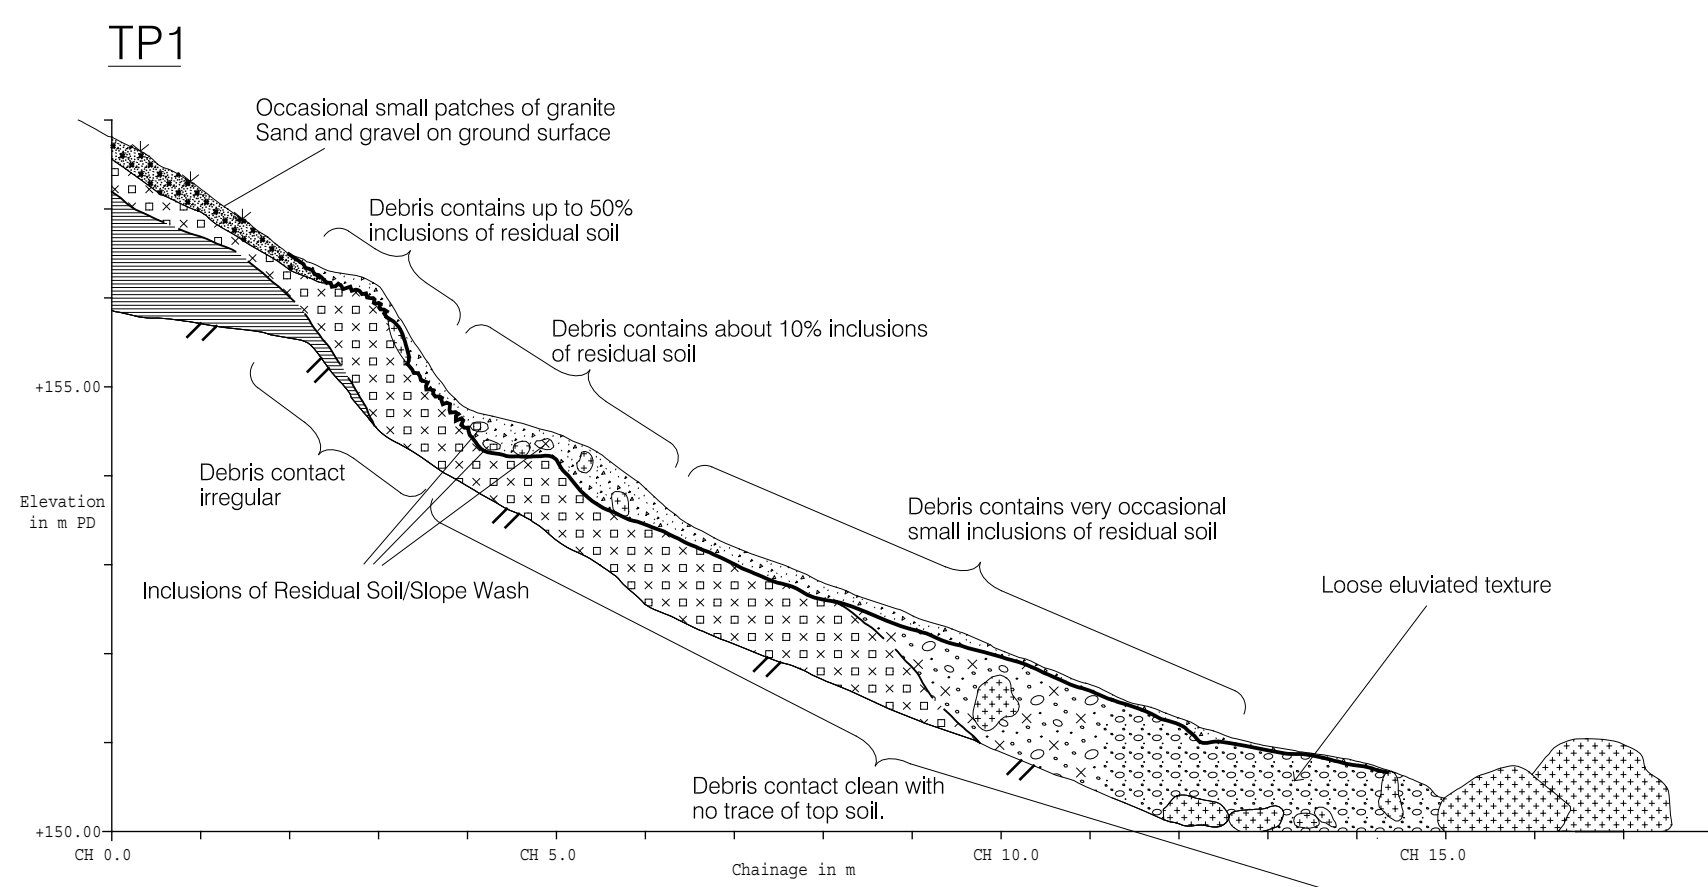
- Loose, greyish brown, slightly clayey, silty, very gravelly SAND with rounded to sub angular granite cobbles and very occasional angular gravel and cobbles of sedimentary rock. Locally with 5mm to 30mm inclusions of orange-brown residual soil. (Debris class 1)

- Firm to stiff, dark brown, clayey sandy SILT with angular gravel of slightly to moderately decomposed sedimentary rock. Many roots are present. (Top soil)

- Stiff, orangeish brown, sandy clayey SILT with many angular gravel and cobble sized clasts of slightly to moderately decomposed sedimentary rock. Grades downwards into weathered sedimentary rock. (Residual soil/slope wash)

- Firm to stiff, orangeish brown, sandy clayey SILT with many angular gravel and cobble sized clasts of slightly to moderately decomposed sedimentary rock and occasional rounded cobbles and small boulders of slightly decomposed to fresh granite. (Lower Valley Colluvium)  
The granite clasts become more numerous towards the valley bottom and the loose eluviated texture implies a high permeability and a region of piping/through flow of groundwater. (Channel deposit)

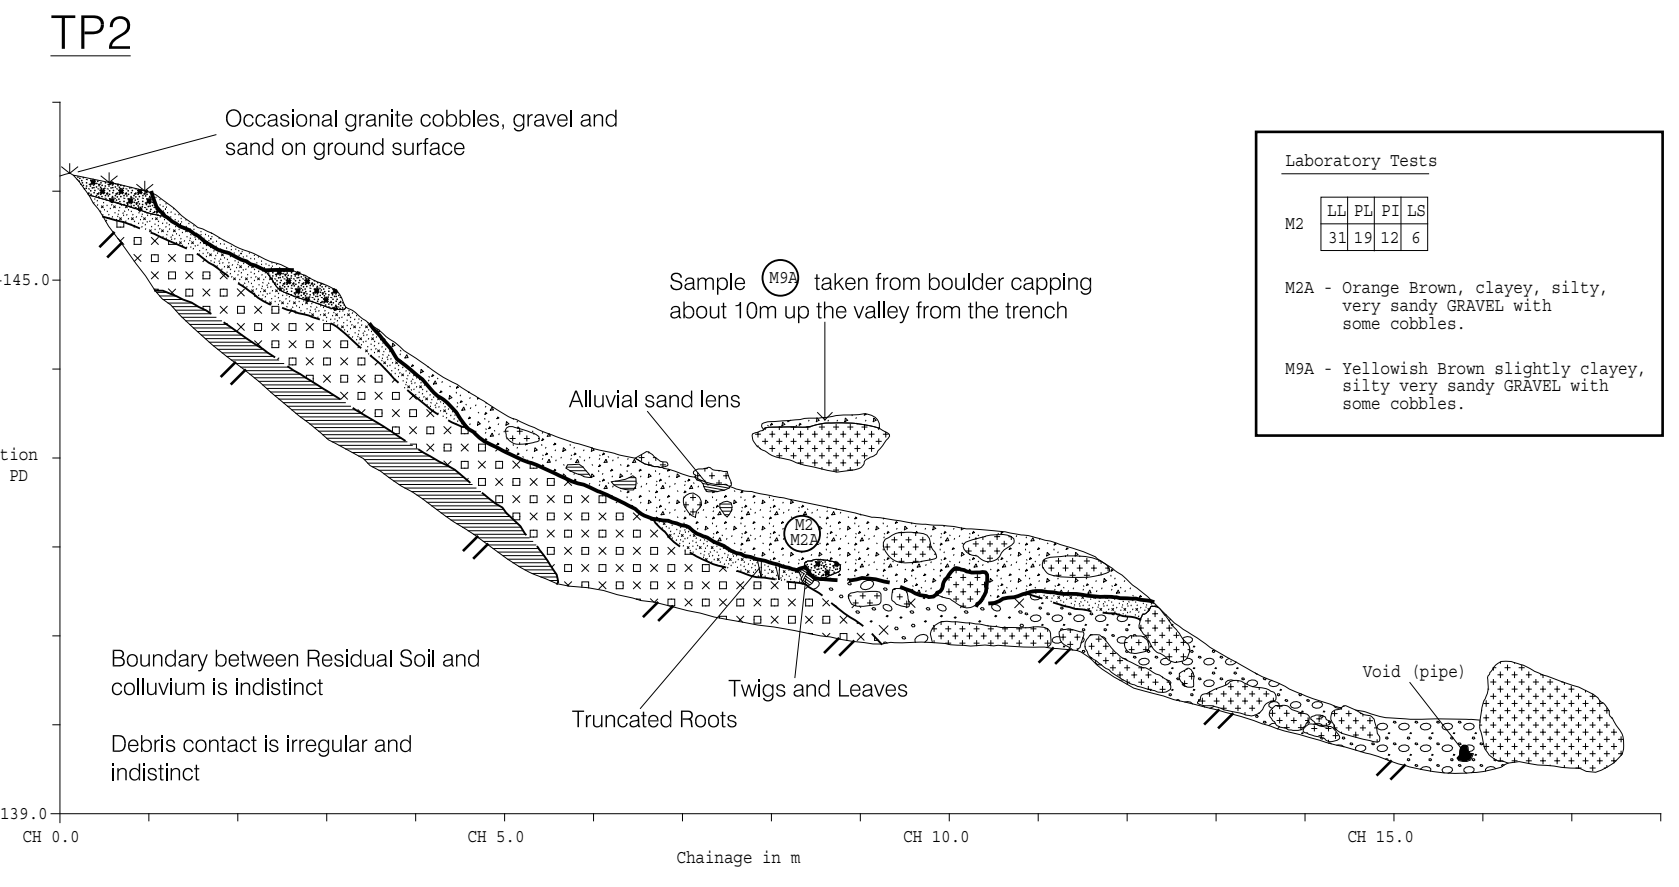
- Loose, brown, silty SAND with granite gravel. (Debris class 1 debris/trail)
- Loose, brown, silty gravelly SAND (Debris) with 5mm to 50mm inclusions of orangeish brown clayey sandy SILT (residual soil), sub rounded cobbles and boulders of slightly decomposed to fresh granite and occasional angular gravel of slightly to moderately decomposed sedimentary rock. Twigs roots and leaves are present mixed with the deposit and locally concentrated. (Debris class 2)

- Firm to stiff, dark brown, clayey sandy SILT with angular gravel of slightly to moderately decomposed sedimentary rock. Many roots are present. (Top soil)

- Stiff, light yellow-brown, sandy SILT. Locally grades up into topsoil and down into residual soil or colluvium. (Lower topsoil profile)
- Stiff, orangeish brown, sandy clayey SILT with many angular gravel and cobble sized clasts of slightly to moderately decomposed sedimentary rock. Grades downwards into weathered sedimentary rock. (Residual soil/slope wash)

- Firm to stiff, orangeish brown, sandy clayey SILT with many angular gravel and cobble sized clasts of slightly to moderately decomposed sedimentary rock and occasional rounded cobbles and small boulders of slightly decomposed to fresh granite. (Lower Valley Colluvium)  
The granite clasts become more numerous towards the valley bottom. (Channel Deposit)

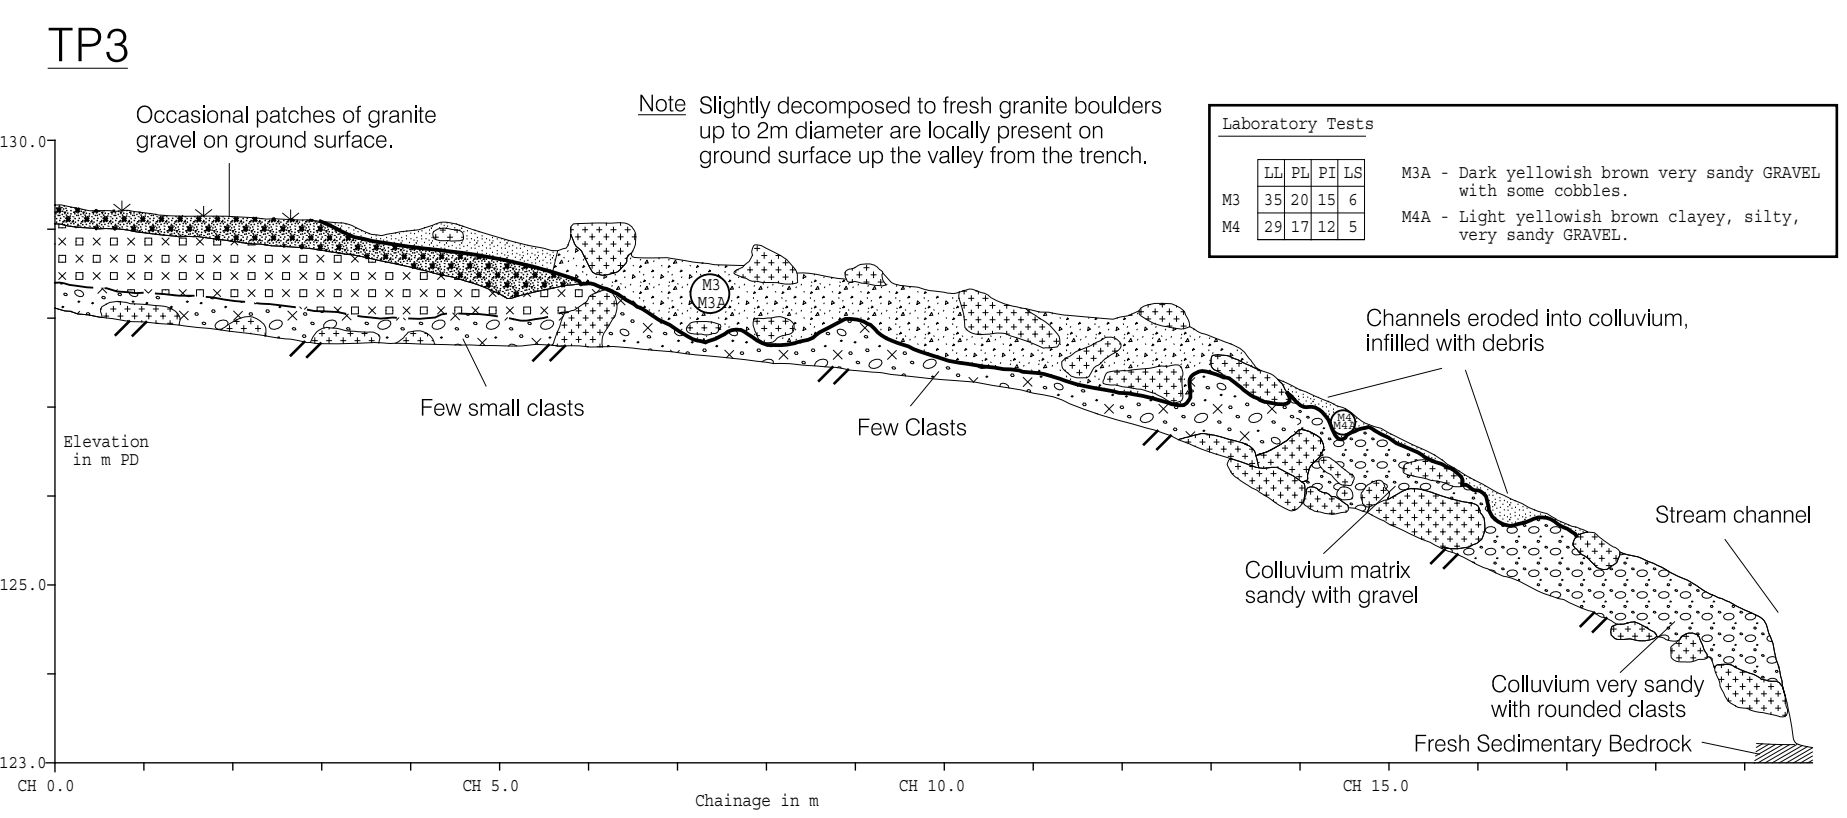
- Loose, light-brown, clayey silty very gravelly sand with occasional small inclusion of orangeish brown silt (Debris class 1).
- Loose, dark brown with orange flecks and streaks, clayey sandy SILT with many sub-rounded cobbles and boulders of slightly decomposed to fresh granite and angular gravel of slightly to moderately decomposed sedimentary rock, and inclusion of orangeish brown silt. (Mixed colluvium, residual soil and debris - debris class 2)

- Firm to stiff, light brown, clayey sandy SILT with angular gravel of slightly to moderately decomposed sedimentary rock. Many roots are present. (Top soil)

- Firm to stiff, orangeish brown, sandy clayey SILT with many angular gravel and cobble sized clasts of slightly to moderately decomposed sedimentary rock. Grades up into topsoil and down into colluvium. (Slope wash?)

- Firm to stiff, orangeish brown, sandy SILT with many rounded to sub-angular boulders of slightly decomposed to fresh granite and gravel and cobble sized clasts of slightly to moderately decomposed sedimentary rock and granite. (Lower Valley Colluvium)  
Becomes clast supported and very sandy towards valley bottom. (Channel Deposit)

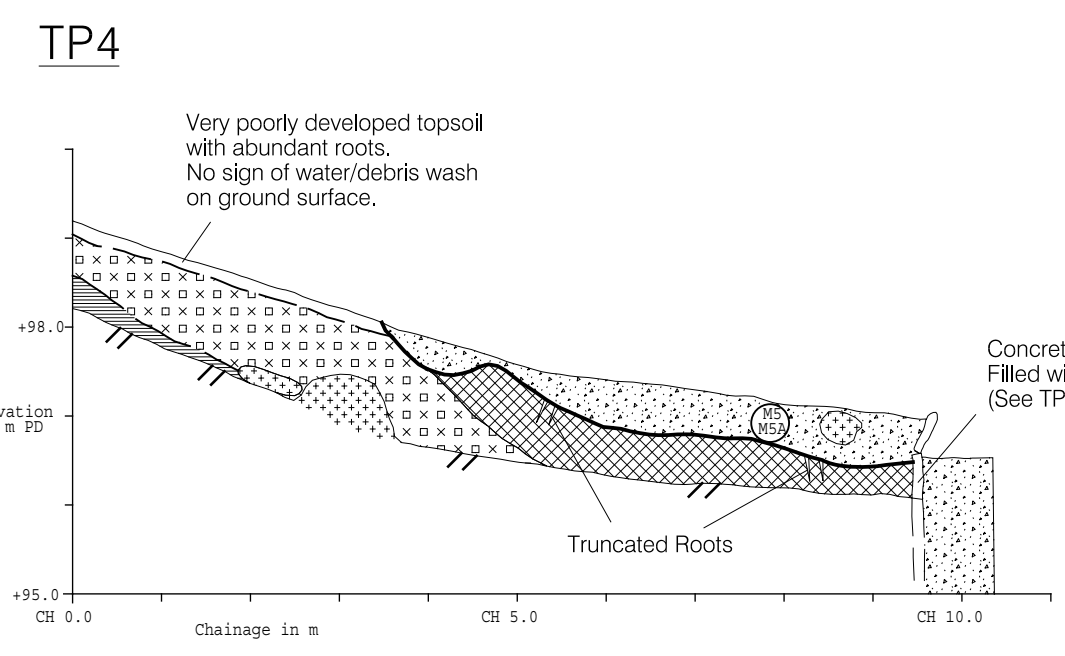
- Loose, brown very silty SAND with many rounded to sub angular gravel, cobble and small boulder sized clasts of slightly decomposed to fresh granite and some angular gravel and cobble sized clasts of slightly to moderately decomposed sedimentary rock. (Debris class 1)
- Firm to stiff, orangeish brown, clayey SILT with some angular gravel and cobble sized clasts of slightly to moderately decomposed sedimentary rock. (Slope wash?)  
Two large slightly decomposed to fresh granite boulders are present at the base? of the deposit. (Lower Valley Colluvium?)
- Soft to firm greenish-yellow clayey SILT with occasional orange brown clayey SILT inclusions, cobbles of sedimentary rock, steel bars and geofabric fragments. (Fill)
