# **Detailed Study of the 8 and 14 September 2023 Landslides on Slope No. 11SE-D/F47 at Shek O Road, Shek O**

**GEO Report No. 376**

**Fugro (Hong Kong) Limited**

**Geotechnical Engineering Office  
Civil Engineering and Development Department  
The Government of the Hong Kong  
Special Administrative Region**

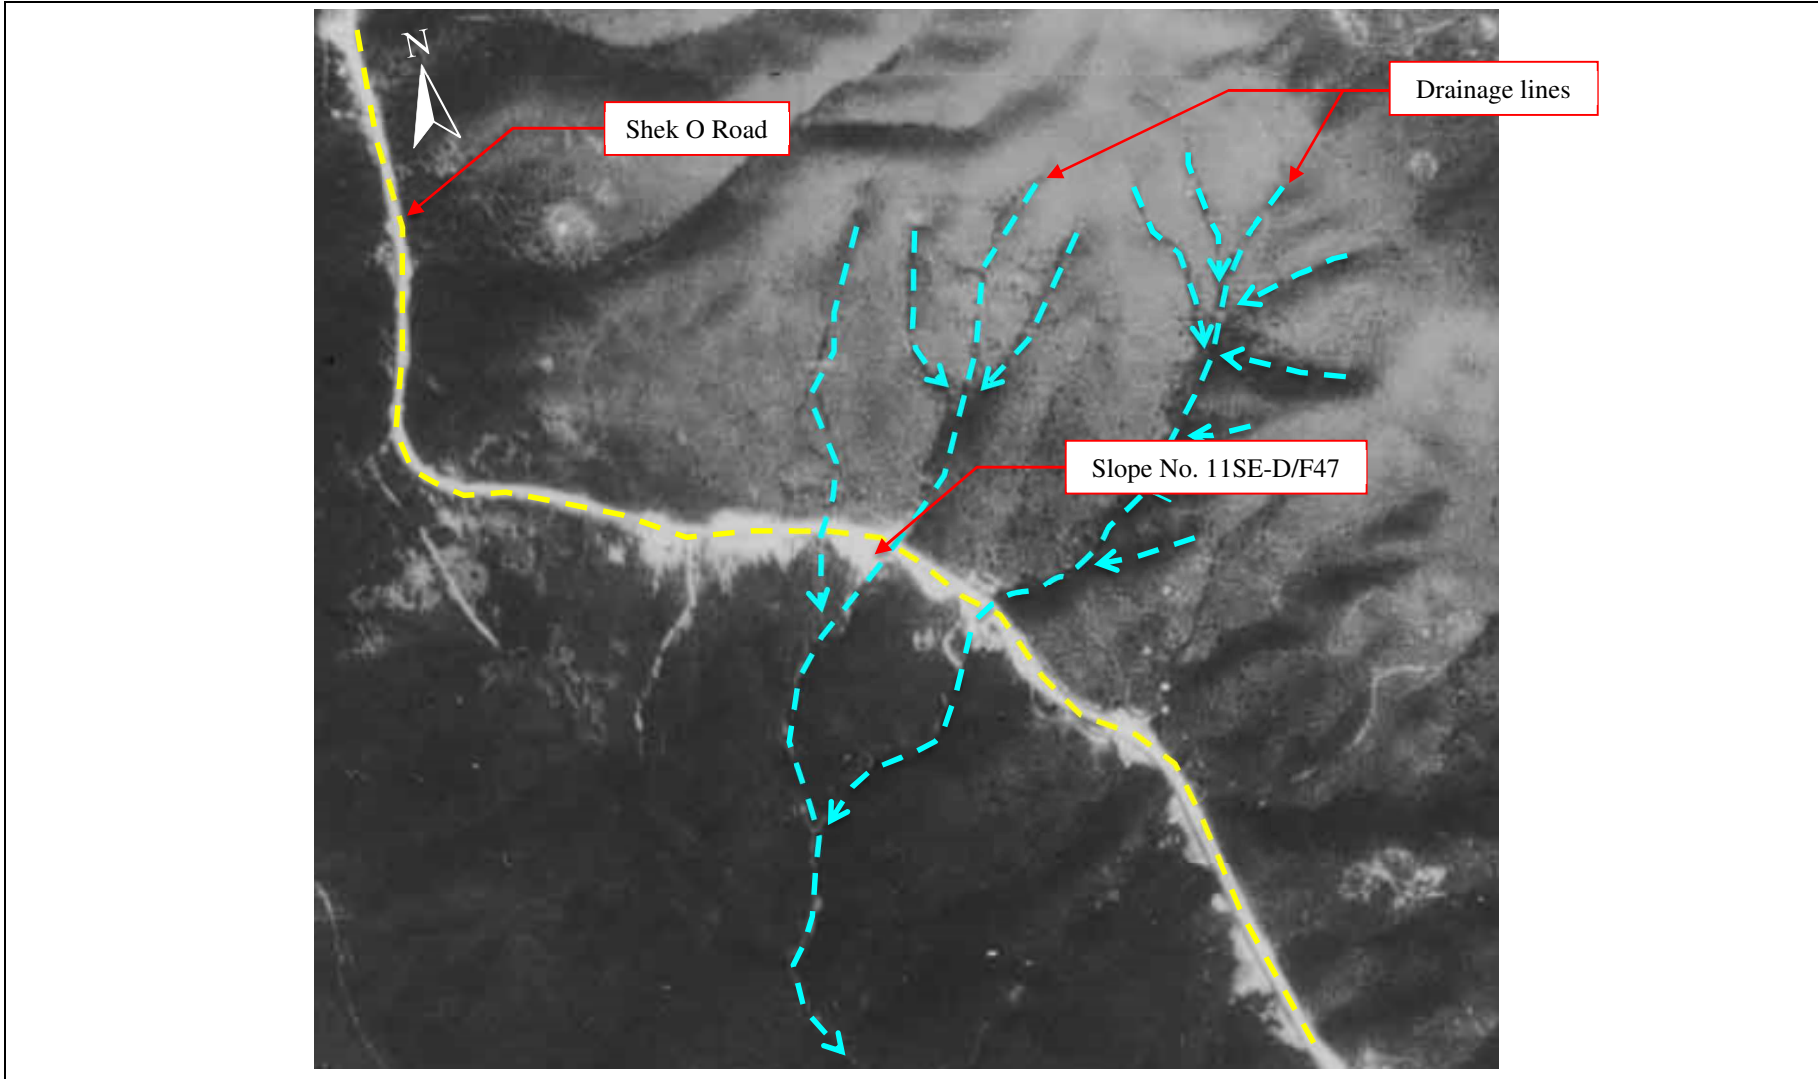
**Figure 3.1 Aerial Photographs Taken in 1924**

The earliest available aerial photographs taken in 1924 show that the fill slope was formed during the construction of Shek O Road (Figure 3.1). The hillside above the fill slope was covered with moderately dense vegetation. It had a concave terrain with several well-defined drainage lines that trended to the southwest in a dendritic pattern. The fill slope was located in a valley that was bounded by steep south- to southwest-sloping, rounded spurlines. The rocky natural stream course descended from the natural hillside to the fill slope.

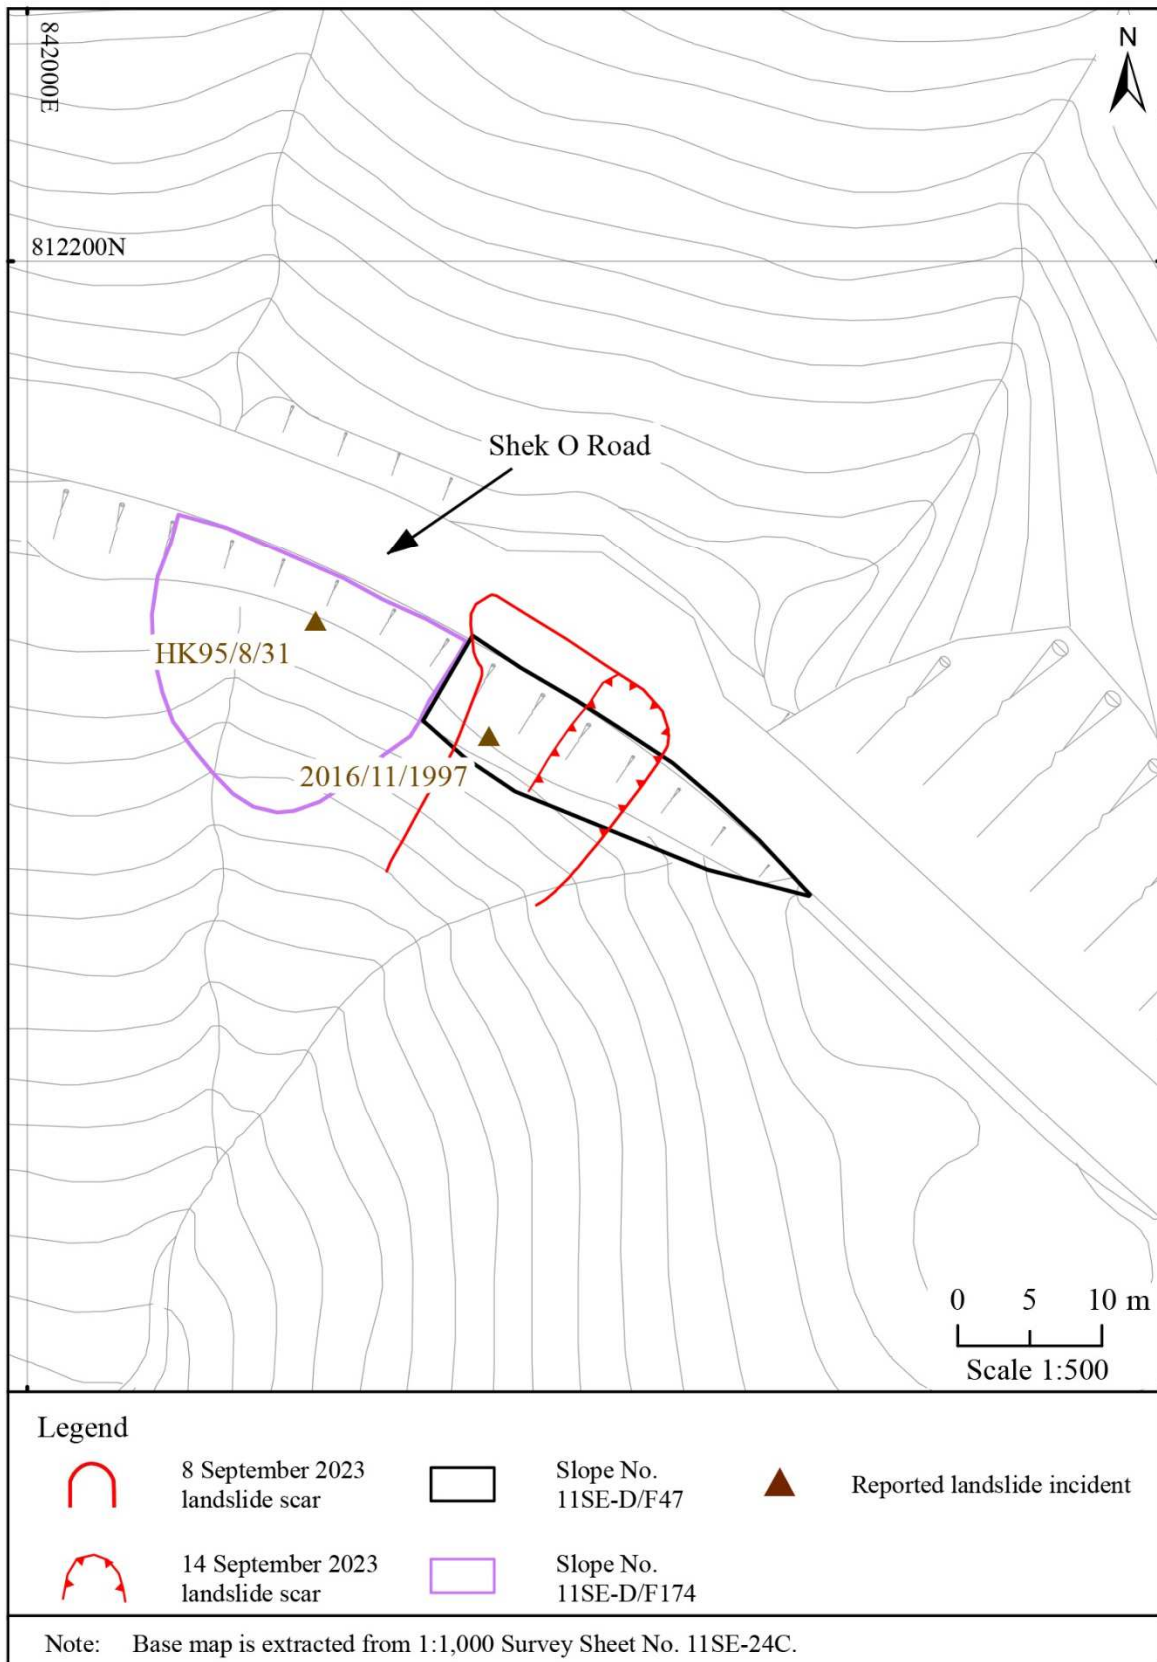
**Figure 3.2 Past Slope Instabilities**

The GEO's landslide database shows that two reported landslide incidents, namely Incident Nos. HK95/8/31 and 2016/11/1997, occurred near the landslide site (Figure 3.2).

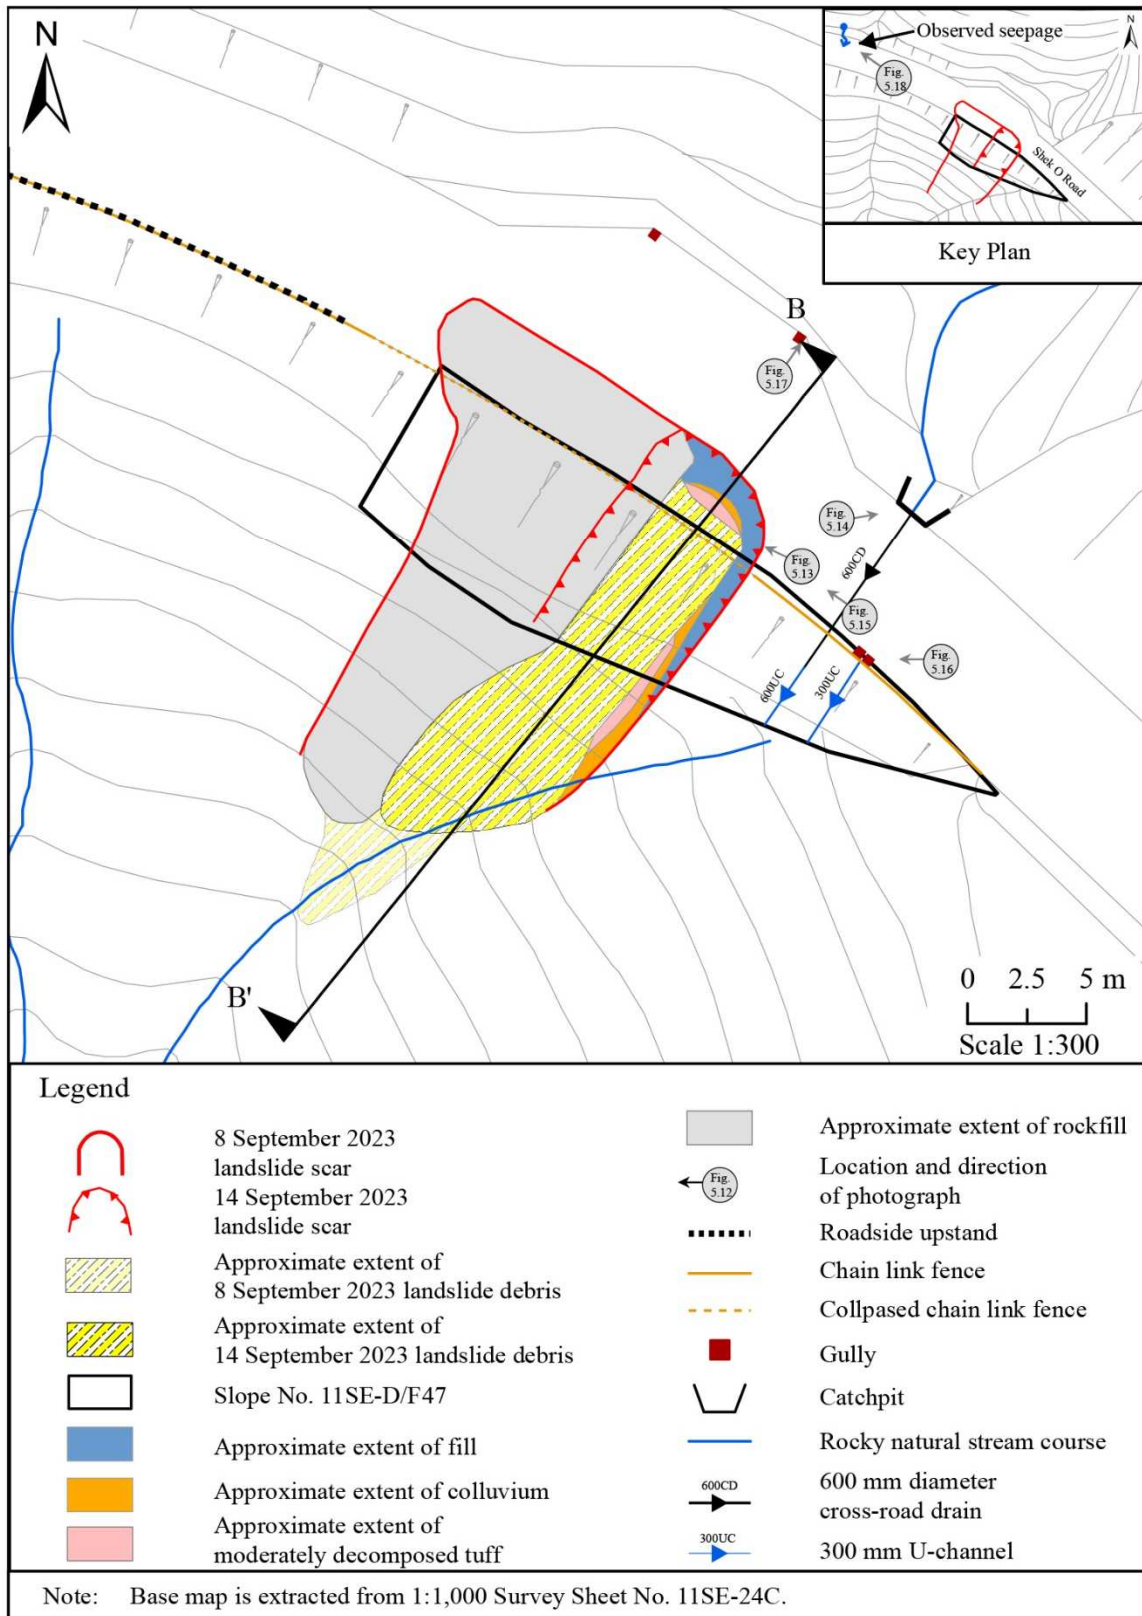
**Figure 5.10 Post-landslide Observations of the Landslide Scar on 14 September 2023**

On 14 September 2023, another landslide occurred at the fill slope, affecting the rockfill placed as part of the emergency repair works following the previous landslide on 8 September 2023. The landslide was a washout failure of the rockfill and the underlying fill and colluvium (Figures 5.10 and 5.11). The landslide originated from the newly placed rockfill with a gradient of about  $50^\circ$ , and an estimated failure volume was about  $126 \text{ m}^3$ .

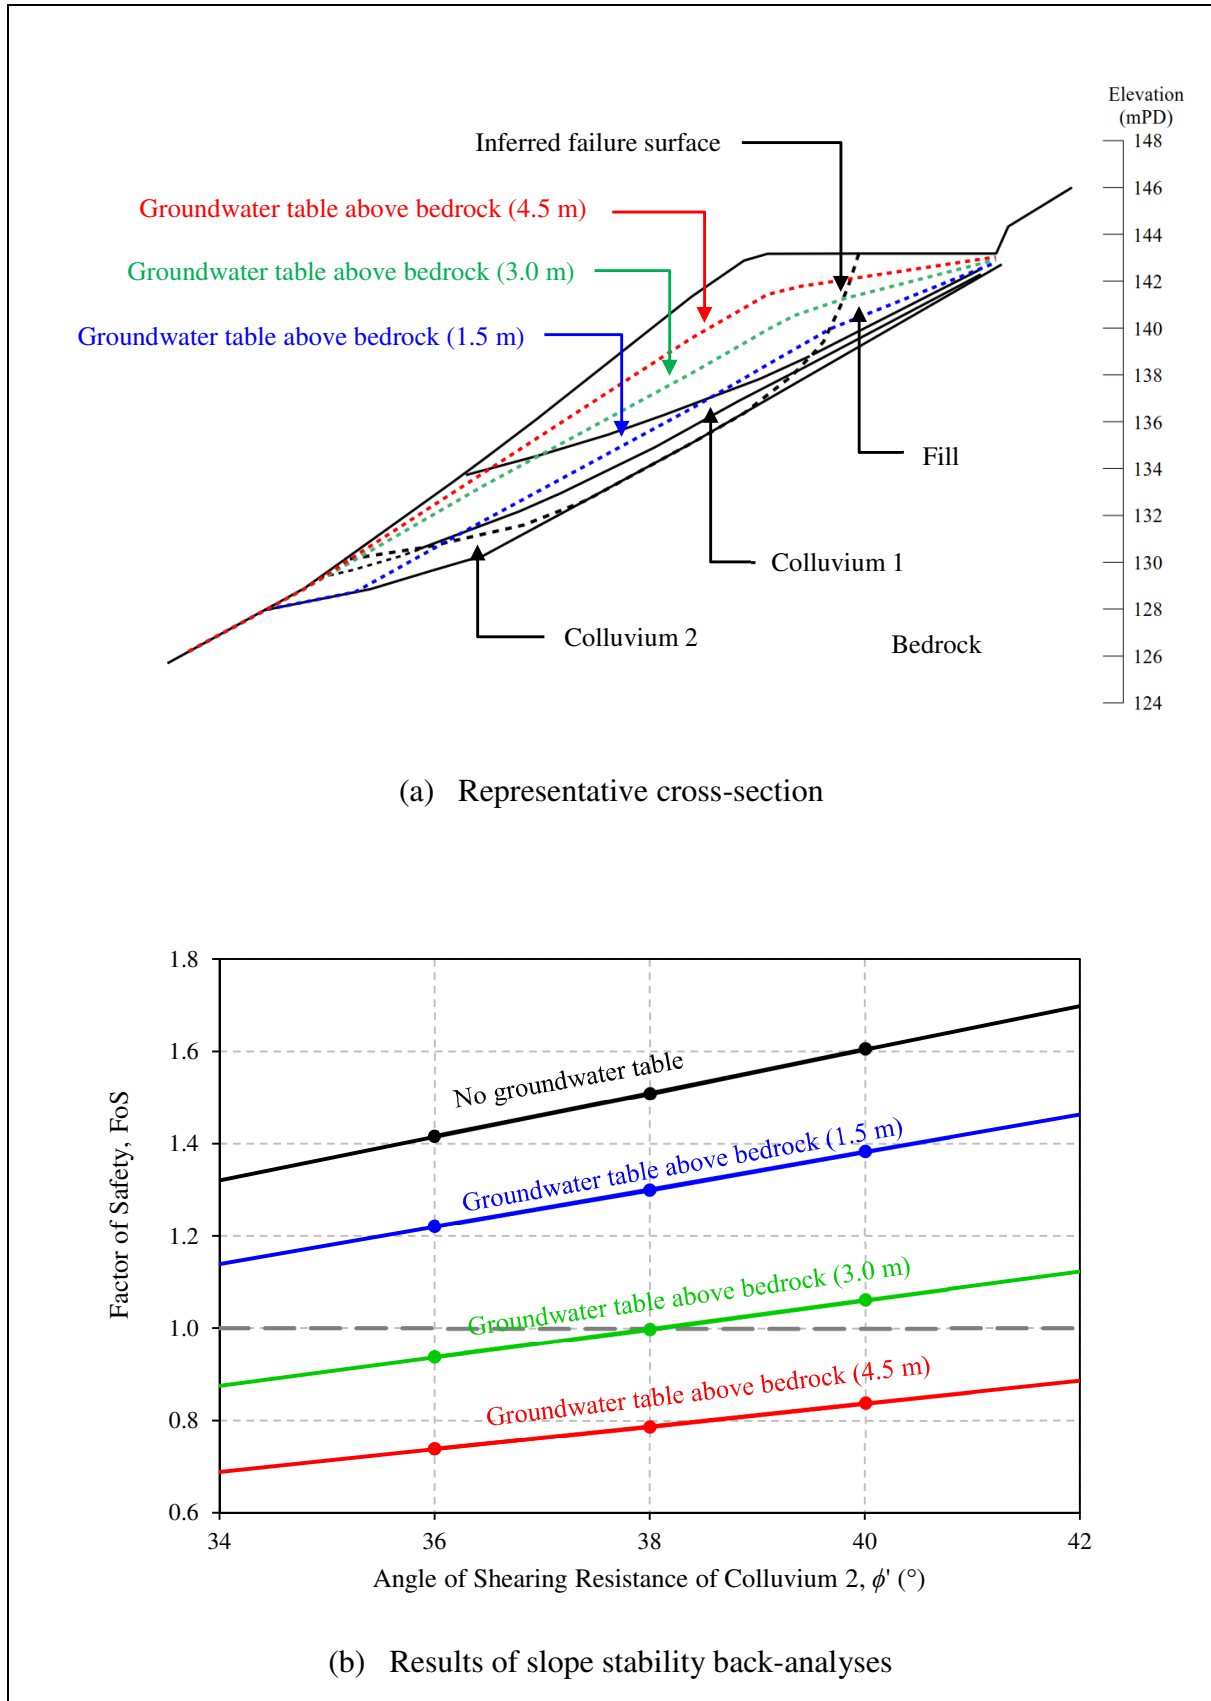
**Figure 7.1 Summary of Slope Stability Back-analyses**

The analyses considered various slip surfaces of shallow and deep-seated sliding failure modes to assess the groundwater conditions during the incident on 8 September 2023. The results indicate that the build-up of the perched groundwater table within the fill layer would result in a shallow failure. On the other hand, the deep-seated sliding failure would correspond to an approximately 3 m rise of the groundwater table above the bedrock, given the ranges of shear strength parameters of the colluvium 2. The results of the rise in the groundwater table above the bedrock rather than the development of the perched water pressure within the fill layer are consistent with the previous groundwater monitoring records (Section 5.3) and field observations that the rupture surface encroached deeply onto the interface of colluvium and bedrock, and seepage was evident on the source floor at this interface (Section 5.1).

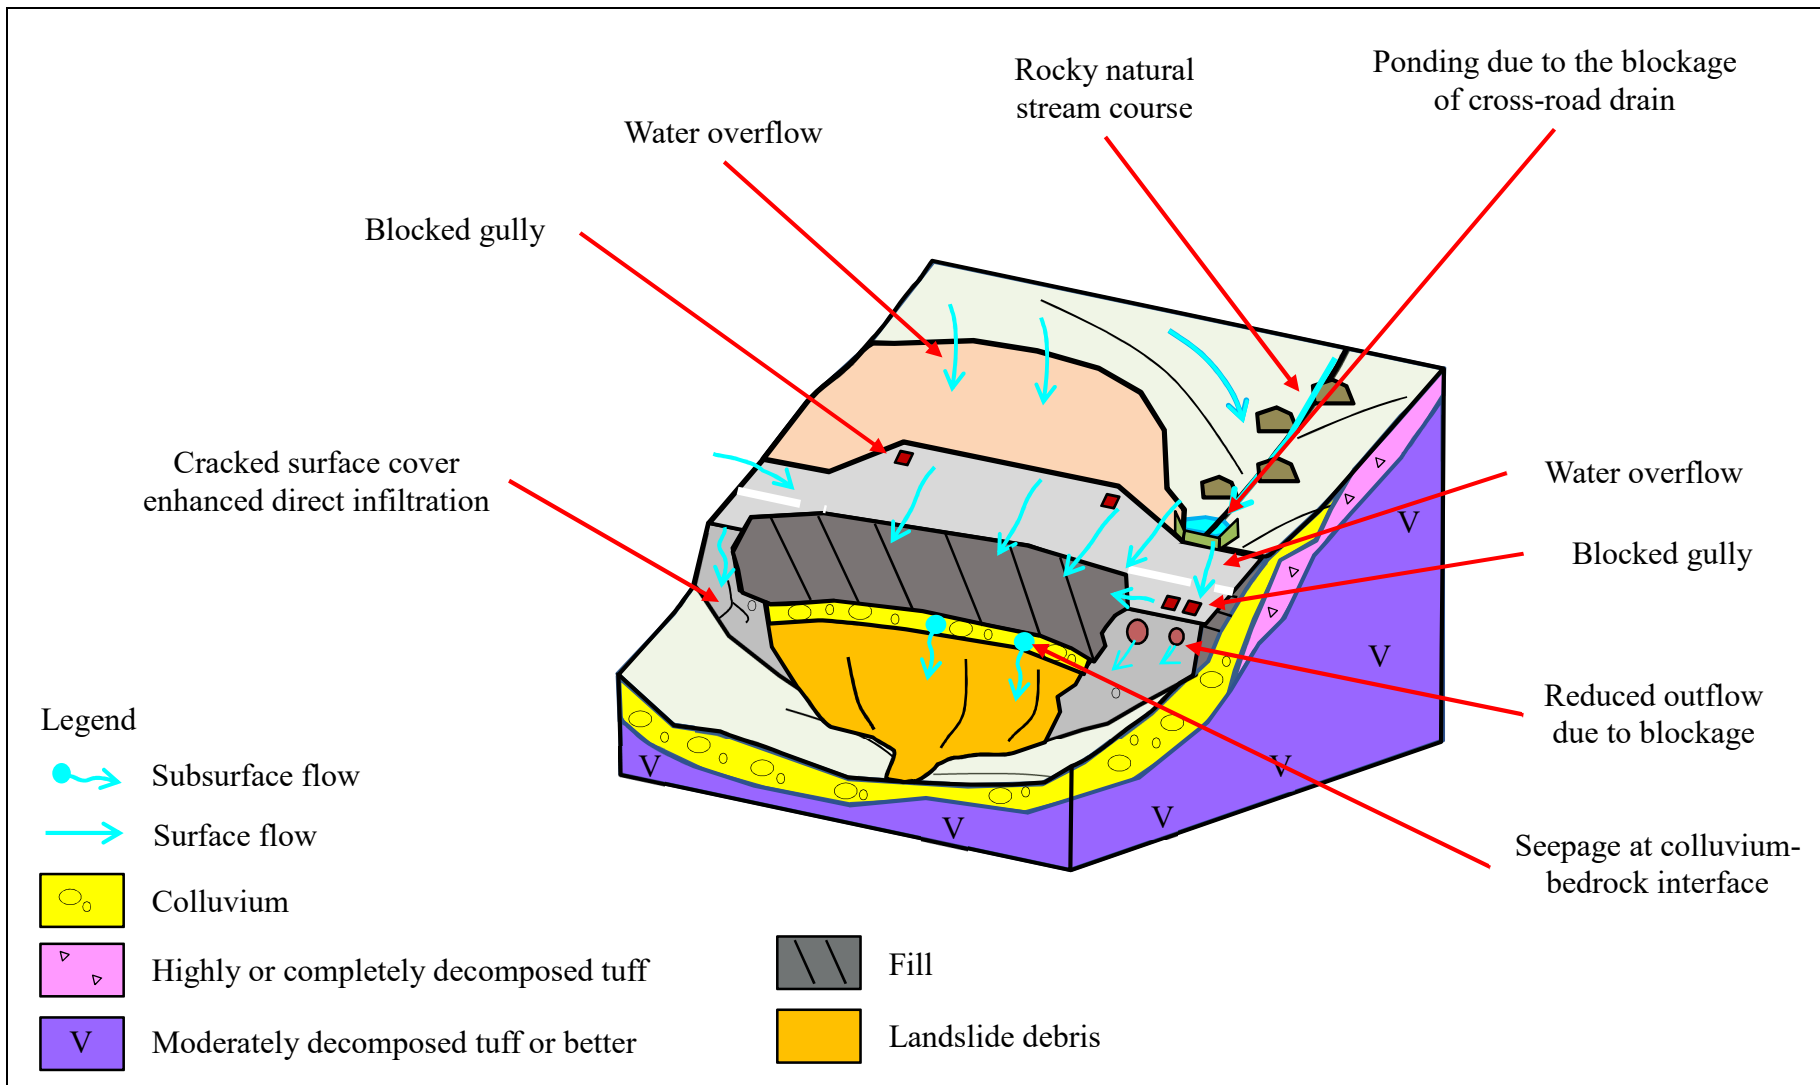
**Figure 8.3 Ground Model – Landslide on 8 September 2023**

In light of the environmental setting at the landslide site, the existing blocked cross-road drain could not cope with the high intensity of rainwater and surface water from the rocky natural stream course. This caused flooding on Shek O Road and overflow onto the fill slope. The overflow from Shek O Road, along with the subsurface flow and direct infiltration through the cracked slope surface, would have resulted in the rise in the groundwater table in the slope body, leading to the failure.

The landslide highlighted the importance of proper and regular maintenance on slopes and roadside drainage provisions. Suitable precautionary measures at drainage inlets, such as trash grilles or debris screens at inlets, are warranted if materials carried down by the flow would block the downstream drainage system. Subsurface drainage measures, such as drainage blankets and prescriptive raking drains, might be necessary to control the possible build-up of groundwater pressures at depth during intense rainfall.

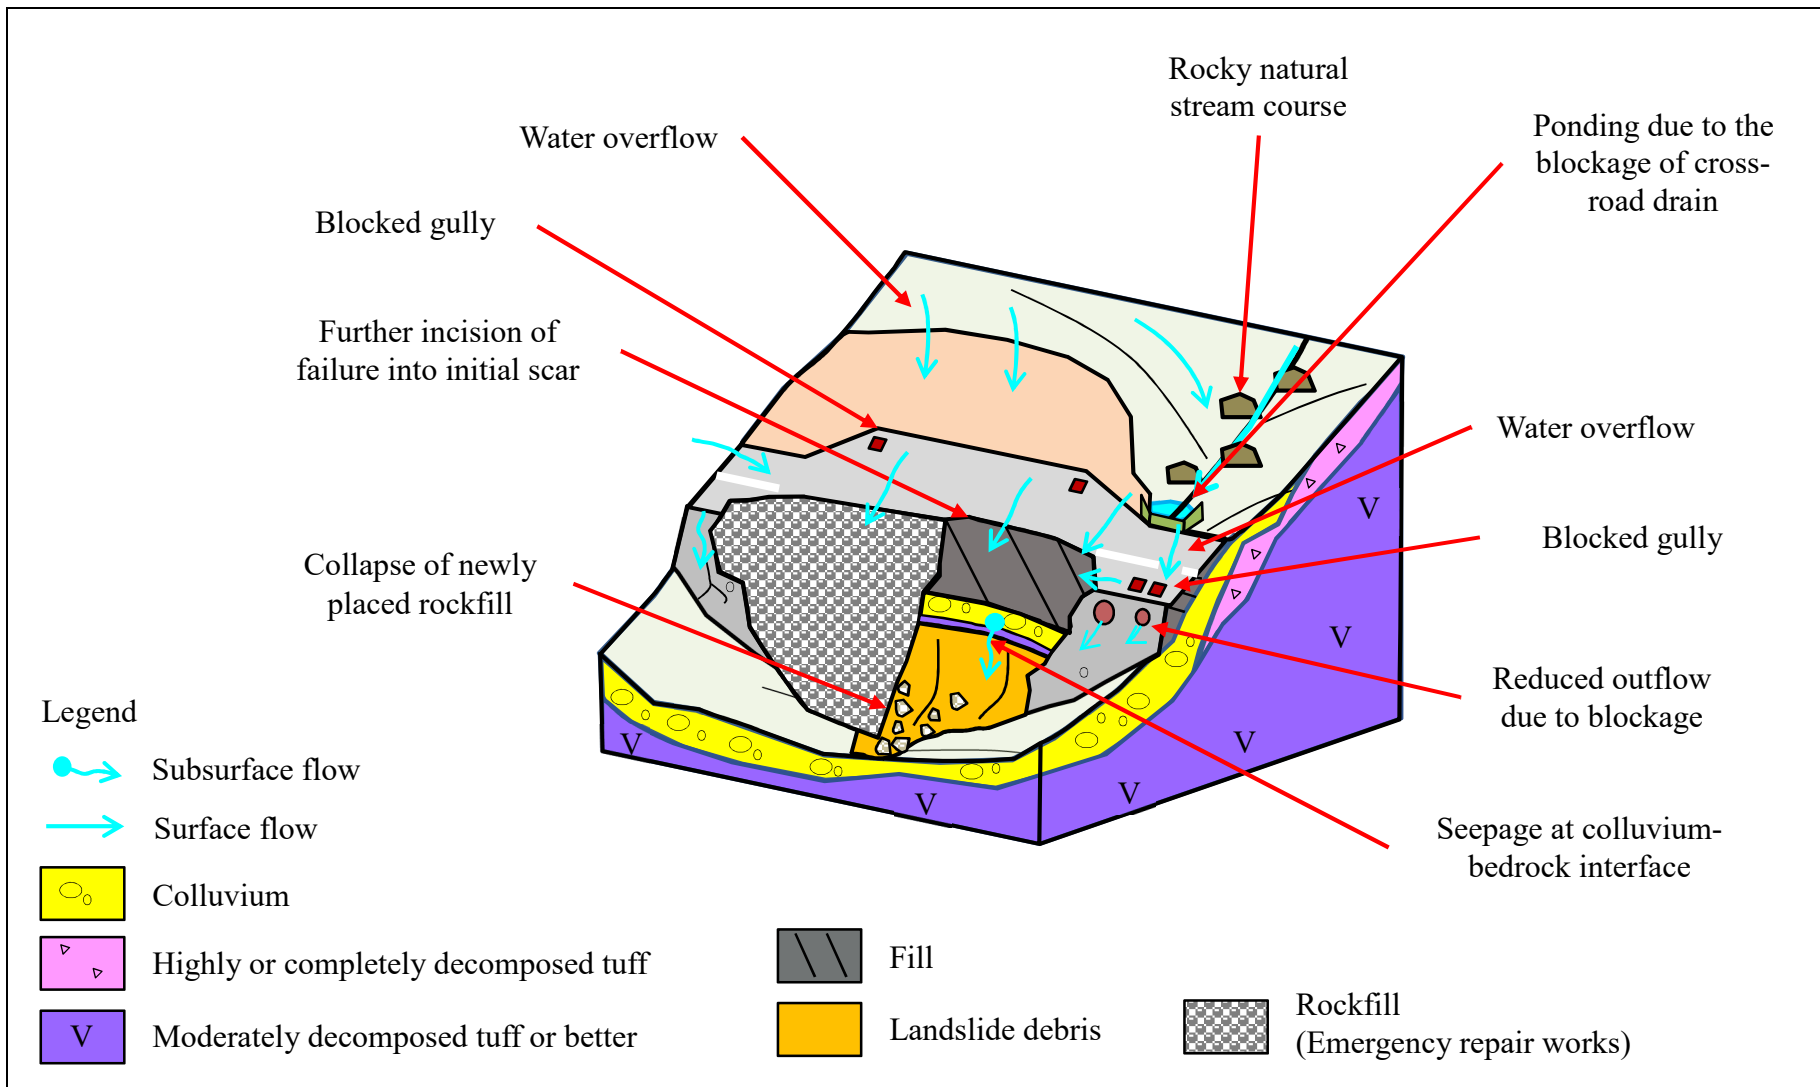
Figure 8.4 Ground Model – Landslide on 14 September 2023

It is important to note that the landslide that occurred on 14 September 2023 was primarily caused by surface erosion on the newly placed rockfill without a distinct slip surface, but an eroded source floor. Therefore, the failure mechanism of the landslide was supported by field observations (Section 5.1.2) instead of slope stability back-analyses using the limit equilibrium method.
