# **REPORT ON THE RAINSTORM OF MAY 1982**

**GEO REPORT No. 25**

**M.C. Tang**

**GEOTECHNICAL ENGINEERING OFFICE  
CIVIL ENGINEERING DEPARTMENT  
HONG KONG**

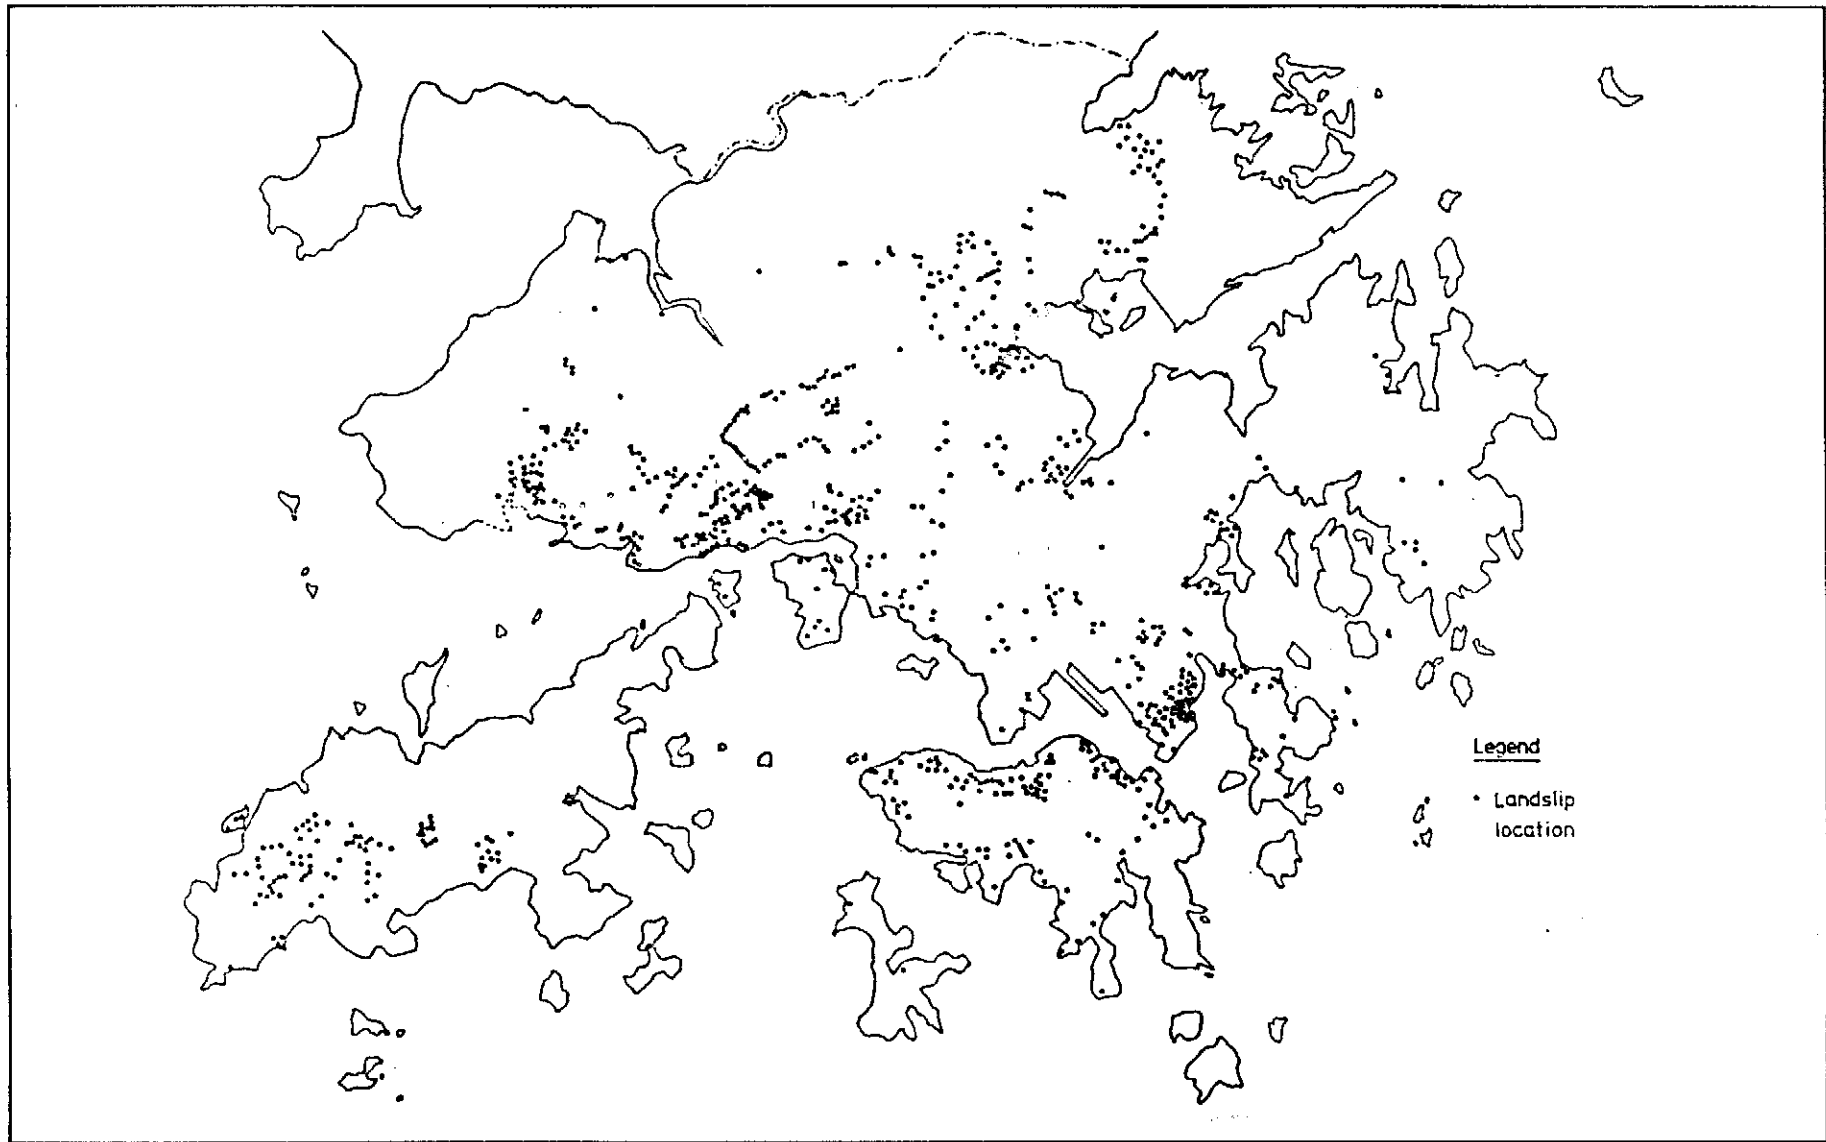
Figure 1 - Location plan of reported and observed landslips resulting from May 1982 Rainstorm

The locations of the reported and observed landslips are plotted on Figure 1. It should be noted that it is not exhaustive in showing the location of all the landslips arising from the May rainstorm because many landslips in remote parts of the Territory remain unrecorded.

Broadly speaking, as shown in Figure 1, the landslips clustered around the Rennies' Mill, east Kowloon, northeastern Hong Kong Island, Sham Tseng, Tsuen Wan and southwestern part of Lantau Island. These areas were subjected to intense rainfall on 28 and 29 May (see Figure 2).

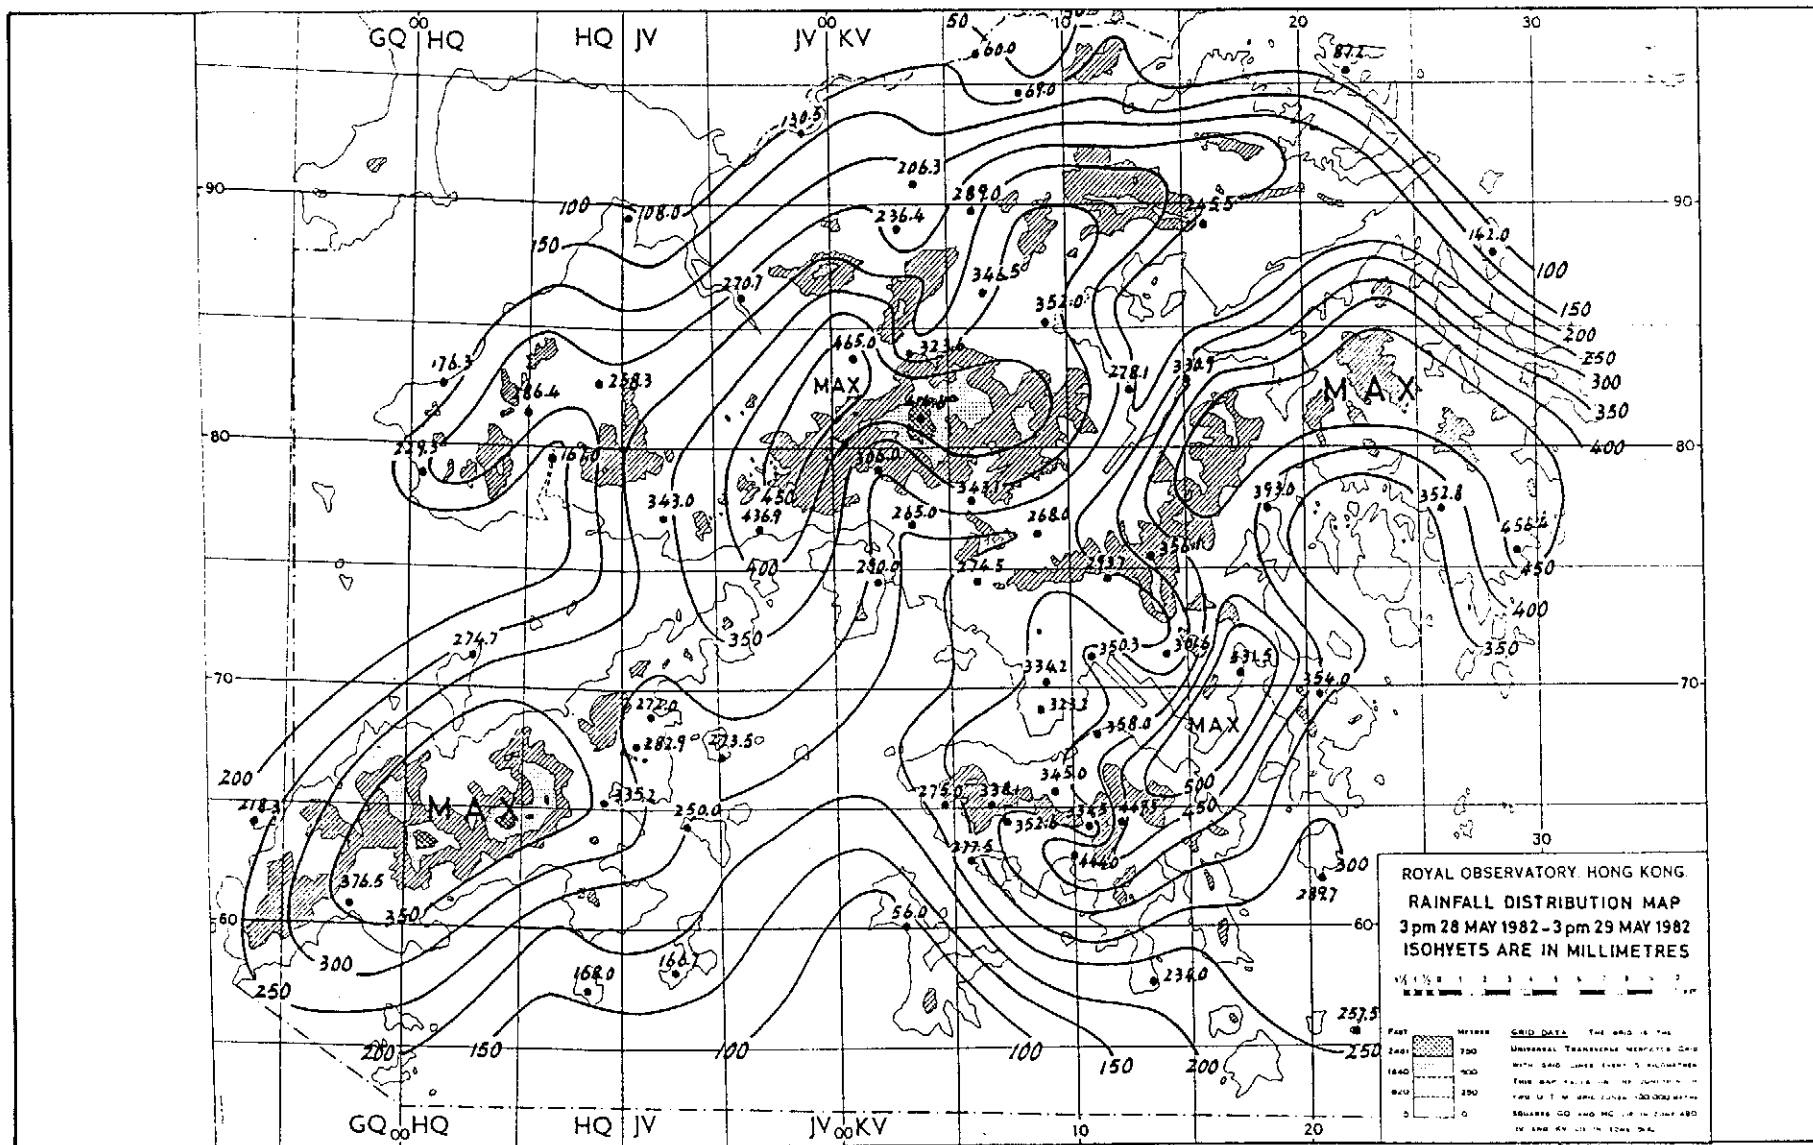
Figure 2 - Rainfall distribution for the 24-hour period from 3 p.m. on 28 May to 3 p.m. on 29 May 1982

Over the whole Territory, the rainfall distribution for the 24-hour period from 3 p.m. on 28 May to 3 p.m. on 29 May is shown in Figure 2. It is apparent that rainfall was heaviest in east Kowloon, Rennie's Mill and on the north eastern side of Hong Kong Island.

Rennie's Mill lies within the area of heaviest rainfall during the May rainstorm (see Figure 2). The fatalities were due to natural slope failures above cut slopes.

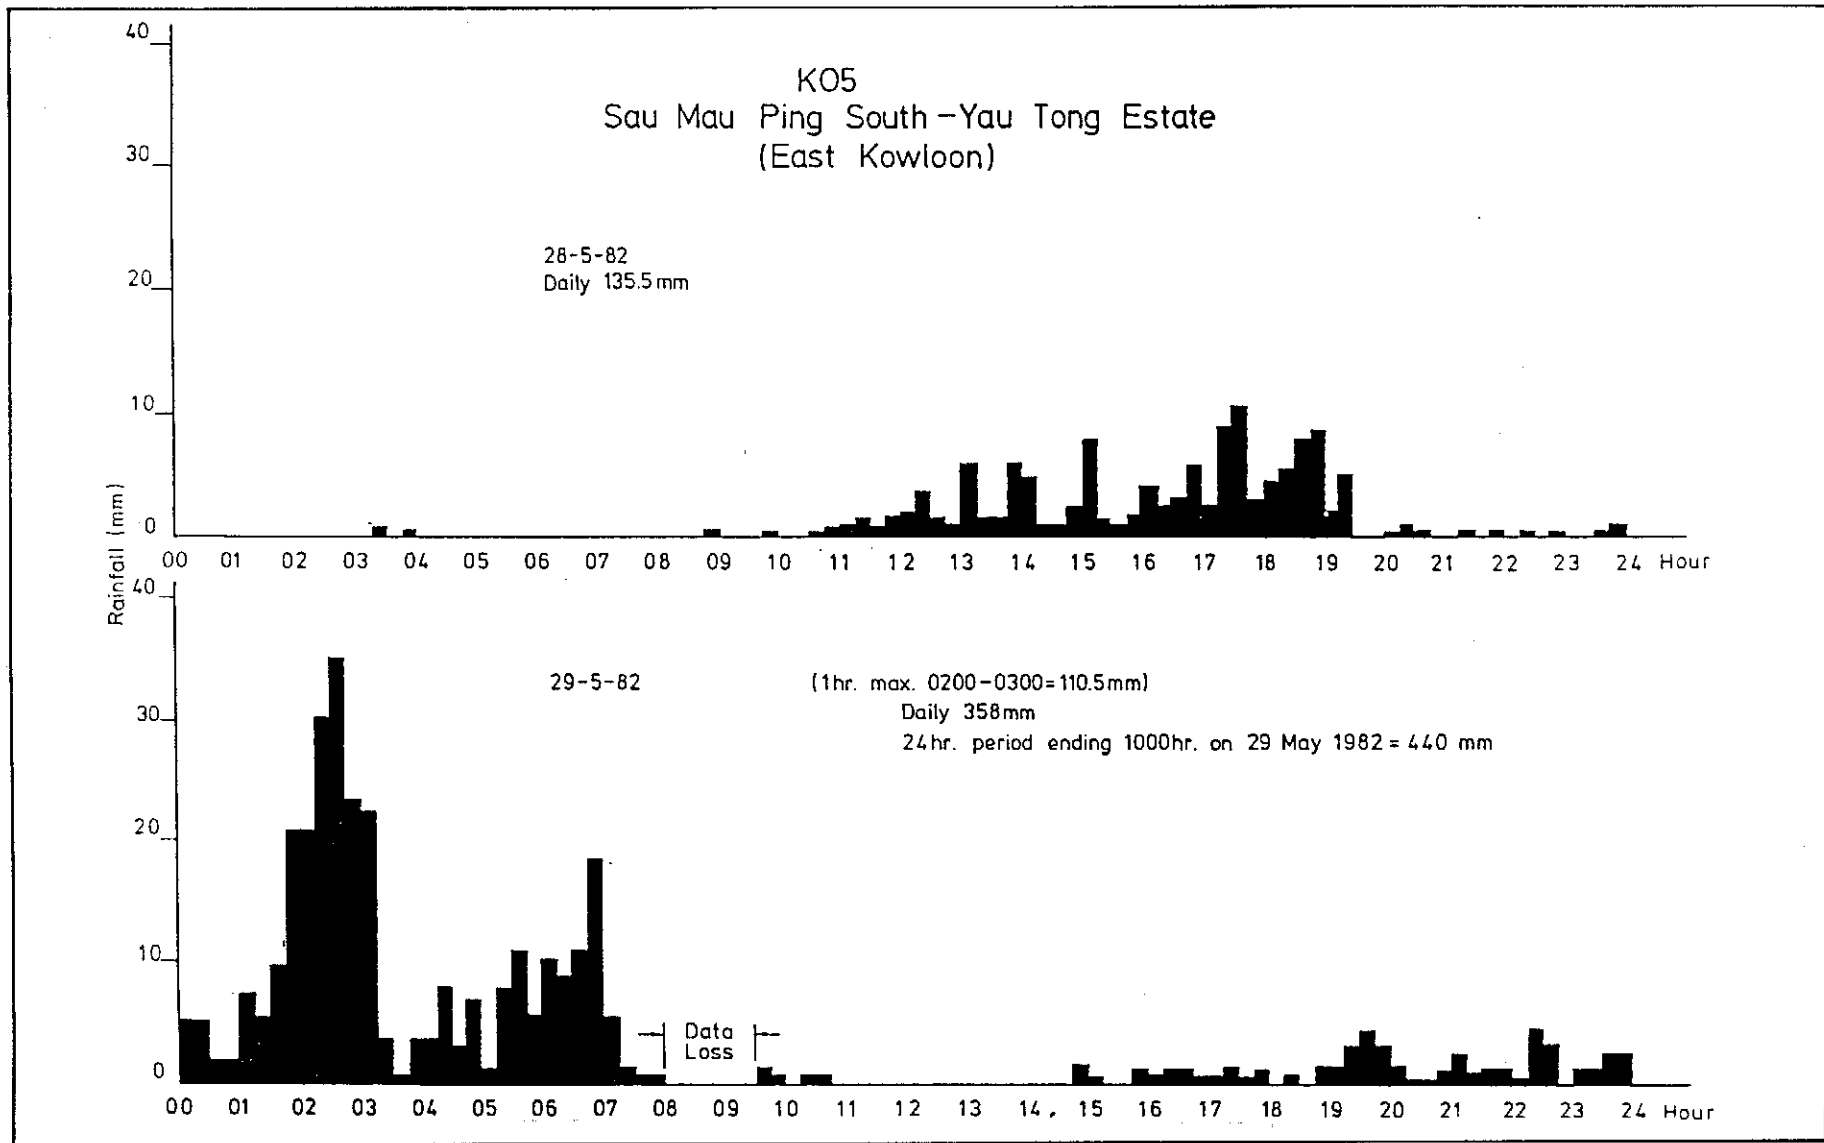
Figure 3 - 15 minute rainfall recorded by GCO Raingauge K05 at Yau Tong, east Kowloon on 28 & 29 May 1982

The most intense rainfall was recorded at the same location. Figure 3 shows the rainfall recorded every 15 minutes on the 28th and 29th May. It may be seen that the heaviest rain fell between 0100 and 0400 hours on the 29th with a peak of 110.5 mm between 0200 and 0300 hours.

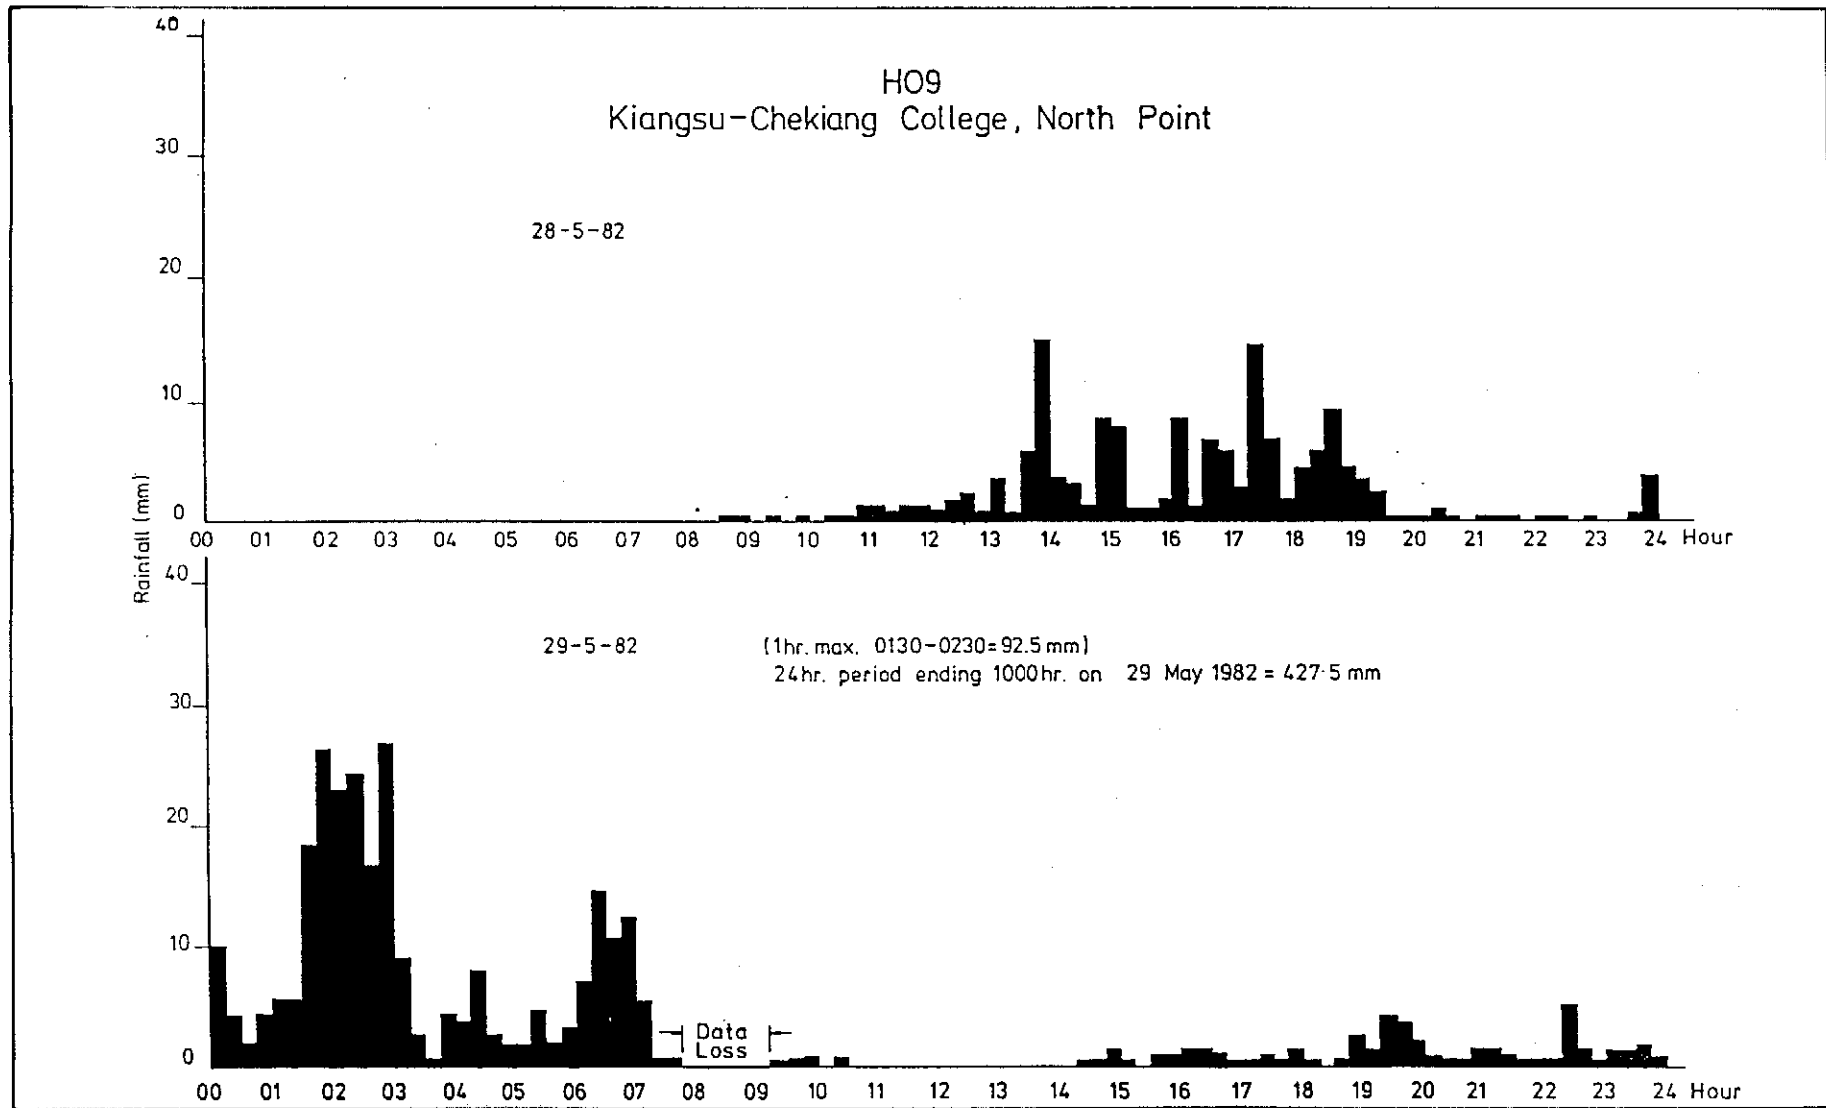
Figure 4 - 15 minute rainfall recorded by GCO Raingauge H09 at Kiangsu-Chekiang College. North Point 28 & 29 May 1982.

Figures 3 and 4 illustrate the variation of rainfall with time as recorded by GCO raingauges K05 at Yau Tong and H09 at Kiangsu-Chekiang College, North Point on 28 and 29 May.

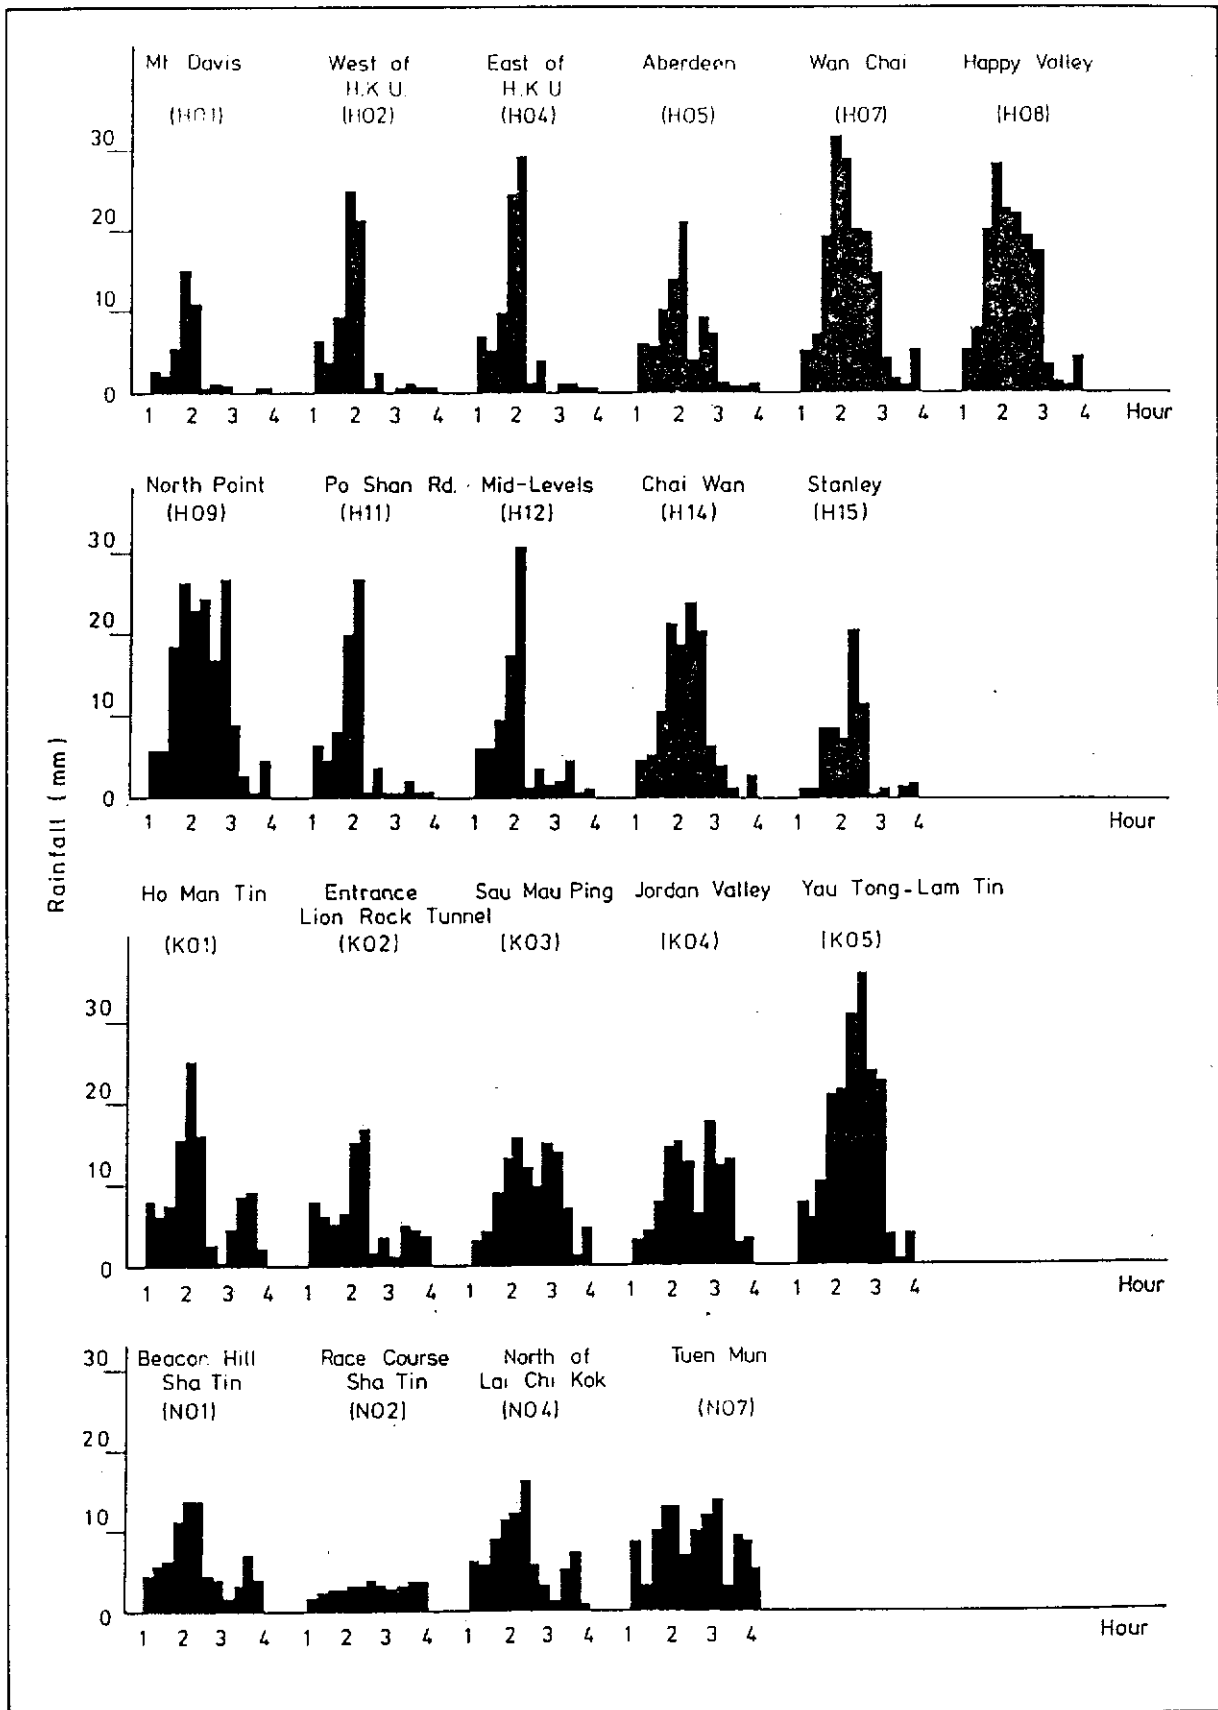
Figure 5 - 15 minute rainfall recorded by GCO Raingauges during 0100 - 0400 hr. on 29 May 1982

Figure 5 shows the 15-minute rainfall records for the twenty GCO raingauges between 0100 and 0400 hours on 29 May. This data demonstrates the significant geographical variation in rainfall. Maximum intensities varied from 110.5 mm at Yau Tong to 12.5 mm at Sha Tin racecourse.

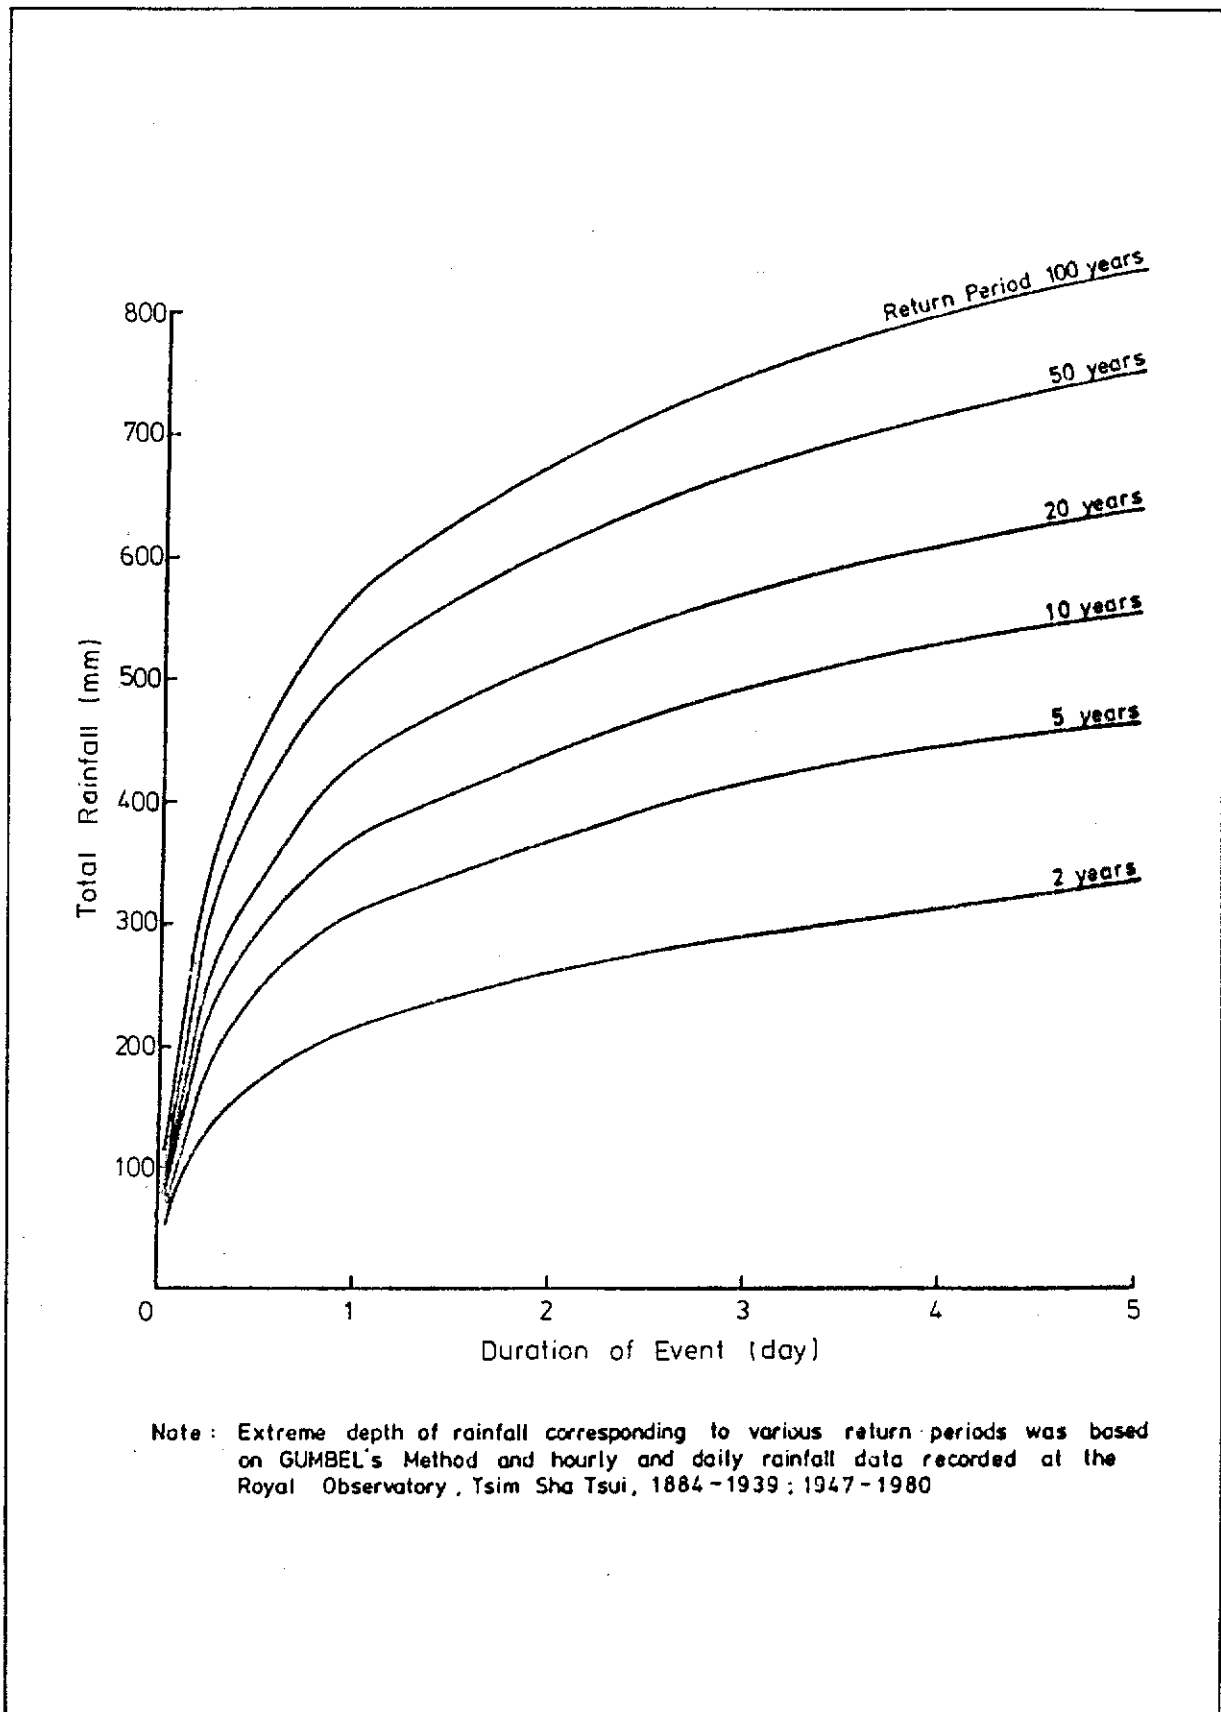
Figure 6 - Extreme rainfall for various durations of events and return periods

The cumulative record of the May 1982 rainstorm may be compared with the maximum records for the rainstorms of June 1966, June 1972 and August 1976 which caused many landslips and much disruption (Figure 7). The extreme rainfalls for various durations of event and return periods are shown in Figure 6 as an overlay to Figure 7.

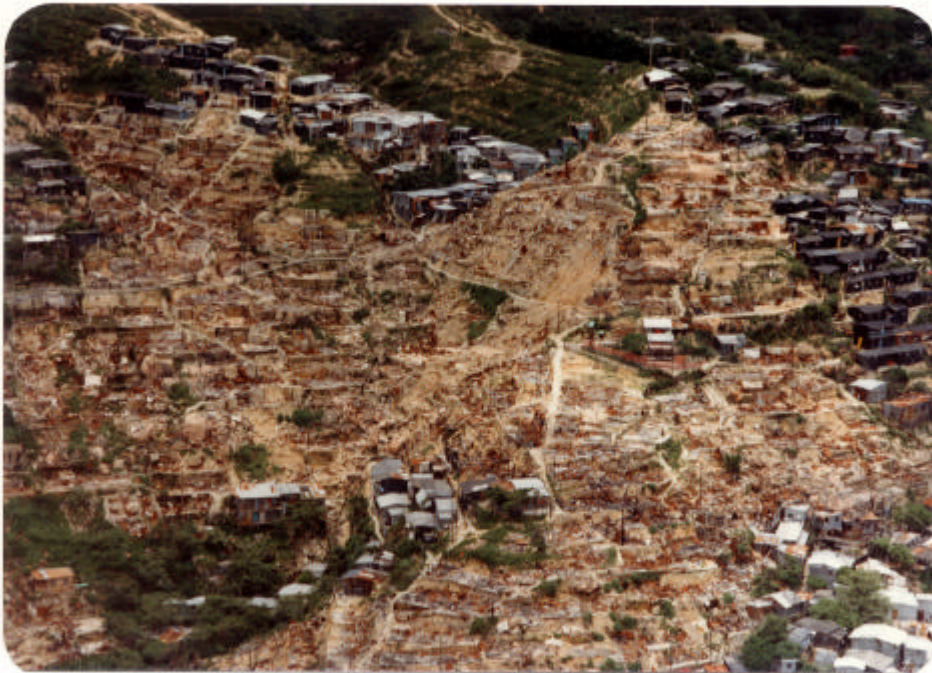
Plate 10

Landslips affecting squatter huts
