**SECTION 2 :
DETAILED STUDY OF THE
LANDSLIDE AT TAI PO ROAD
NEAR CHAK ON ESTATE
ON 9 JUNE 1998**

Fugro Scott Wilson Joint Venture

**This report was originally produced in January 2000
as GEO Landslide Study Report No. LSR 18/99**

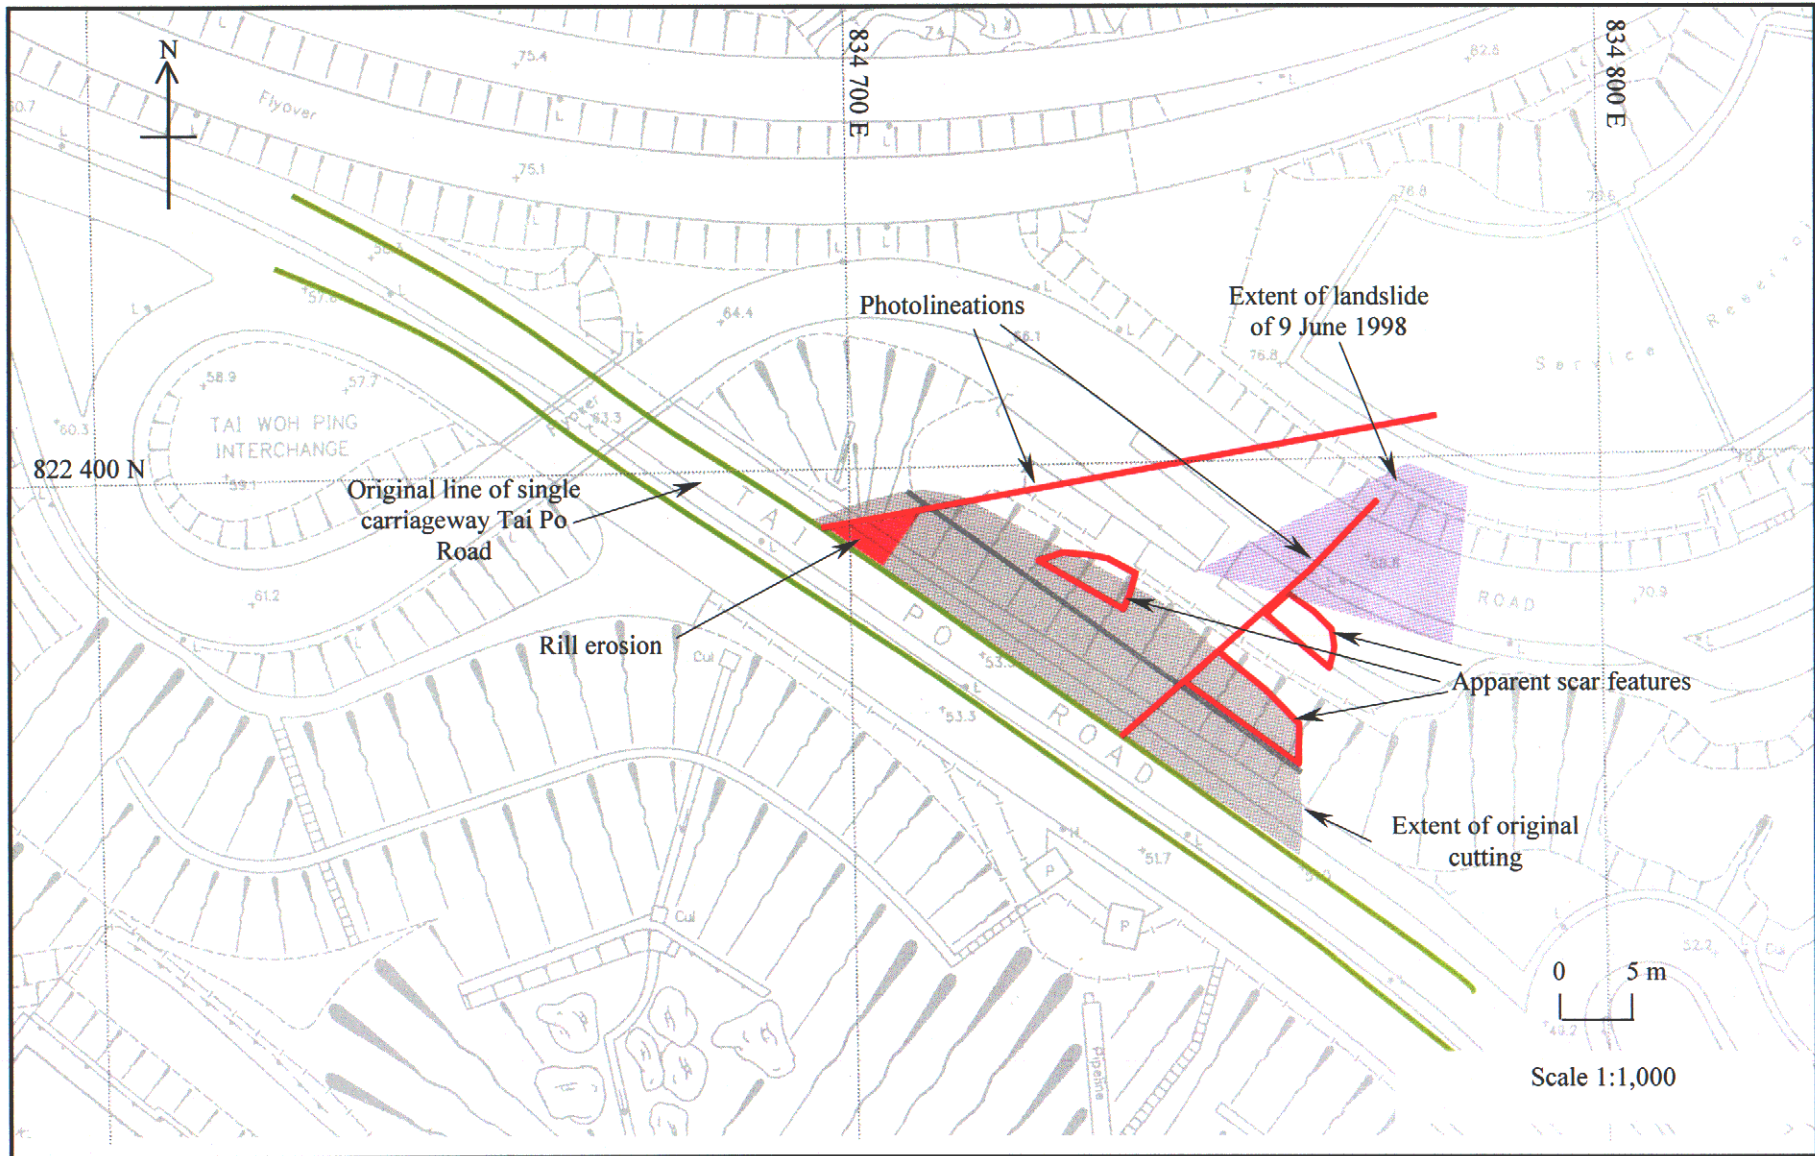
Figure 4 – Observations from the 1949 Aerial Photographs

There is some evidence to suggest former instability in the original Tai Po Road cutting, based on the 1949 photographs. Although some of the scars evident in and around the cut face at this time may represent overbreak of excavation due to the presence of boulders/corestones, there is considered to be a possible planar structure controlled type failure in the upper eastern part of the cutting at this time. The position of this feature, relative to the landslide is shown in Figure 4 in the main report.

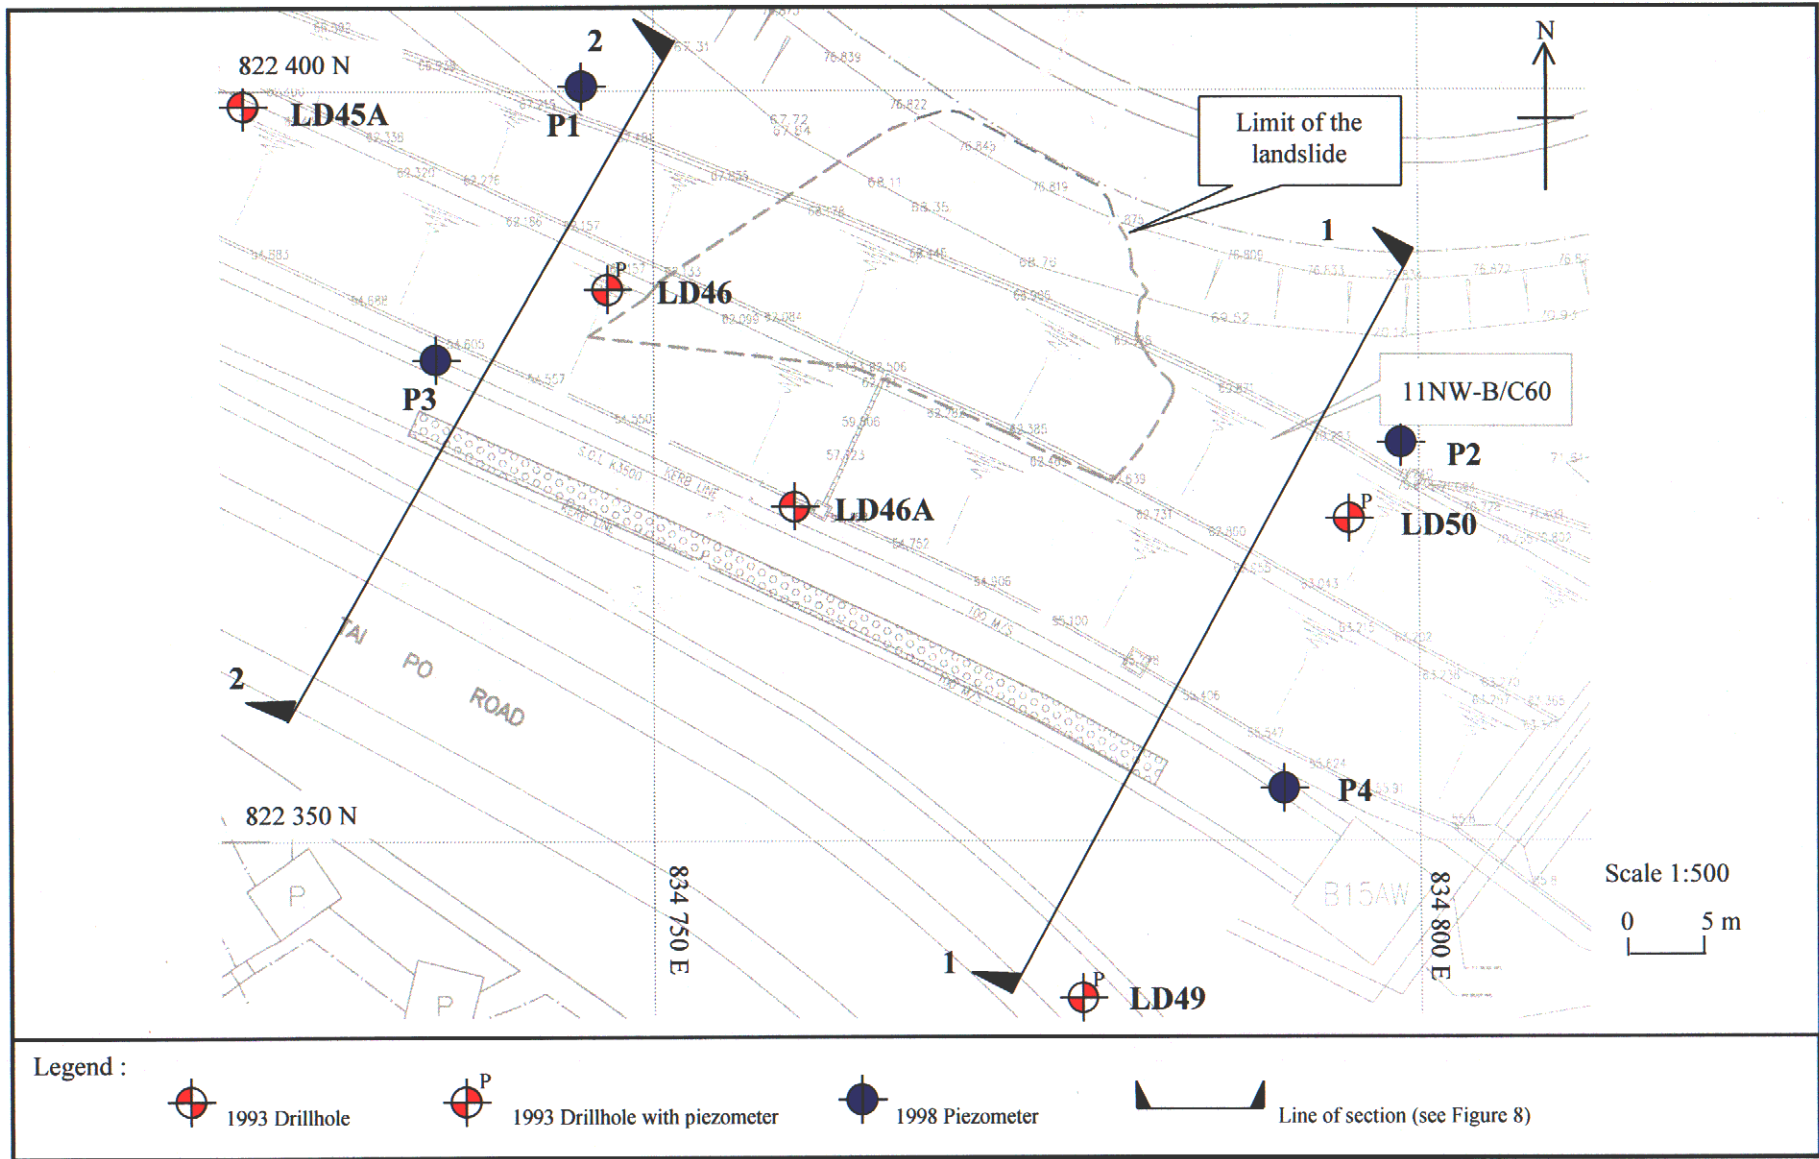
Figure 5 – Drillhole and Piezometer Location Plan

Groundwater records for both the original (August to December 1993) and recent (June to October 1998) monitoring exercises have been reviewed. The locations of both sets of groundwater monitoring stations are shown in Figure 5, and sections summarising the findings are given in Figure 8.

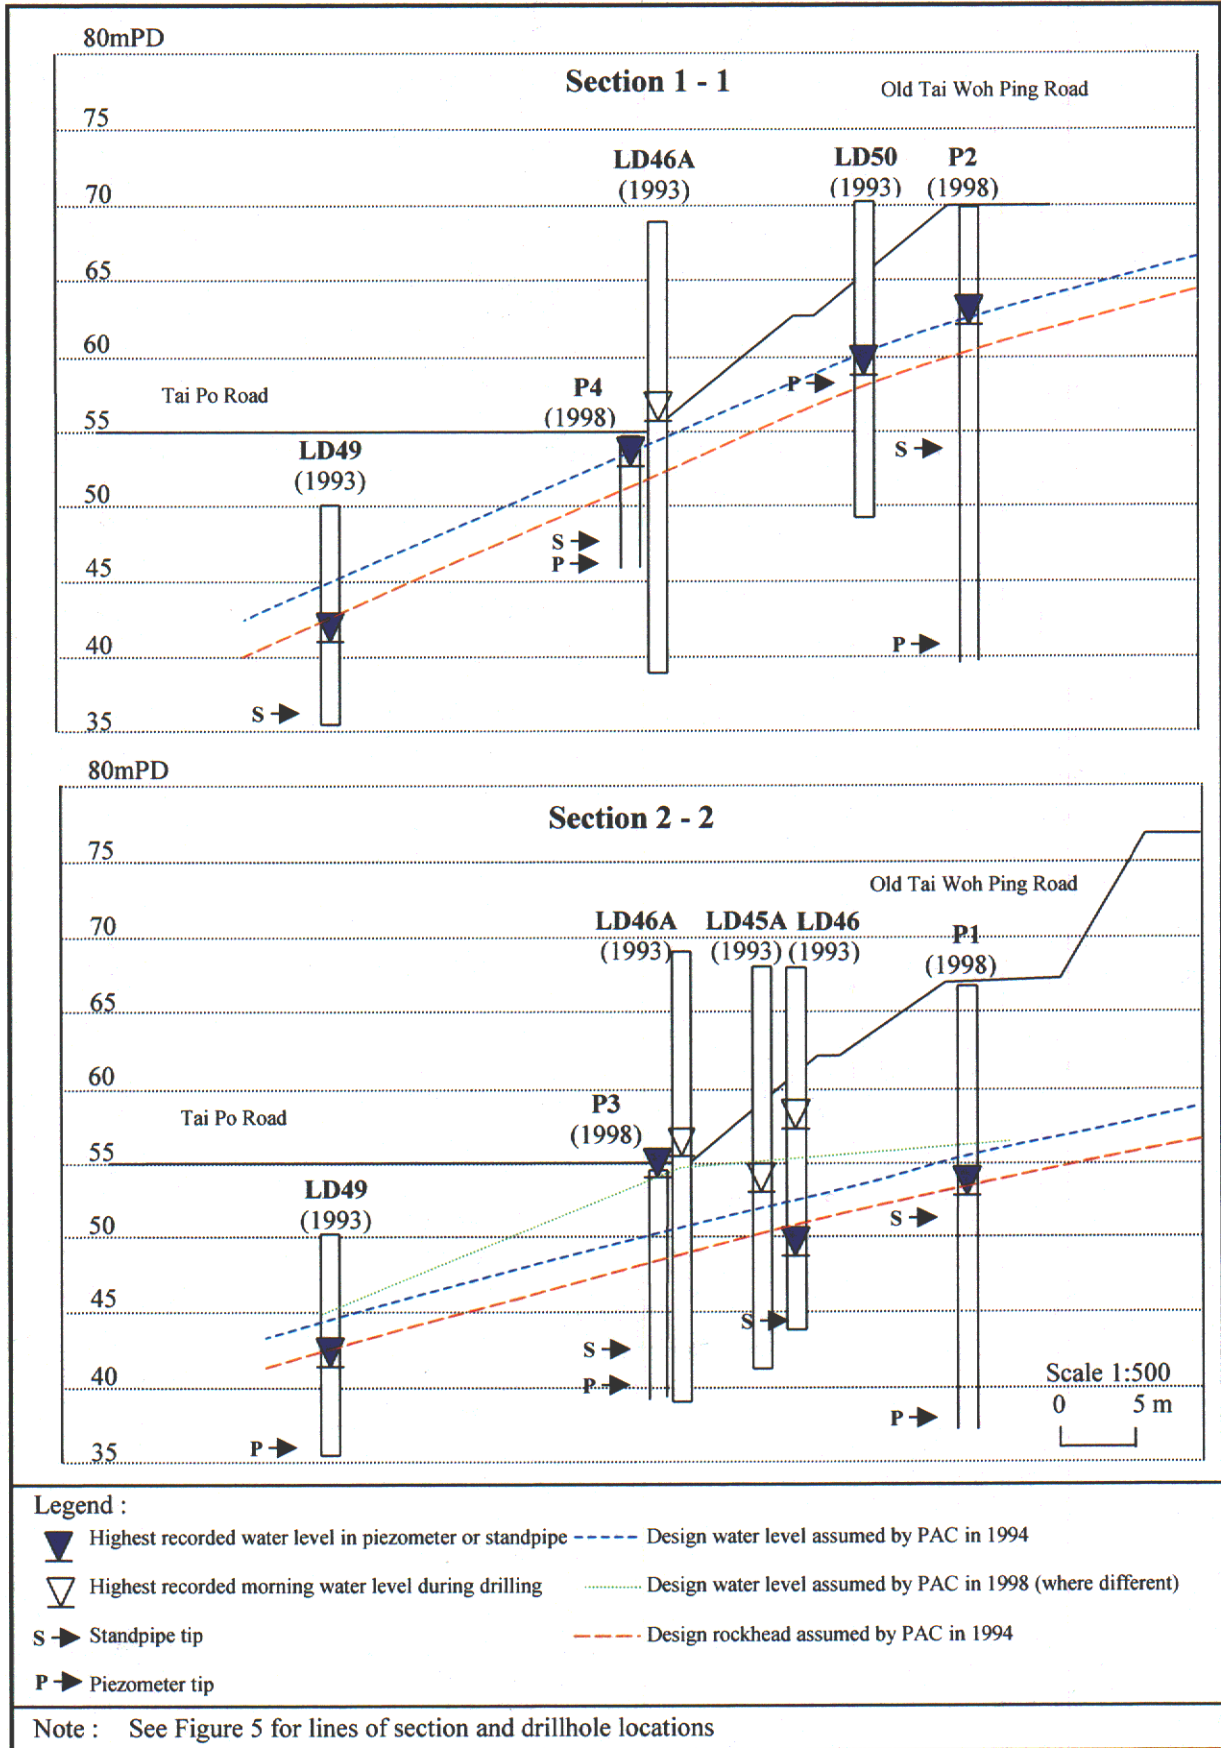
Figure 8 – Summary of Groundwater Monitoring Results

The recent monitoring exercise has included daily readings (since the end of June 1998) of four new sets of groundwater monitoring installations, two at the toe of the cut slope and two on the old Tai Woh Ping Road, each of which has a deep piezometer and a shallower standpipe installed at levels indicated in Figure 8. Readings from June 1998 to the end of October 1998 have been made available by PAC. It should be noted that the peak transient water levels may not have been recorded by the piezometers, because no Halcrow buckets were installed. The two higher installations (P1 and P2) indicate water levels at about 2 m above rockhead, similar to the original assessment by PAC. The two lower installations near the slope toe (P3 and P4), however, indicate that water levels up to over 7 m above rockhead can develop.

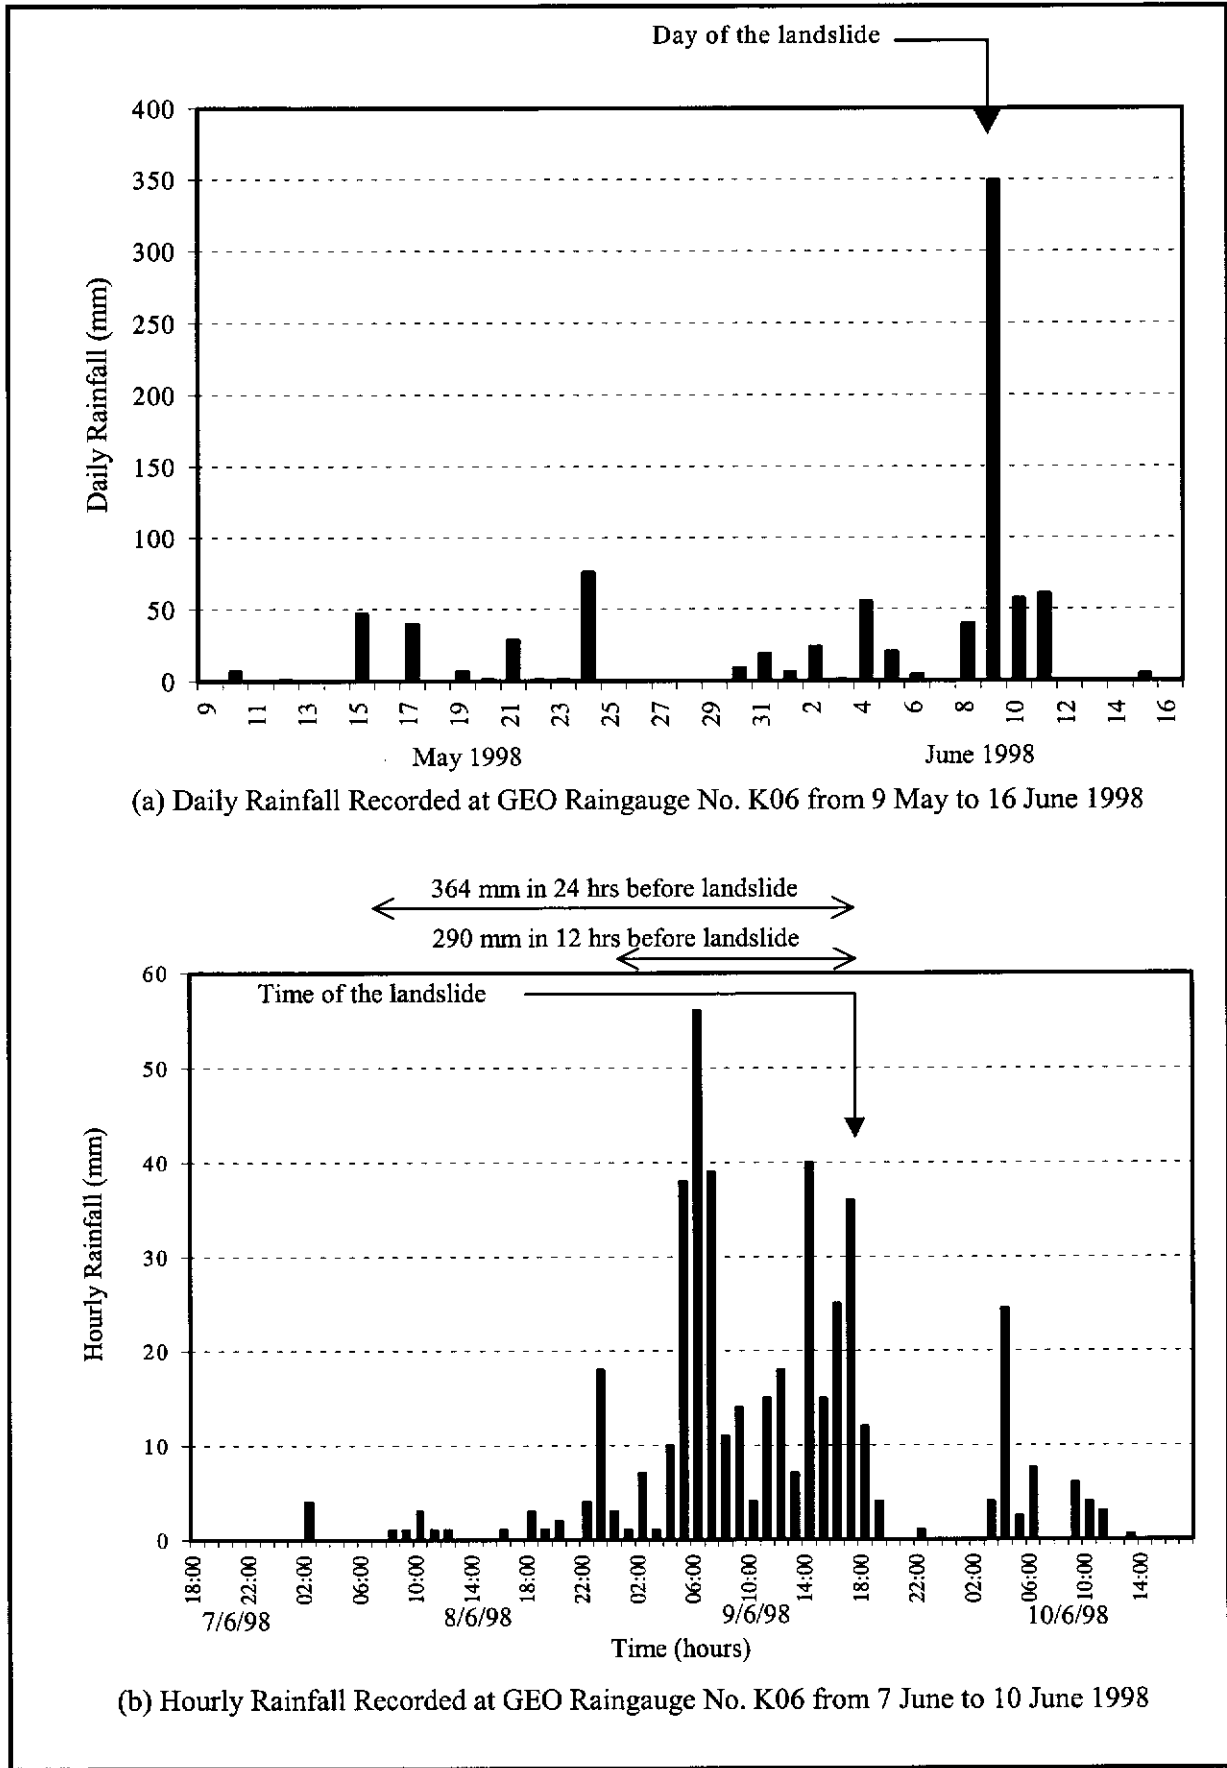
Figure 9 – Daily and Hourly Rainfall Records from GEO Raingauge No. K06

Daily rainfall for one month preceding and seven days following the event, and hourly rainfall for 48 hours before and 8 hours following the landslide are given in Figure 9. The daily rainfall records show that the storm was concentrated around 9 June 1998 (the day of the landslide), with the hourly data indicating intense peaks from 05:00 to 08:00 hours, 14:00 to 15:00 hours and 16:00 to 17:00 hours.

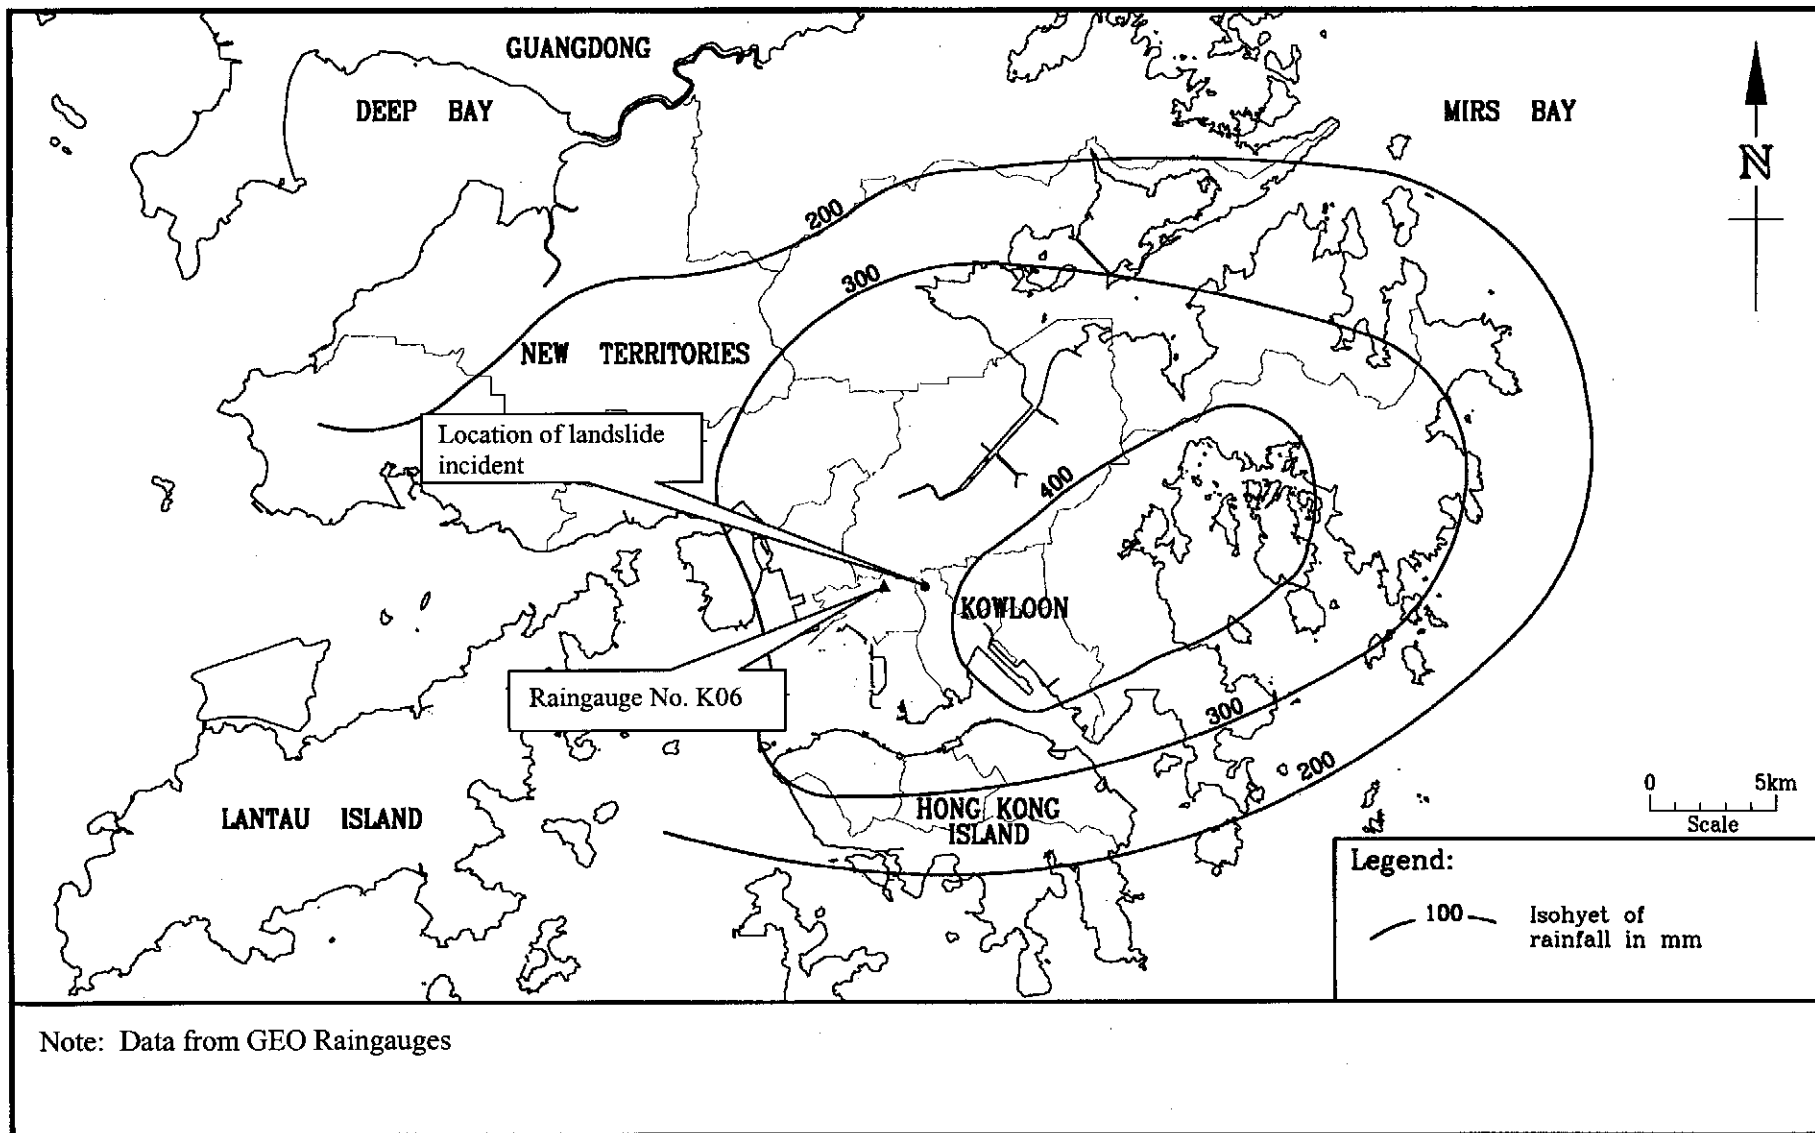
Figure 10 – Isohyets of Rainfall for 24 hour Period Ending 17:00 hrs. on 9 June 1998

For the purposes of rainfall analysis, the time of the landslide has been taken to be 17:00 hours on 9 June 1998. Isohyets of rainfall for the 24-hour period preceding the landslide are shown in Figure 10.

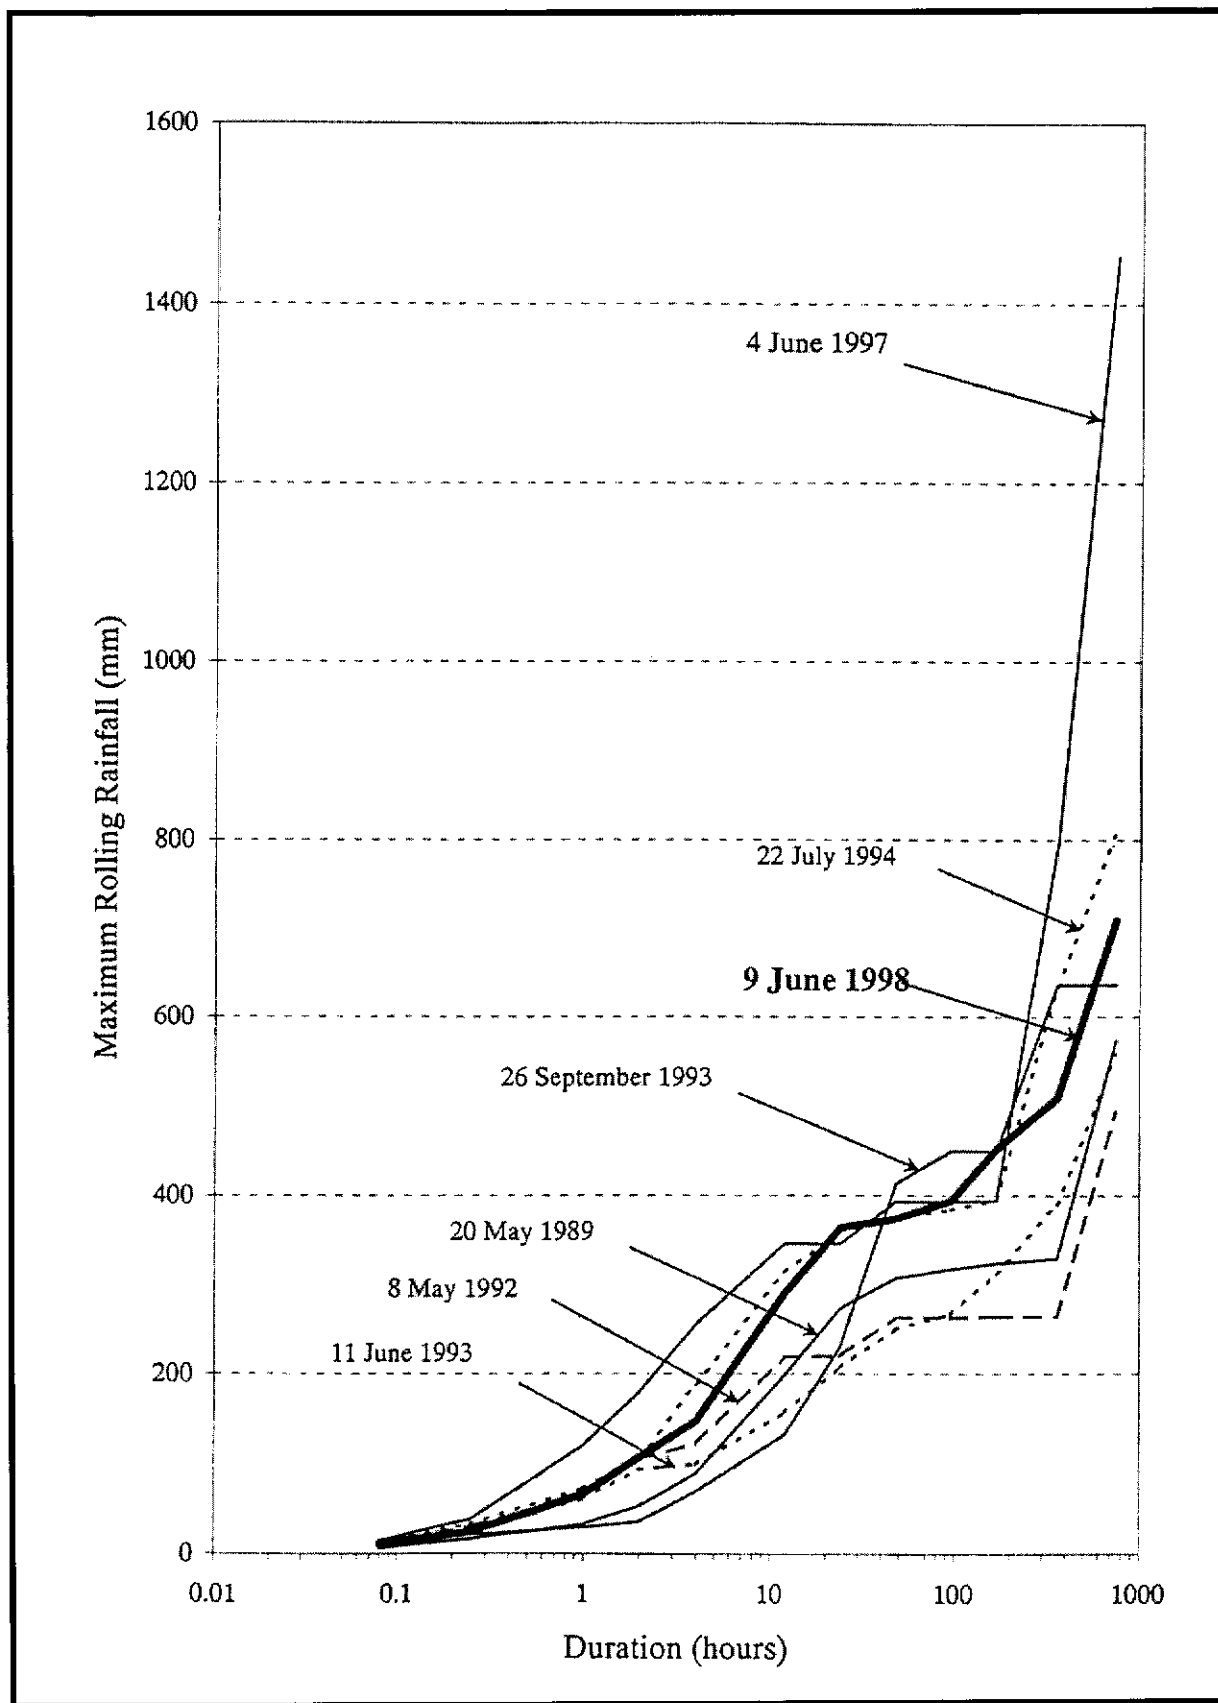
Figure 11 – Maximum Rolling Rainfall Preceding the Landslide of 9 June 1998 and Other Major Rainstorms Recorded by Raingauge No. K06

A comparison of the 9 June 1998 rainstorm with that of other past major storms recorded by raingauge No. K06 is presented in Figure 11. The 9 June 1998 rainstorm was less severe than other previously recorded significant storms since installation of the raingauge in 1983. However, it is pertinent to note that the rainfall preceding the landslide was the first severe rainstorm that the cutting was subjected to since its substantial modification in late 1997.

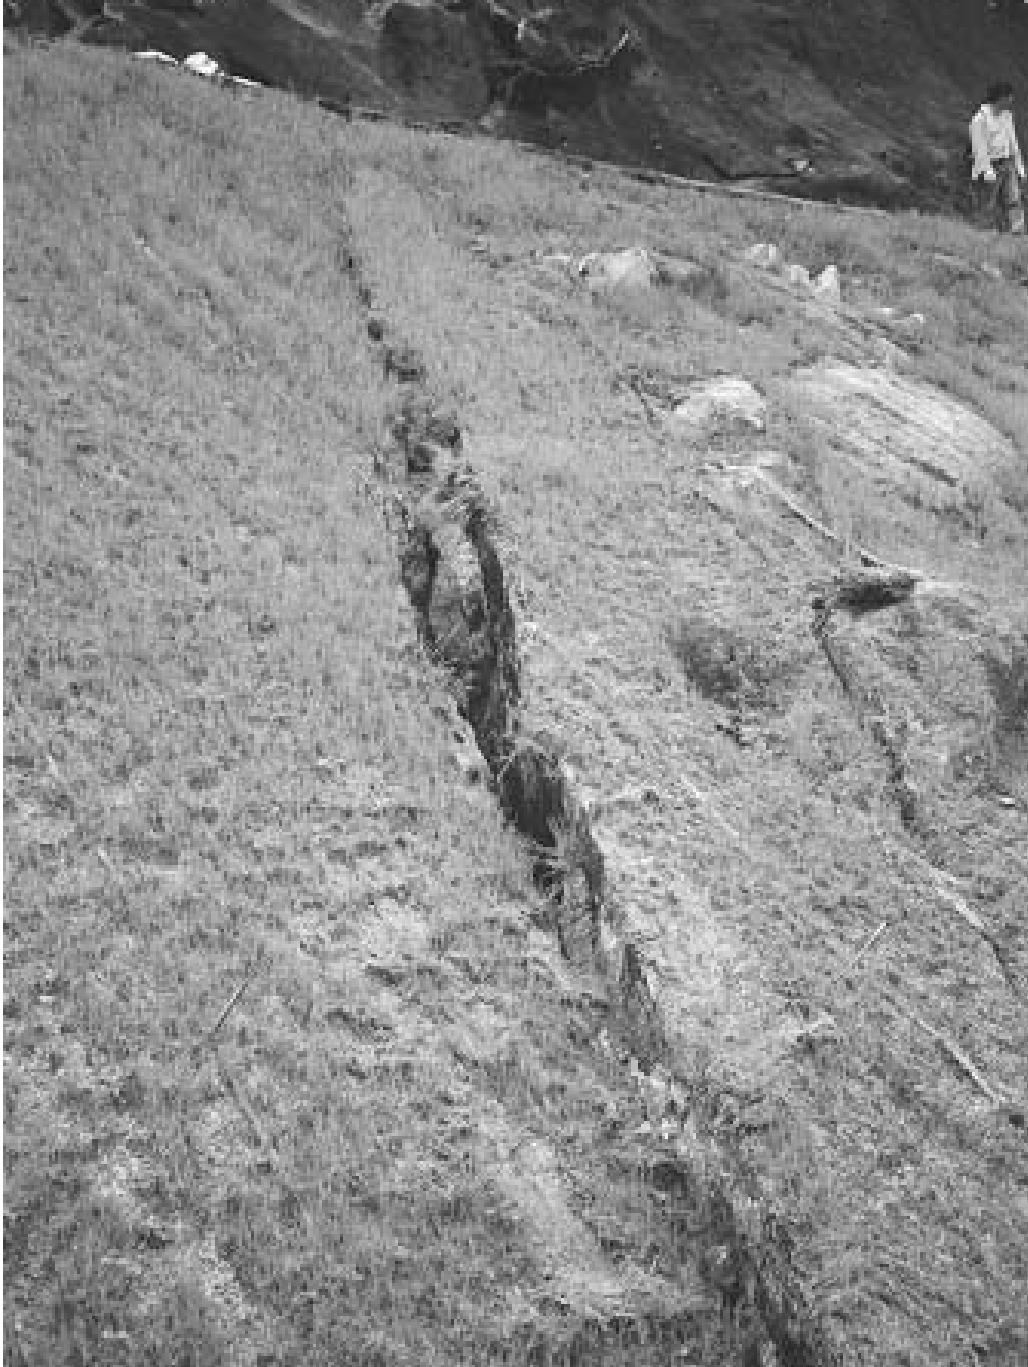
Plate 9 – View of the Landslide Western Margin from Mid-Berm
(Photograph Taken on 10 June 1998)
