**REVIEW OF INCIDENTS
INVOLVING SLOPES AFFECTED
BY LEAKAGE OF
WATER-CARRYING SERVICES**

GEO REPORT No. 203

**This report was originally produced in May 2005
as GEO Landslide Study Report No. LSR 7/2005**

This report presents the findings of an overall review of selected notable incidents involving slopes affected by leakage of water-carrying services. Areas that warrant attention are identified and follow-up actions are recommended.

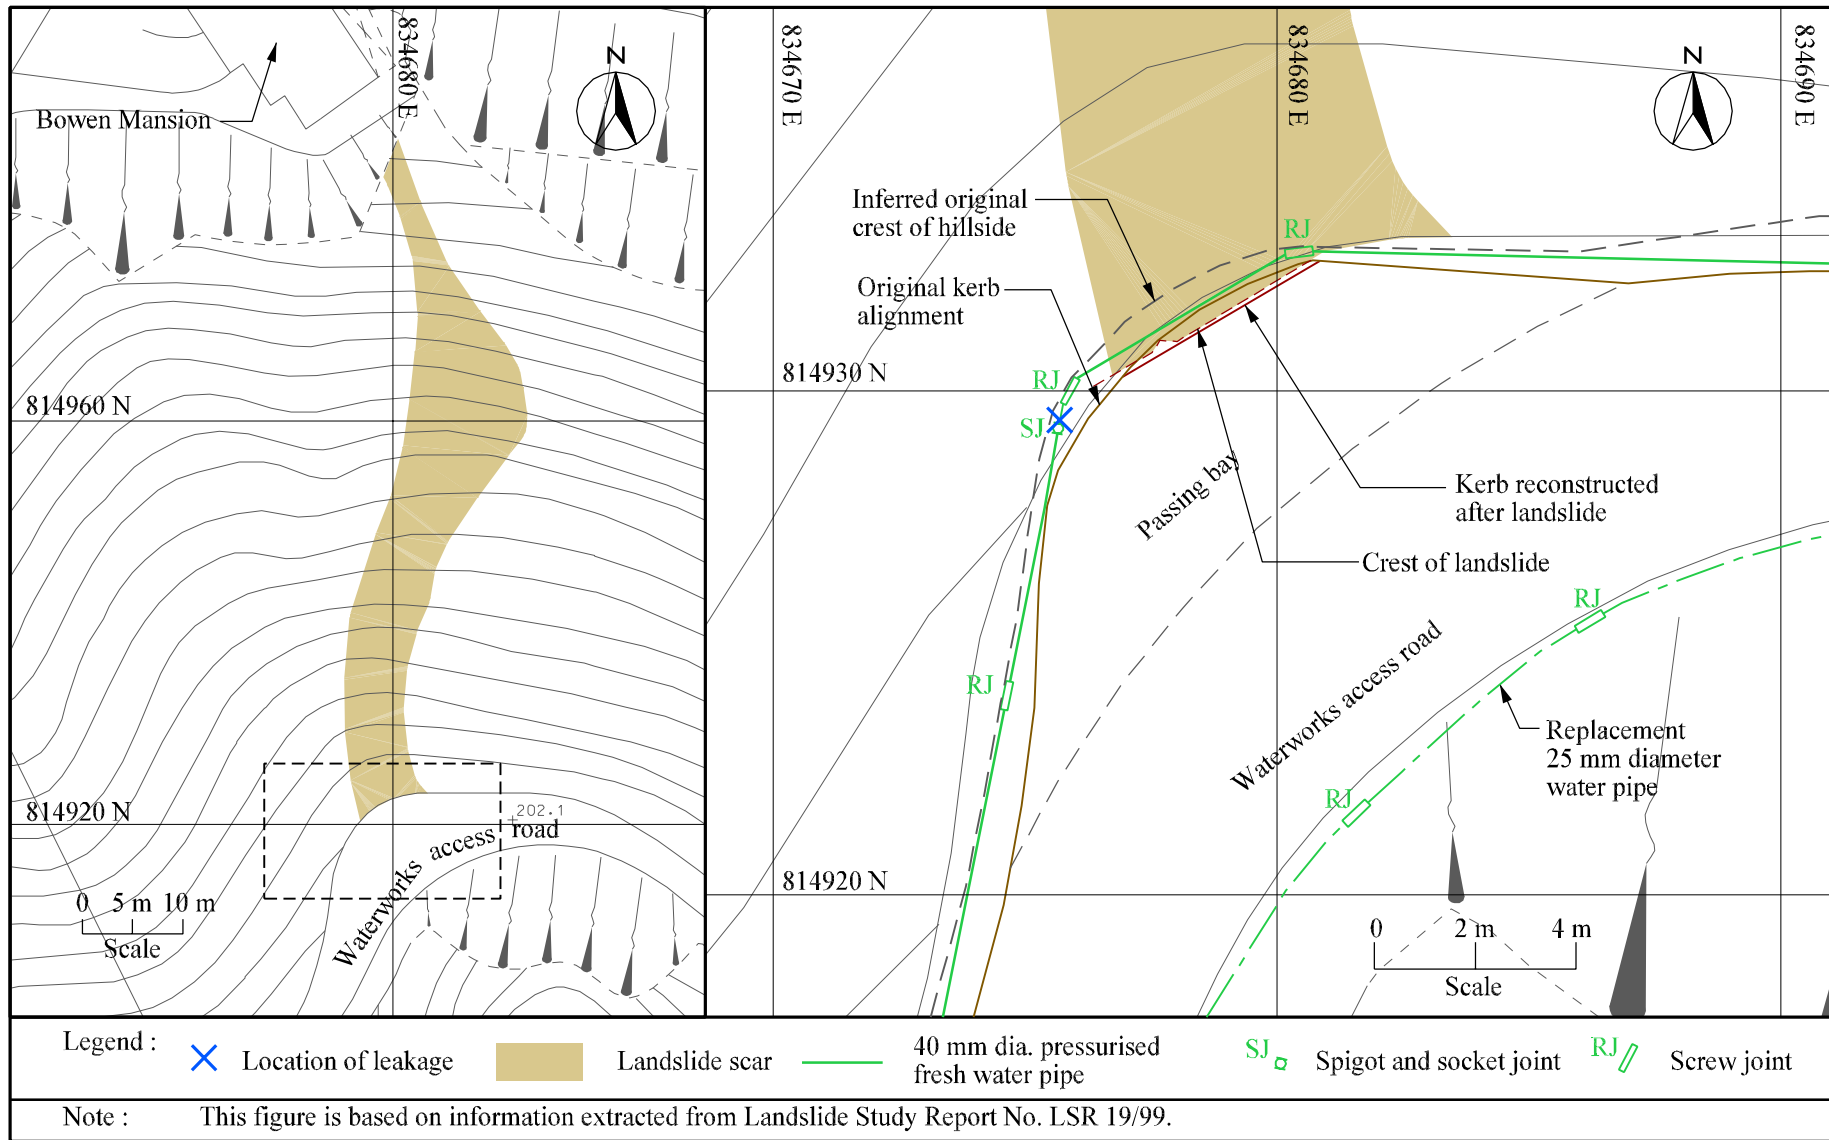
Figure 11 - The 11 June 1998 Landslide on the Natural Hillside behind No. 7C Bowen Road

This minor landslide (about 10 m³ in volume) on a natural hillside was probably caused by the leakage from an exposed 40 mm pressurised freshwater main along the outer edge of a WSD access road at the slope crest leading to a service reservoir (Figure 11, Plates 19 and 20). The landslide caused minor damage to the residential building below and the residents of five flats were temporarily evacuated following the incident.

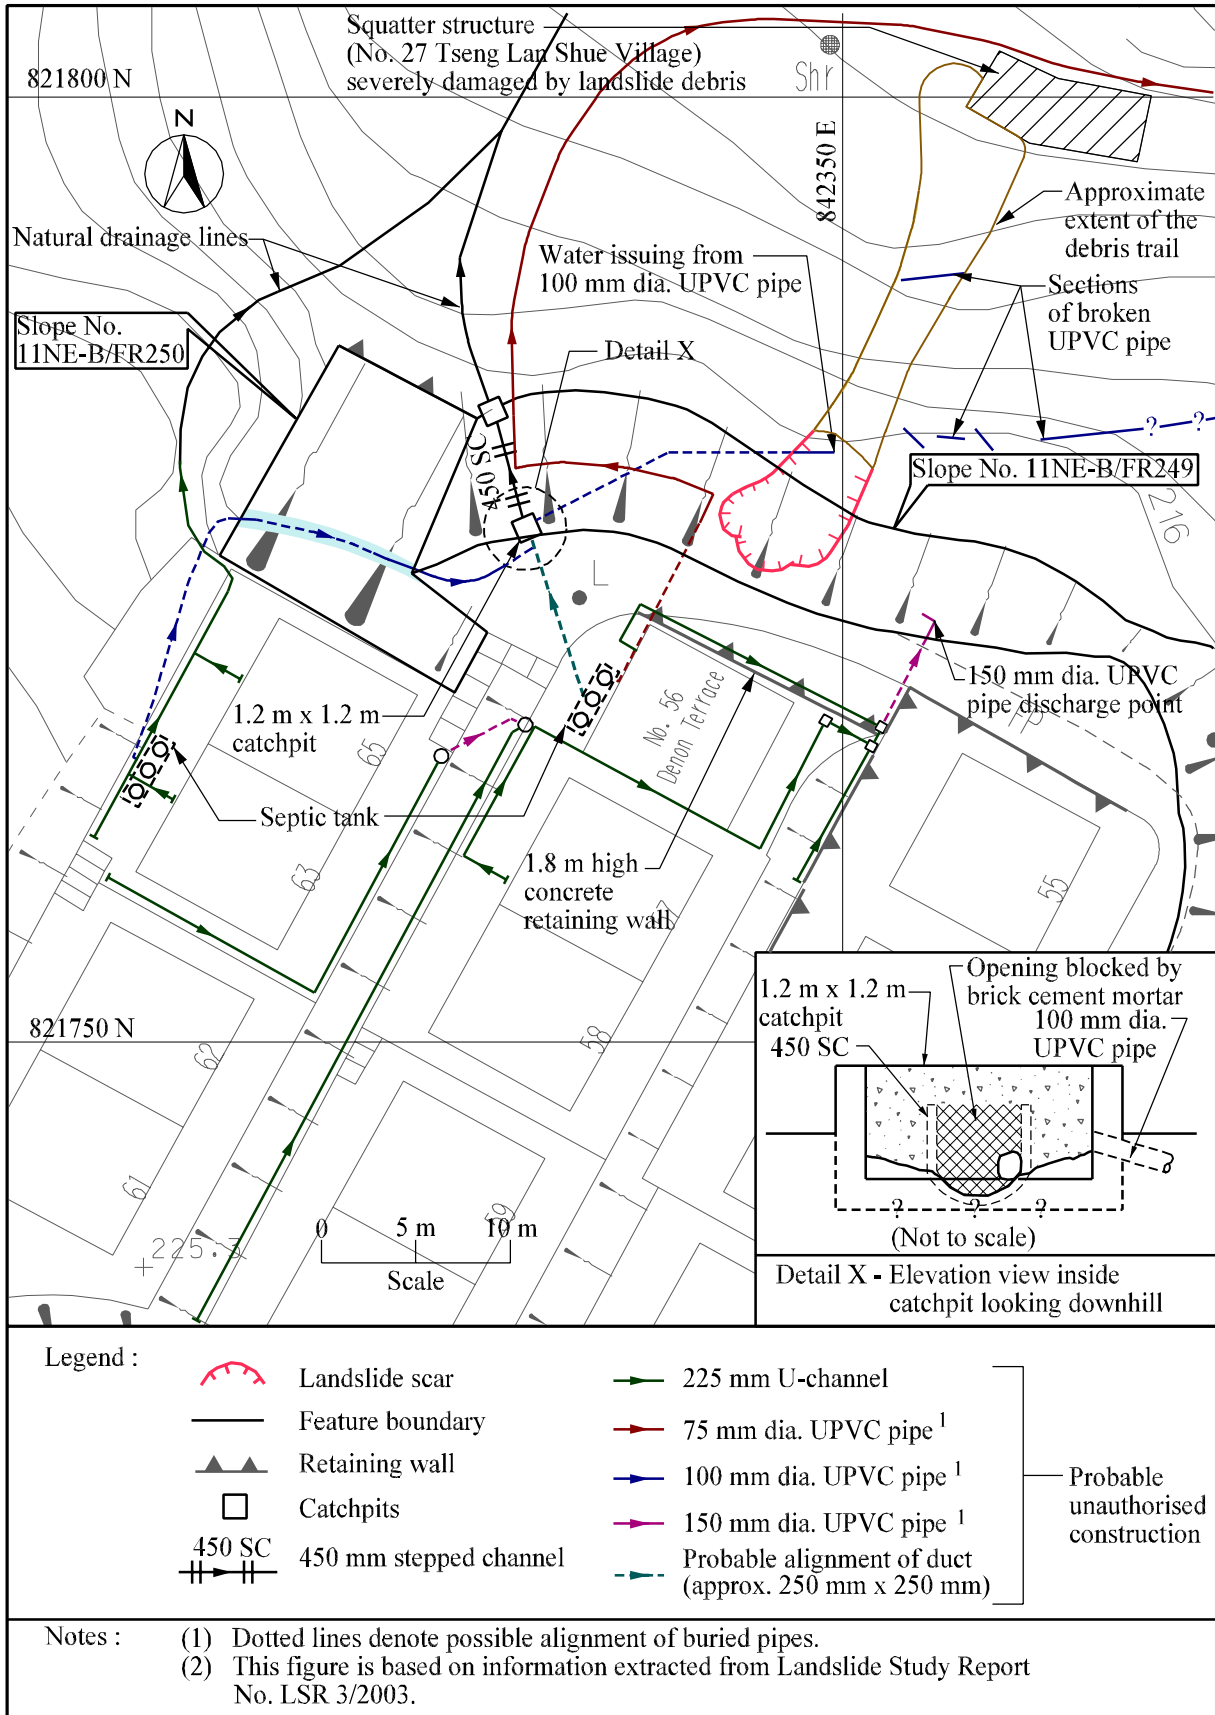
Figure 12 - The 1 September 2001 Landslide at Slope No. 11NE-B/FR249 below No. 56 Denon Terrace, Tseng Lan Shue

This landslide (about 50 m³ in volume) was probably caused by a combination of rainfall and prolonged leakage from an unauthorised, 100 mm diameter, UPVC foul water pipe, affecting primarily a fill slope, which was assessed as being up to the required geotechnical standard (although the presence of loose fill was not known at the time of the previous assessment). An inhabited, registered squatter dwelling comprising a substantial structure located at the slope toe was severely damaged by the landslide (Figure 12 and Plate 22) and the residents were subsequently permanently evacuated.

Site evidence suggests that the unauthorised foul water pipe was likely to have been broken for some time prior to the landslide and that the break was probably caused by illegal dumping of construction debris. Prolonged intermittent discharge from the broken foul water pipe was probably the primary contributory factor to the failure. Another unauthorised 150 mm diameter UPVC pipe collecting surface runoff from the building platform above the slope crest was observed to be discharging directly onto another part of the fill slope outside the landslide scar (Plate 23).

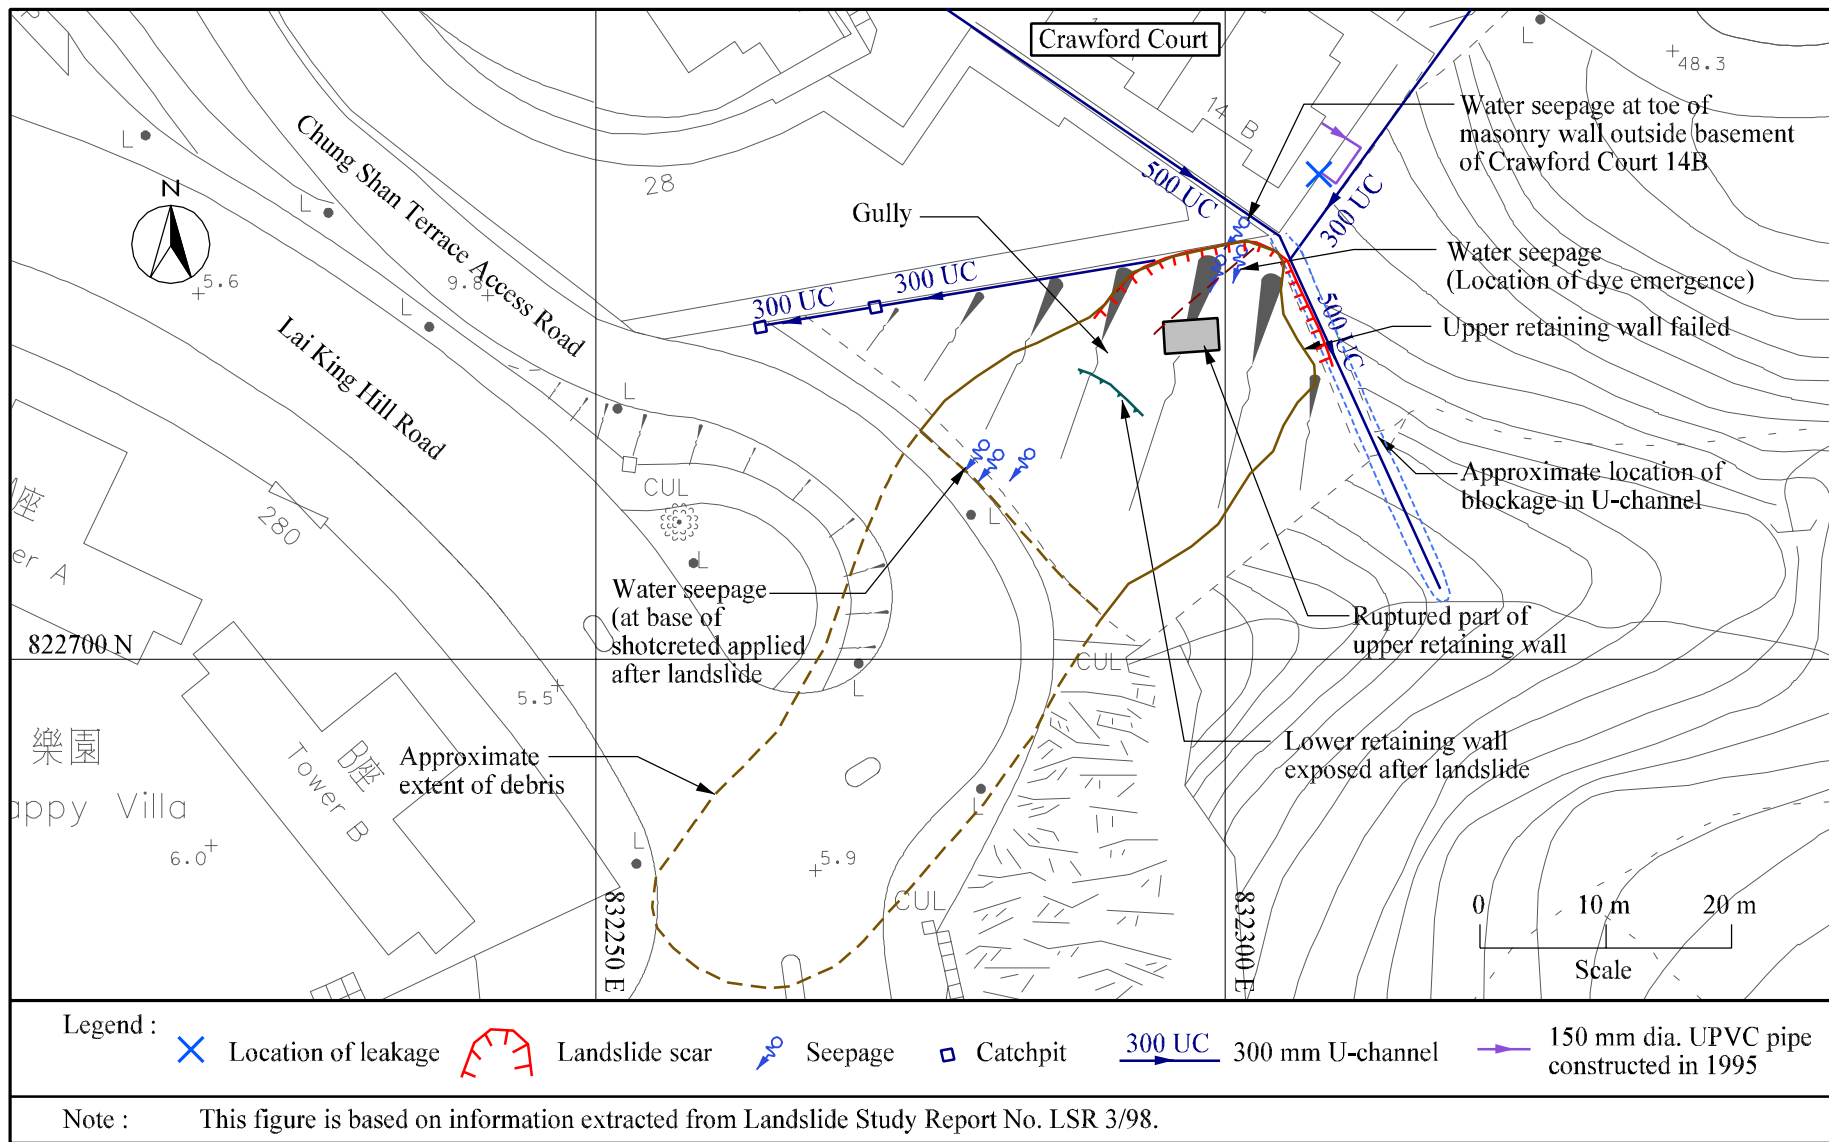
Figure 13 - The 4 June 1997 Landslide at Chung Shan Terrace, Lai King Hill Road

The landslide was probably triggered by heavy rainfall with leakage from a 150 mm privately-owned buried water pipe being diagnosed as a key contributory factor. The water pipe was installed at the private development at the slope crest in 1995 to accept both stormwater and foulwater from the buildings (Figure 13 and Plate 24). Tracer tests carried out for the landslide investigation revealed that leakage from the 150 mm water pipe seeped directly into the landslide scar. The effects of leakage from the water pipe were probably exacerbated by the presence of a buried old, retaining wall at about mid-slope, which acted as a dam to groundwater flow. The landslide debris was mobile with a travel angle of about 18°.

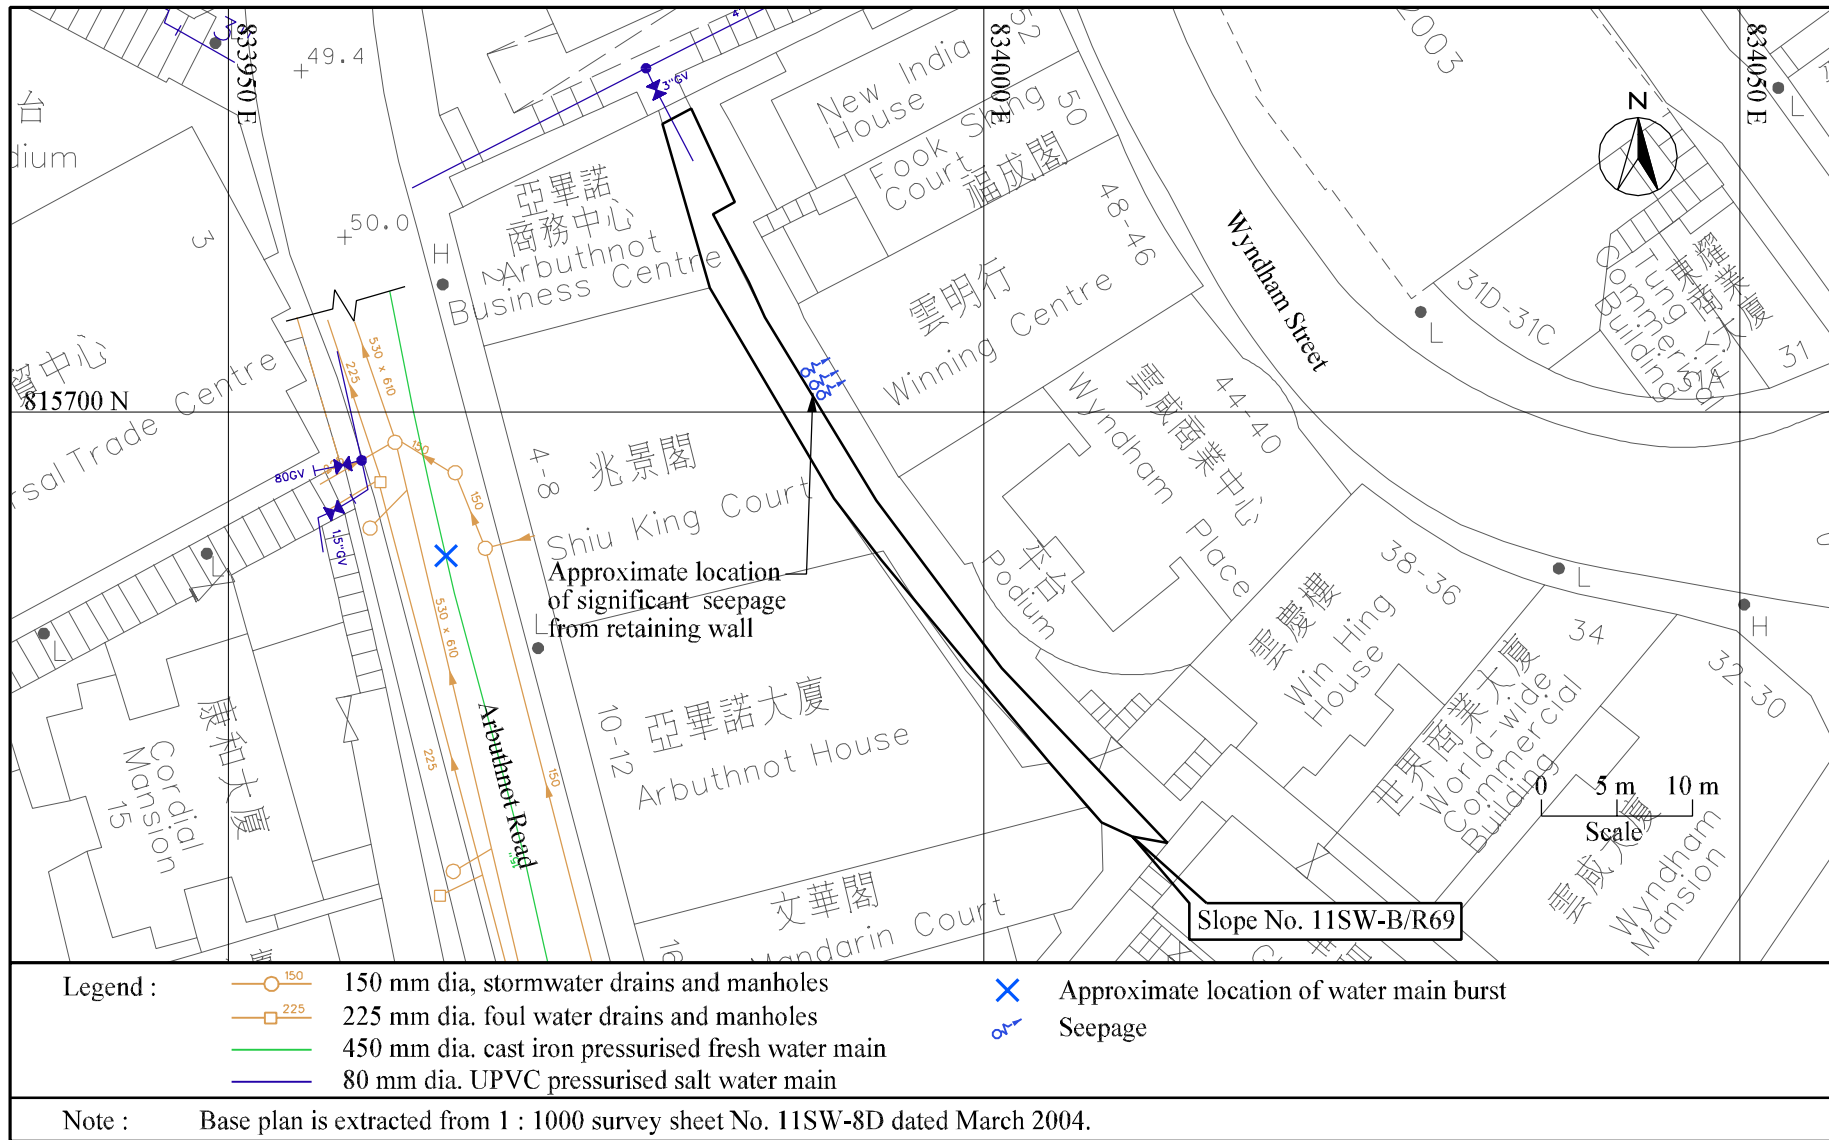
Figure 14 - The 17 February 2003 Seepage Incident at Retaining Wall No. 11SW-B/R69 behind Nos. 40 to 52 Wyndham Street

On 17 February 2003, heavy seepage was reported by the local residents to be ‘jetting out’ from weepholes at about the mid-height of a 12 m high old masonry wall (Figure 14, Plates 25 and 26). Subsequently, WSD carried out chemical tests on samples of the seepage and the results indicated that “the seepage is neither potable nor salt water”. According to WSD, they had also carried out leakage detection tests for “all water mains located in the vicinity” of the masonry wall and no signs of leakage from a water main were identified.

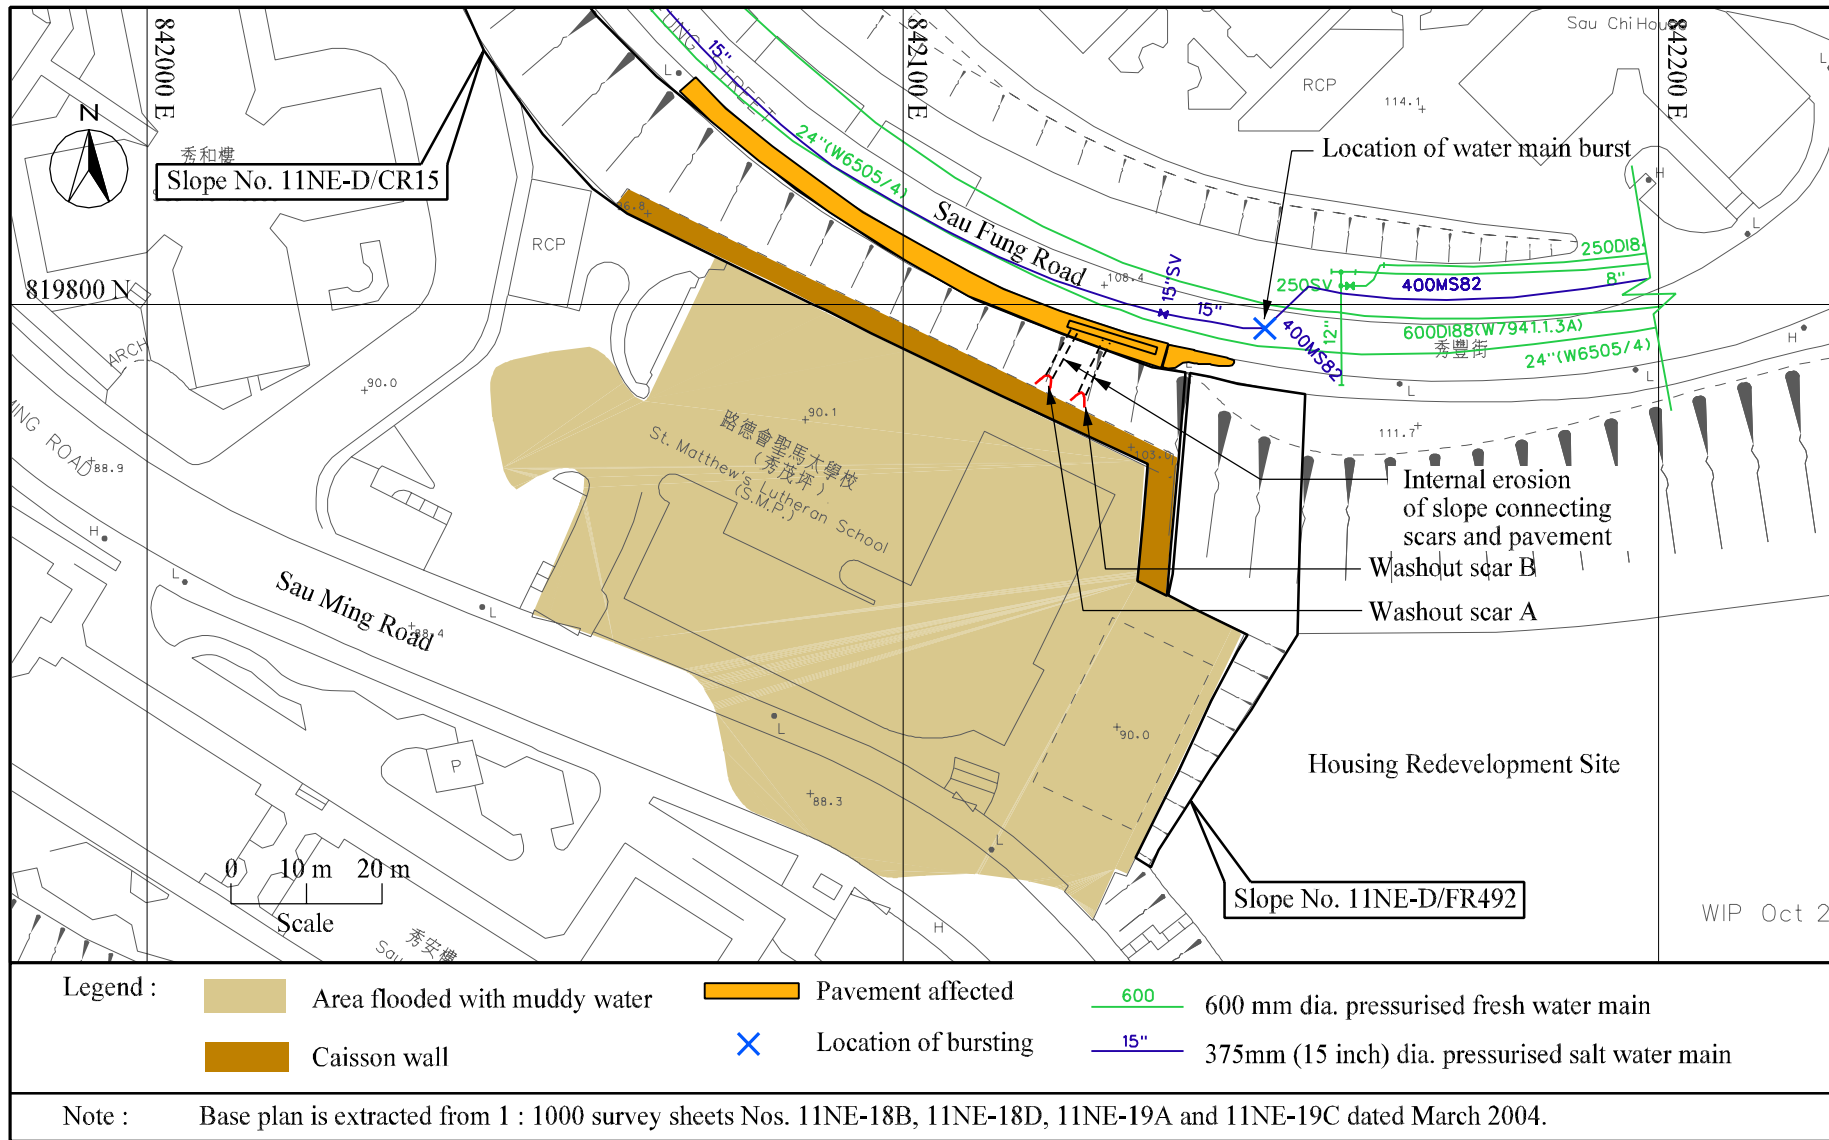
Figure 15 - The 23 November 2004 Water Main Burst Incident at Slope No. 11NE-D/CR15 at Sau Fung Street, Sau Mau Ping

At about 12:30 p.m. on 23 November 2004, bursting of a 375 mm diameter pressurised, asbestos cement, saltwater main at about 2 m below ground surface occurred at Sau Fung Street some 6 m beyond the crest of an engineered slope feature (Figure 15 and Plates 27 to 29). A 70 m long section of the block-paved footway on the south side of Sau Fung Street was affected. Copious amounts of water gushed from the burst water main for about an hour, mostly from subsurface seepage, and overtopped the 12 m high caisson wall at the lower portion of the slope. The water flow completely flooded the playground and ground floor of St. Matthew's Lutheran School below.

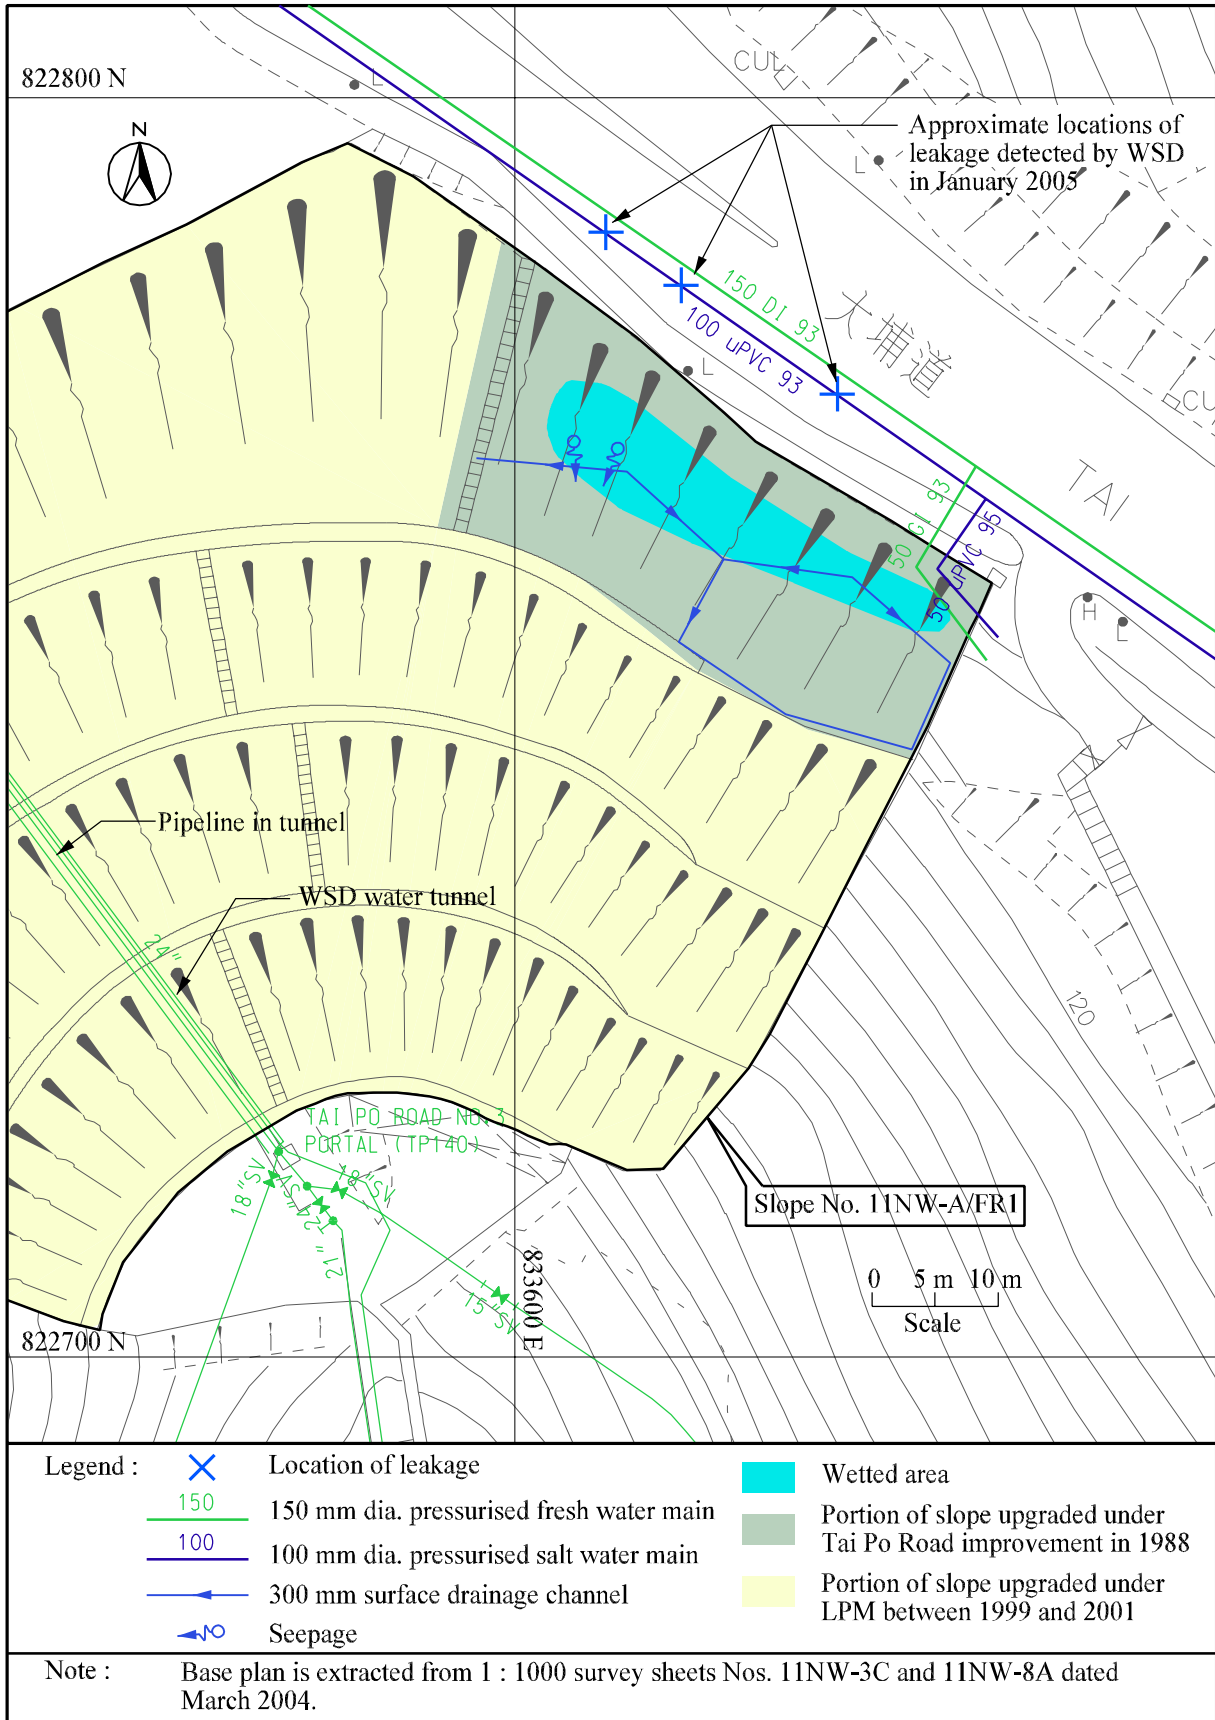
Figure 16 - The November 2004 Saltwater Main Leakage Incident at Slope No. 11NW-A/FR1 below Tai Po Road

In November 2004, seepage was noted by WSD's consultant on the uppermost batter of an engineered fill slope below Tai Po Road (Figure 16), which was upgraded by Highways Department (HyD) as part of the Tai Po Road improvement works between 1988 and 1990.

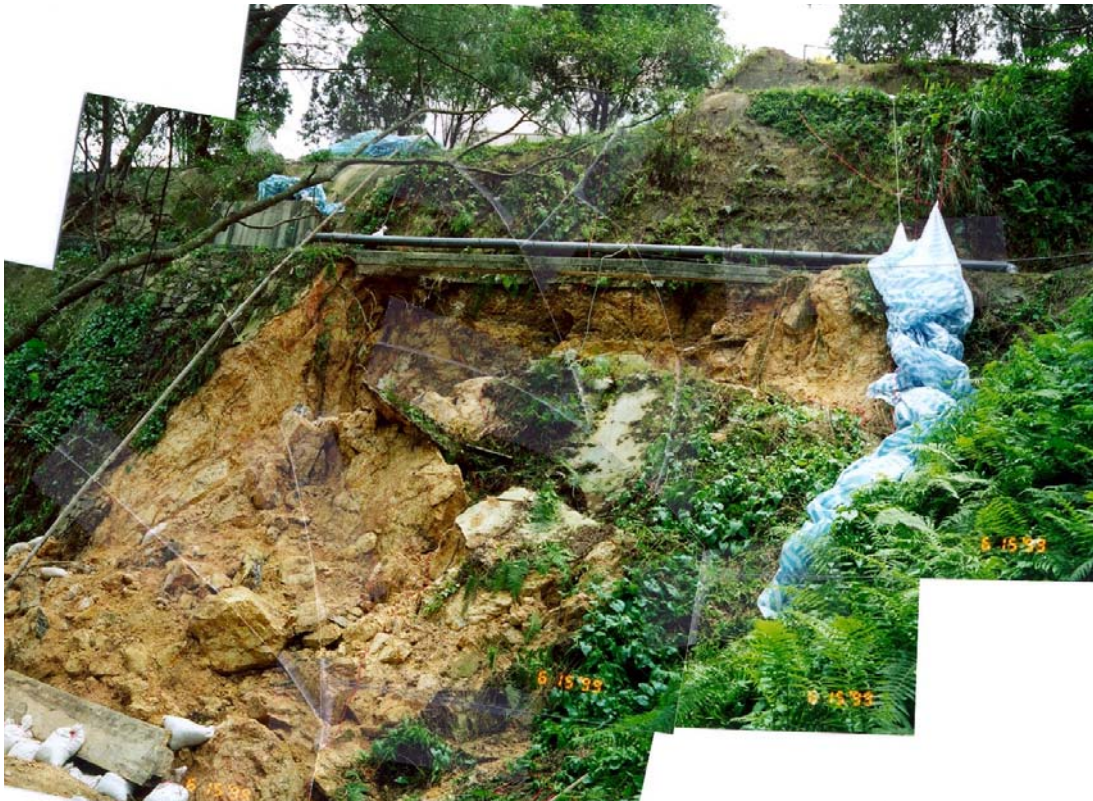
Plate 16 - General View of the Landslide - Chinese University
(Photograph taken on 15 June 1999)

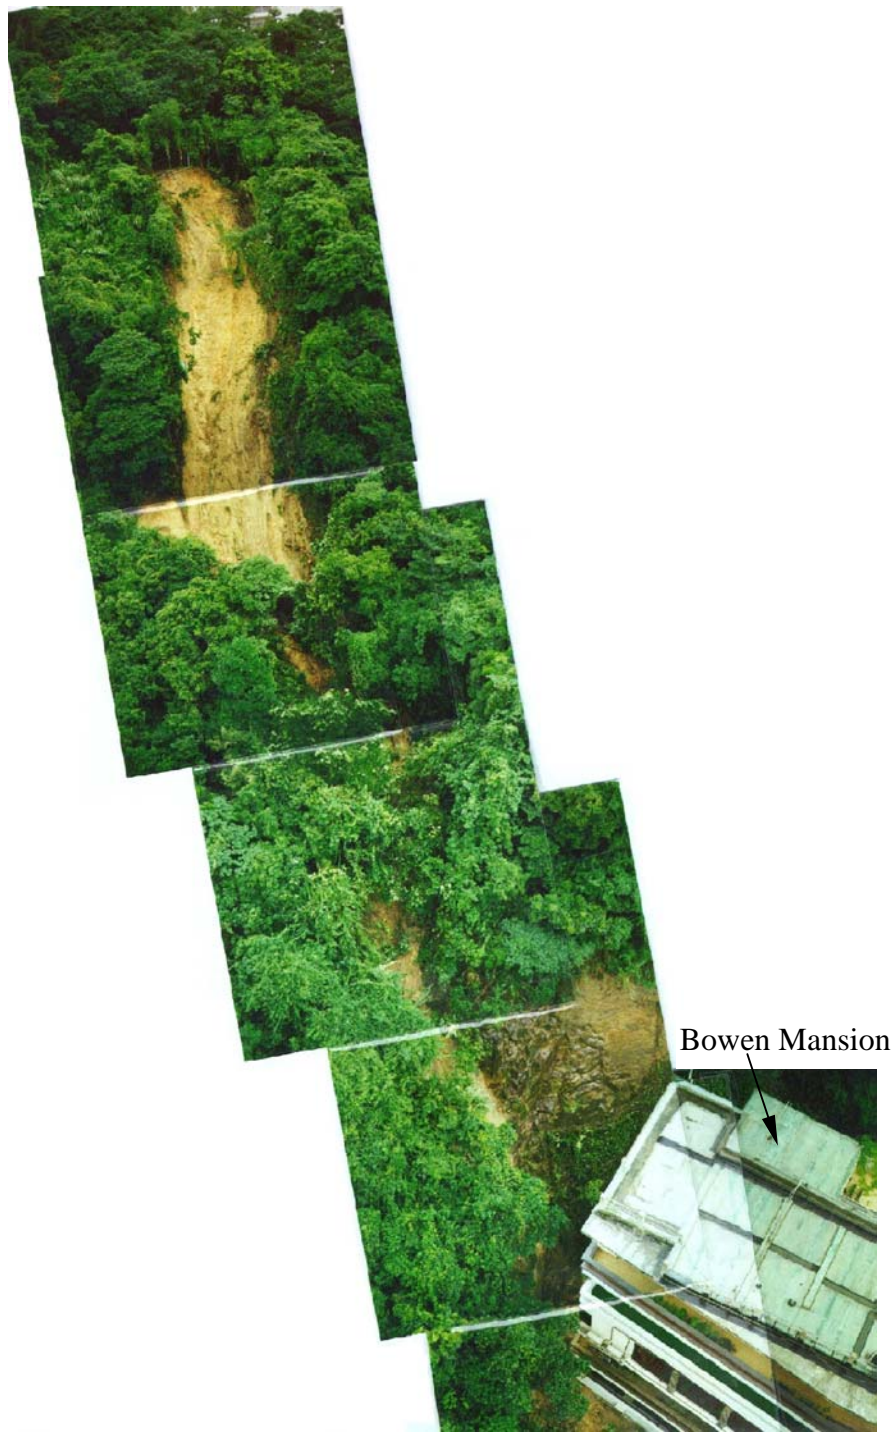
Plate 19 - General View of the Landslide - Bowen Road
(Photograph taken on 11 June 1998)

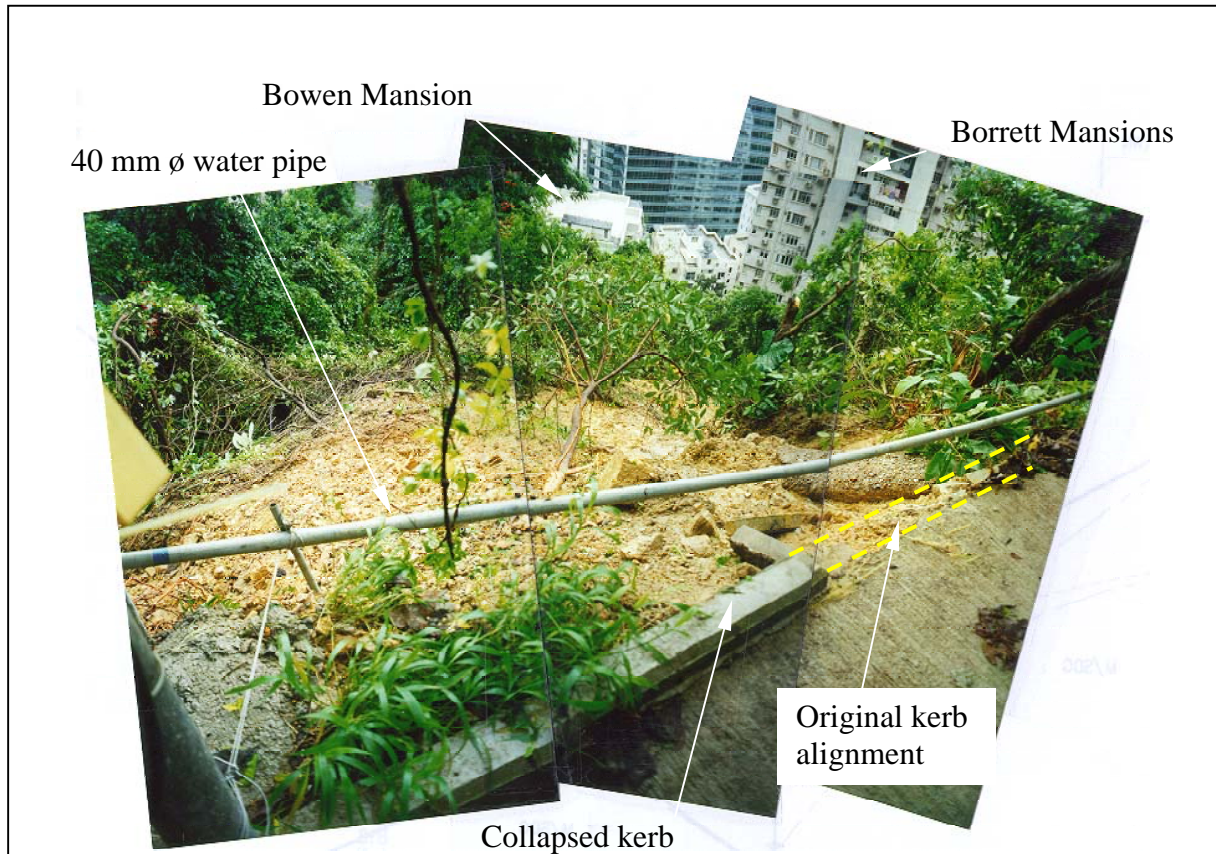
Plate 20 - General View of the Landslide Scar near the Crest - Bowen Road
(Photograph taken on 11 June 1998)

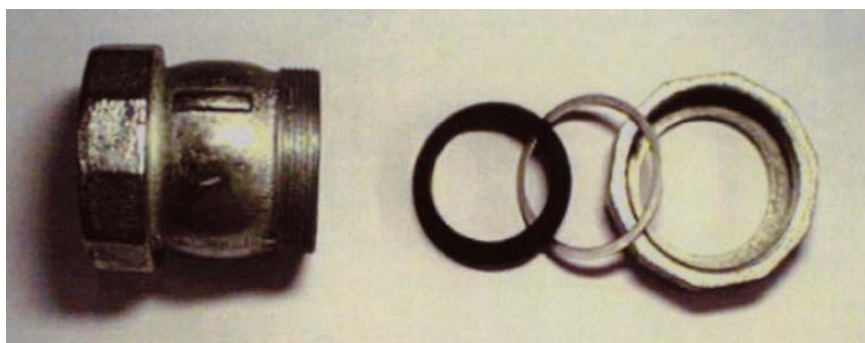
The detailing of the joints in the water pipe (i.e. 'union joints', or sometimes referred to as 'simple joints') near the crest of the failed natural hillside comprises a coupler for plain-ended pipes (without threading, welding or flanging), and involves tightening the cap nut (with internal threads in the coupler) and squeezing a rubber ring to form a 'watertight' joint and hold the two sections of pipe together (Plate 21). This type of joint can sustain a limited amount of movement.

Plate 21 - Details of 'union joint'

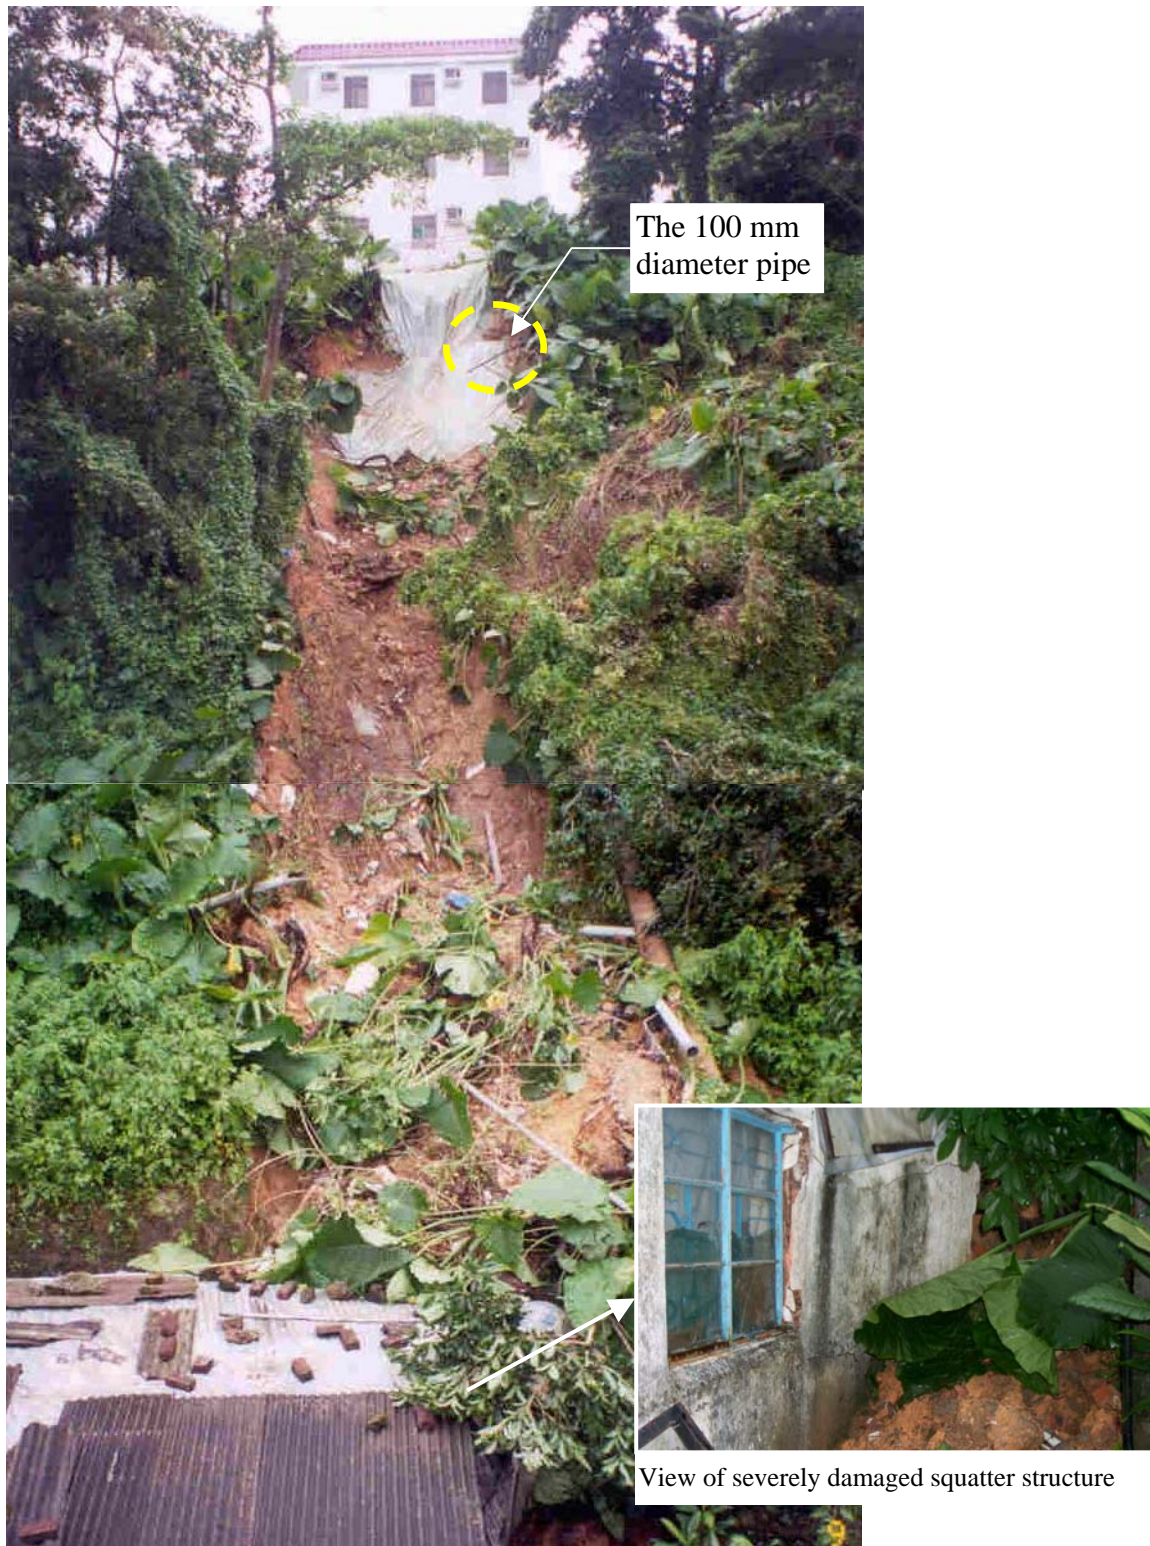
Plate 22 - General View of the Landslide - Denon Terrace
(Photograph taken on 3 September 2001)

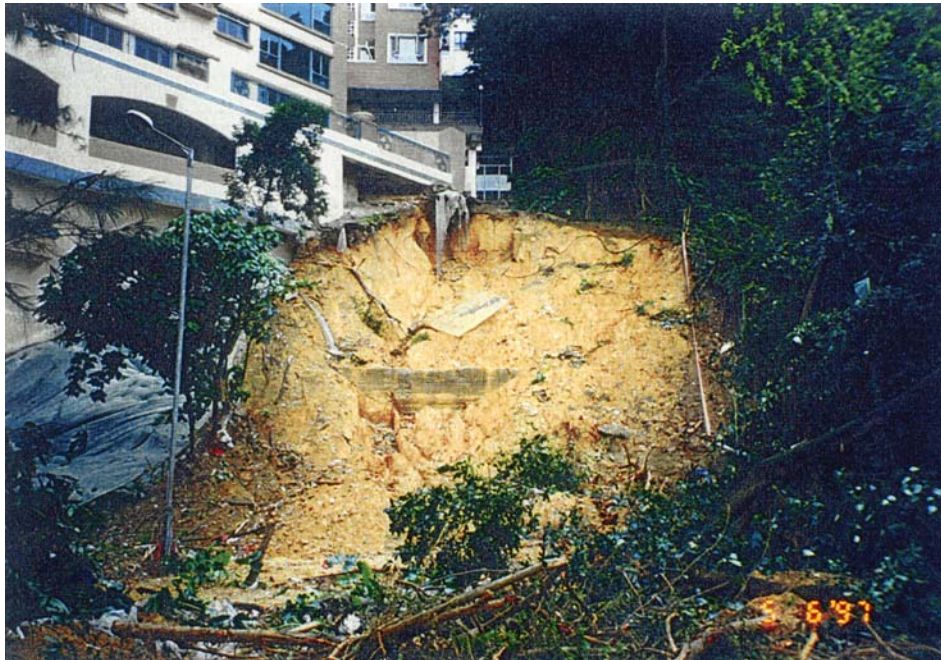
Plate 24 - General View of the Landslide - Chung Shan Terrace (Photograph taken on 5 June 1997)

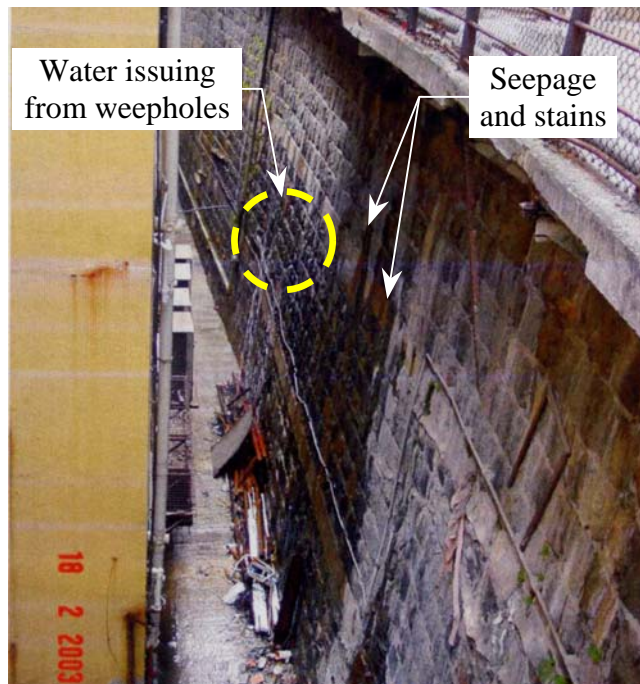
Plate 25 - View of the Masonry Retaining Wall No. 11SW-B/R69 behind Nos. 40 to 52 Wyndham Street (Photograph taken on 18 February 2003)
